SKETCHES TO SHOW REUSED CRUCK TIMBERS.

Mason's barn, Burnasall

RE-USED CRUCK at

12 BEANLANDS PARADE, JILKLEY.

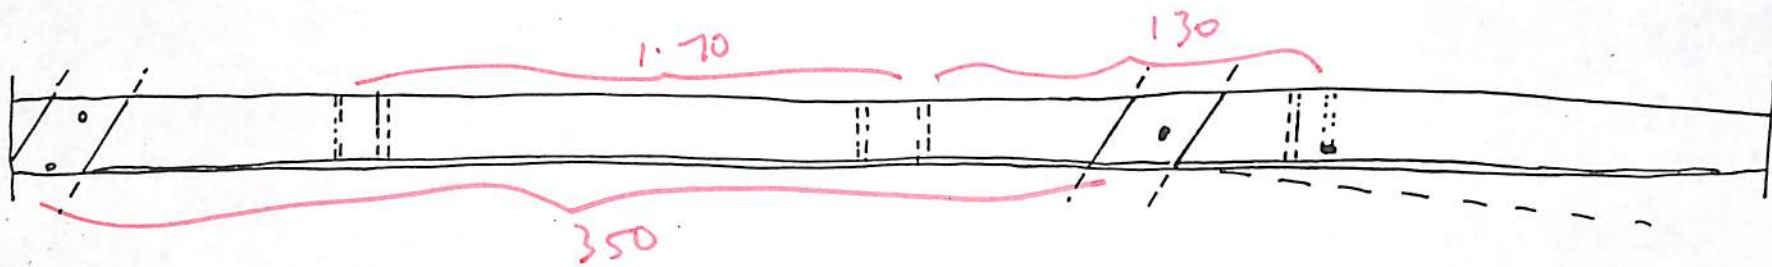
Former left hand blade

curve at base of blade removed

peg holes in sides probably for purlins

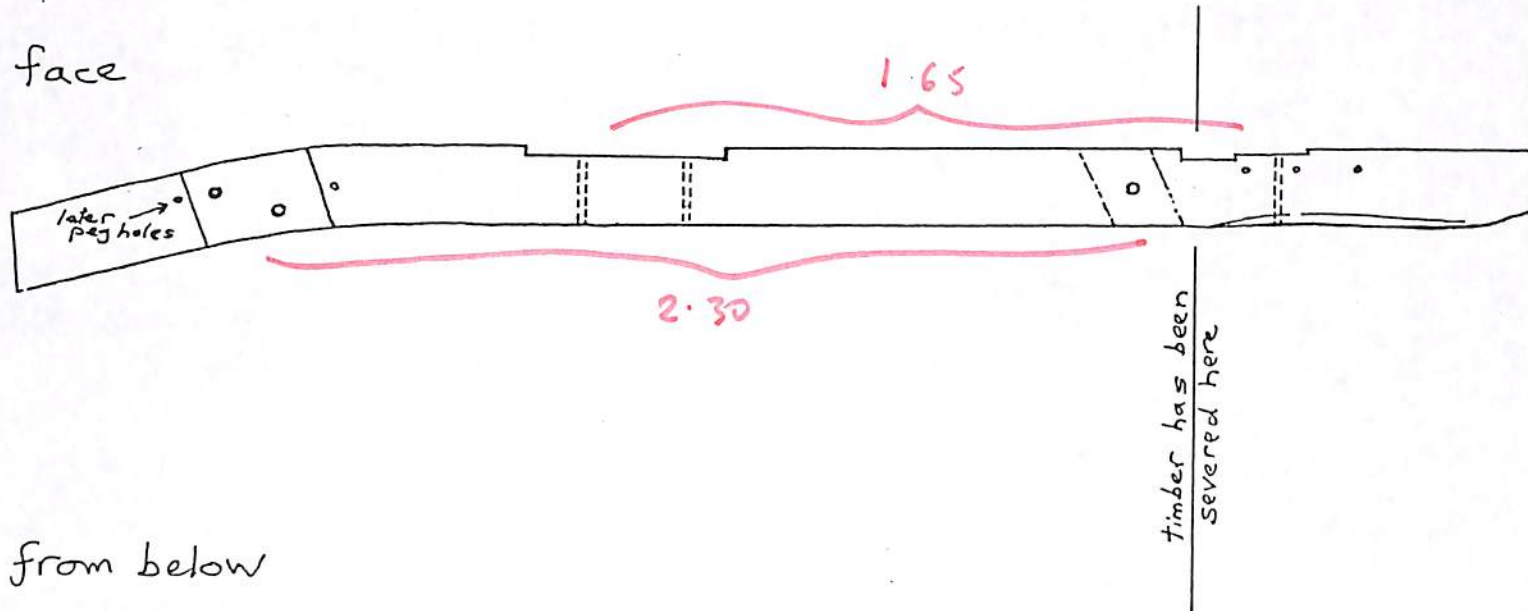
main face

until 1989 this was re-used  
as a purlin in a barn roof.  
Now a fireplace lintel.

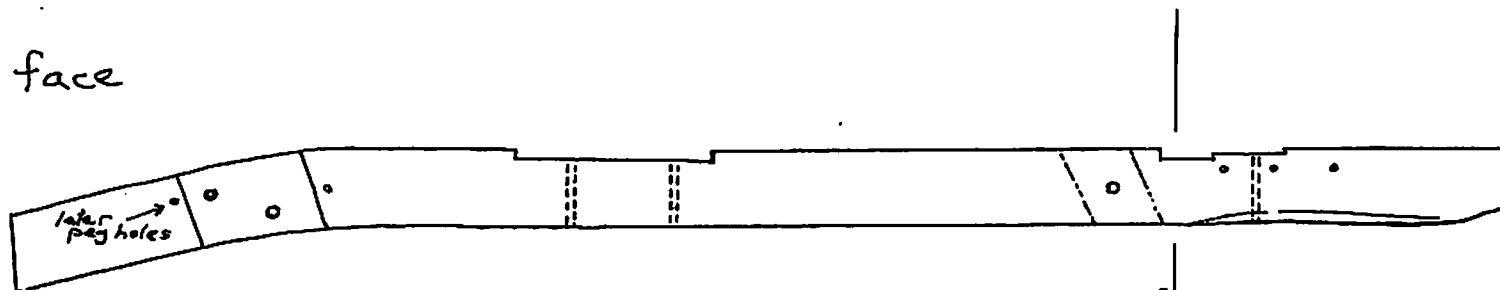
main face

until 1989 this was re-used  
as a purlin in a barn roof.  
Now a fireplace lintel.

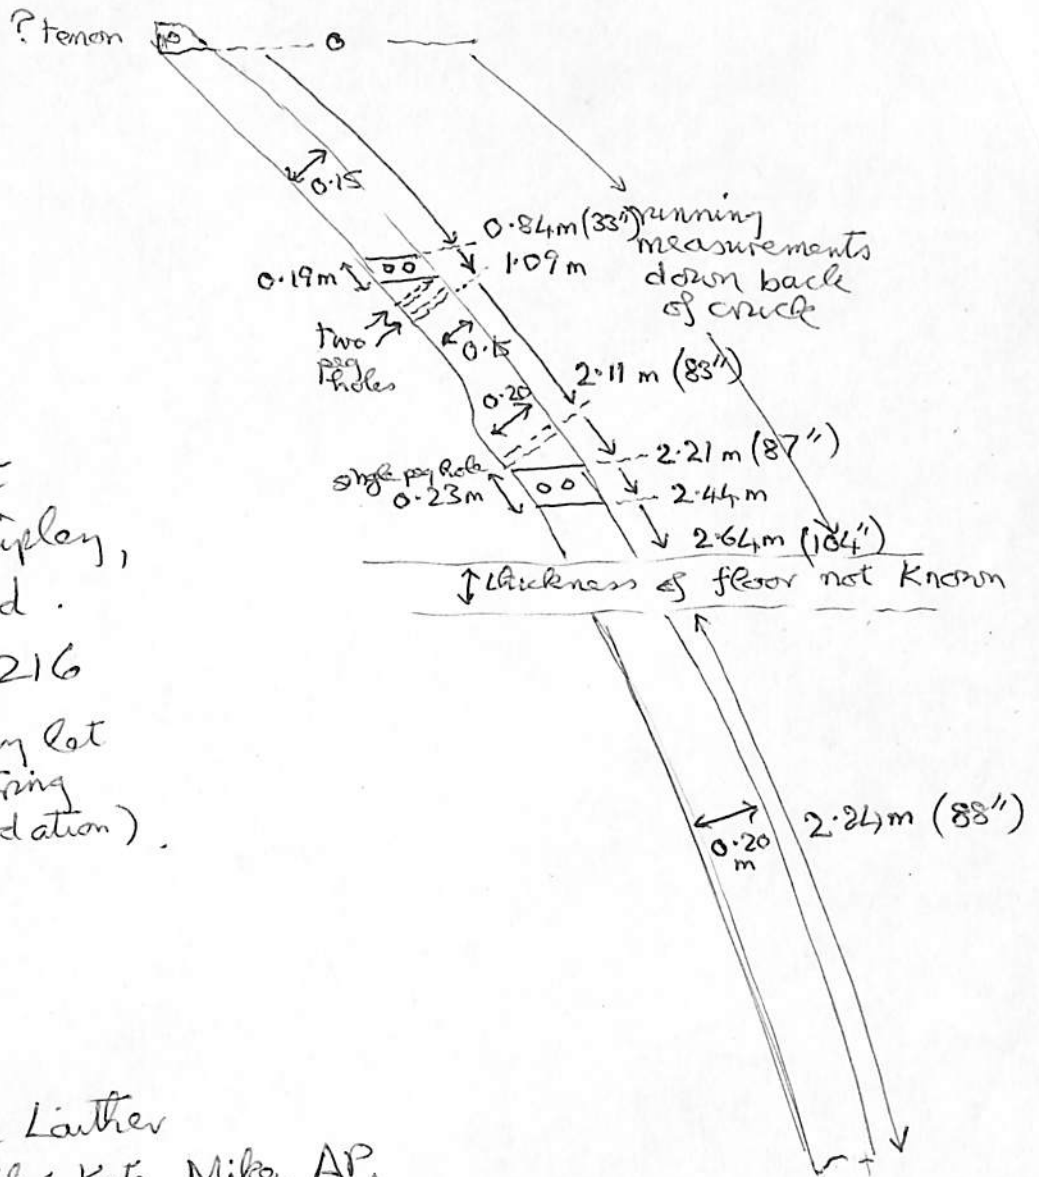
timber has been  
severed here

Crack at  
High Shipley,  
Marwood.  
NZ 014216  
(where they let  
self-catering  
accommodation).
