# INGLEBOROUGH DALES LANDSCAPE PARTNERSHIP

## "Stories in Stone Project"

### VERNACULAR BUILDINGS TRAINING DAYS (2016-2019)

**BUILDING RECORDED: *Pinder Ing barn or Tithe barn***

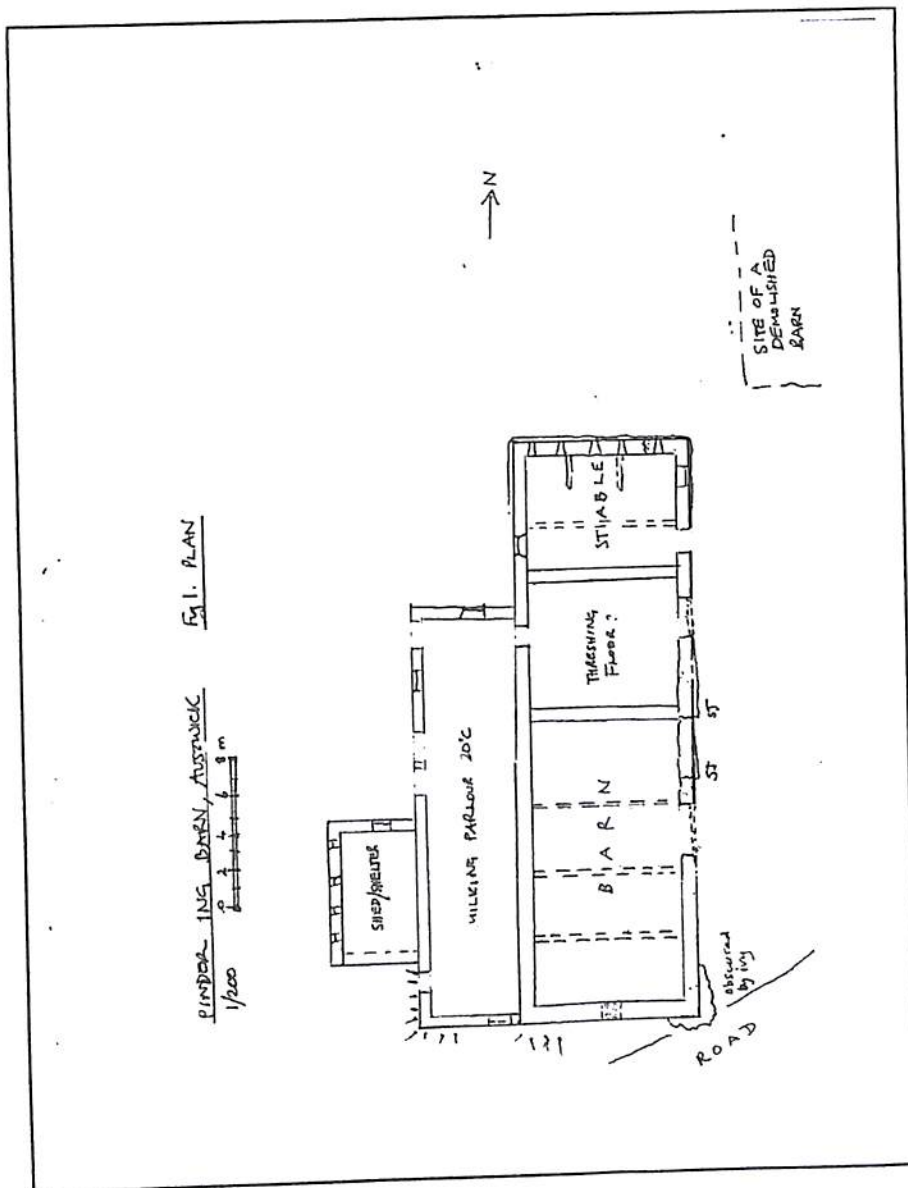
Fig 1 Plan of barn

A rather long barn for the Craven area with later additions indicating varied use over time. There are added 20thC milking sheds, earlier stables and threshing floors. (See plan Fig 1).

Dr Sylvia Harrop, in her book "Austwick" (2011) states that this "was the village tithe barn". This would explain the rather unusual plan. The stonework shows evidence of extensions and changes of use over time. The older, long, barn structure is present on the OS map 1848 and the extensions are later. (See plan fig 1)

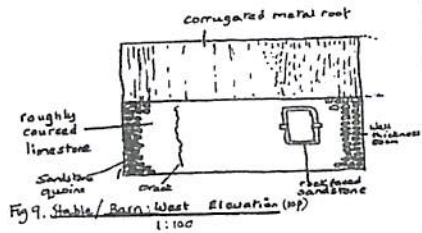
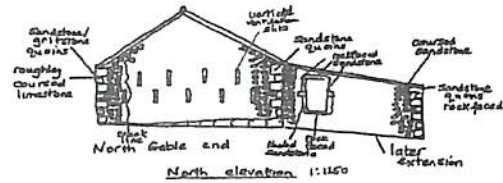
Fig 4b  
NORTH GABLE END  
Scale 1:100

**3.3. The north gable end** of the building (see elevation drawing fig 4 a,b,c)has slit vents, rather than square ones seen near the south end. The plinth seen lower down continues. The quoins are of sandstone. The walling has prominent vertical cracks which may indicate that part of the gable wall is from an older structure.
