REPORT ON THE DERAILMENT

18th April 1952 at

BLEA MOOR

LONDON MIDLAND REGION

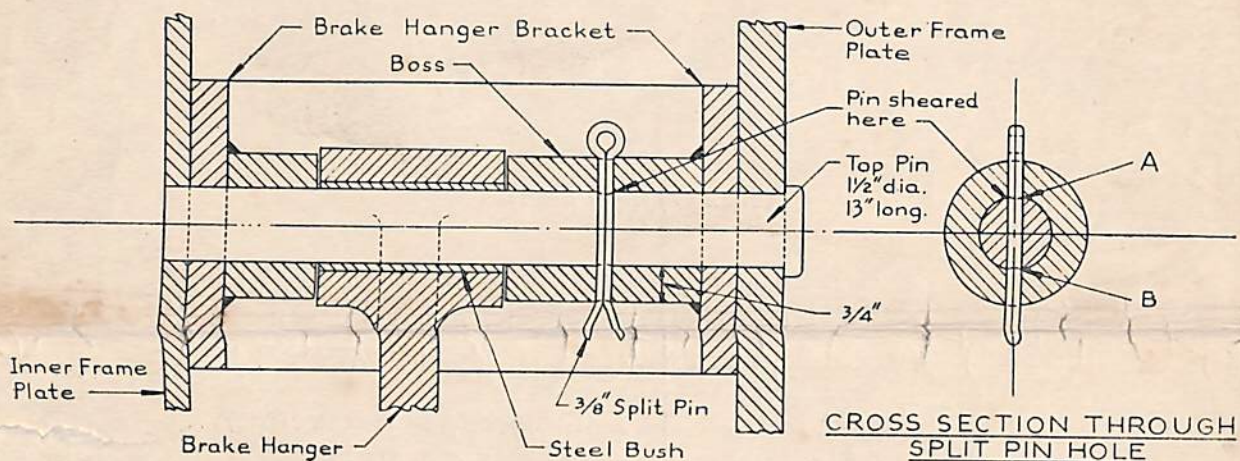
The arrangements for supporting the brake hanger are shown in the sketch below:—

After the accident, only the upper portion of the split pin (above A) was in position, and the top pin was missing. It was subsequently found about  $1\frac{1}{2}$  miles beyond the first marks on the track. The legs of the split pin were not found and they may have fallen out many miles back.

The top pin was of case hardened steel and had a clearance, when new, of  $\frac{1}{64}$  inch in the brake hanger bracket and in the boss. The split pin was an easy fit in the holes. There was no means of lubricating the top pin and consequently friction with the brake hanger bush caused it to rotate slightly whenever a brake application was made, thus subjecting the split pin to shear.

An examination of the upper portion of the split pin concerned showed that this rotating movement caused one of its legs to be sheared through almost entirely, and the second leg partially, at A. The first leg then fractured, but the burring of the metal probably prevented it from falling out. The shearing then continued in the second leg at a different angle, but before it became extensive that leg also fractured. Presumably both the legs then dropped out and the vibration of the engine caused the top pin to work out of its position; when it cleared the brake hanger bush, the hanger fell. It was difficult to estimate the period of time between the fractures of the two legs of the split pin, but it may not have been great.

The split pins securing other top pins were examined and showed similar signs of shearing action at A and also, but to a lesser extent, at B.

It was not a satisfactory feature in the design of the Merchant Navy class engine that the split pins should be subjected to shear. This feature was noticed for the first time in December, 1951, after the class had been in service for over ten years, when a similar incident occurred near Woking, fortunately without any damage. As a result, a modification of the arrangements for supporting the brake hanger was proposed, and it was still under consideration. After the present accident, however, immediate steps were taken to remedy the defect. All the split pins concerned were examined, and renewed if necessary. It was also decided to fit a longer top pin and to secure it outside the frame plate by a split pin which could not be subjected to shear. The work on all the engines in traffic was completed on 5th November, 1952. Action is also in hand by the Headquarters of the Railway Executive to ascertain whether the same feature in design exists on other classes of engine and, if necessary, to modify it.

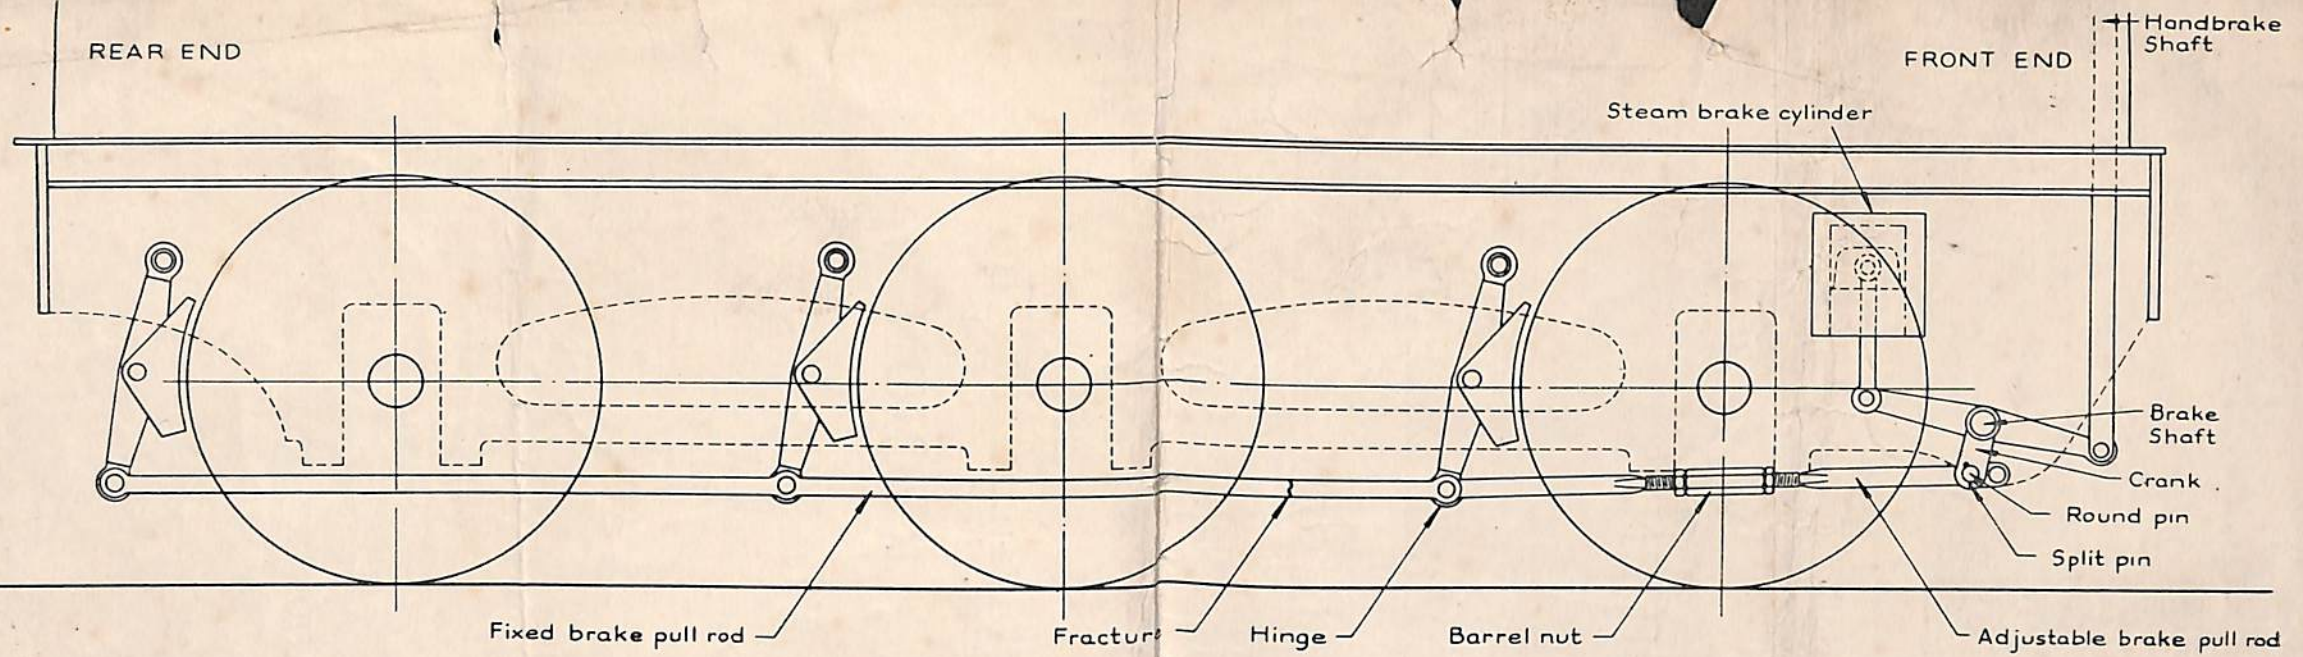
ENLARGED SKETCH SHOWING FITTING OF ADJUSTABLE BRAKE PULL ROD TO BRAKE SHAFT

5. There are two adjustable brake pull rods on the tender of the pilot engine No. 41040 and they are each about 5 feet 8 inches long. The front ends are attached to the cranks on the brake shaft by case hardened round steel pins  $1\frac{3}{4}$  inches diameter and  $5\frac{1}{2}$  inches long, held in position by  $\frac{1}{2}$  inch diameter split pins. The general arrangements are shown in the sketch opposite page 3.

6. The round pin from the right hand adjustable rod and its split pin was missing from the engine. A similar type of round pin was subsequently found in the vicinity of the first mark on the sleepers and I assume it to be the missing pin ; no split pin was found. The round pin was undamaged ; it had slight wear marks made by the bushes in the fork of the brake shaft crank, and these marks extended halfway across the split pin hole.

7. The round pin from the left hand brake rod was removed for examination. It was not of standard size and again the wear on it extended well over the  $\frac{7}{16}$  inch diameter split pin hole. The split pin was only  $\frac{5}{16}$  inch diameter and it was kinked and partially sheared at the head and in the legs

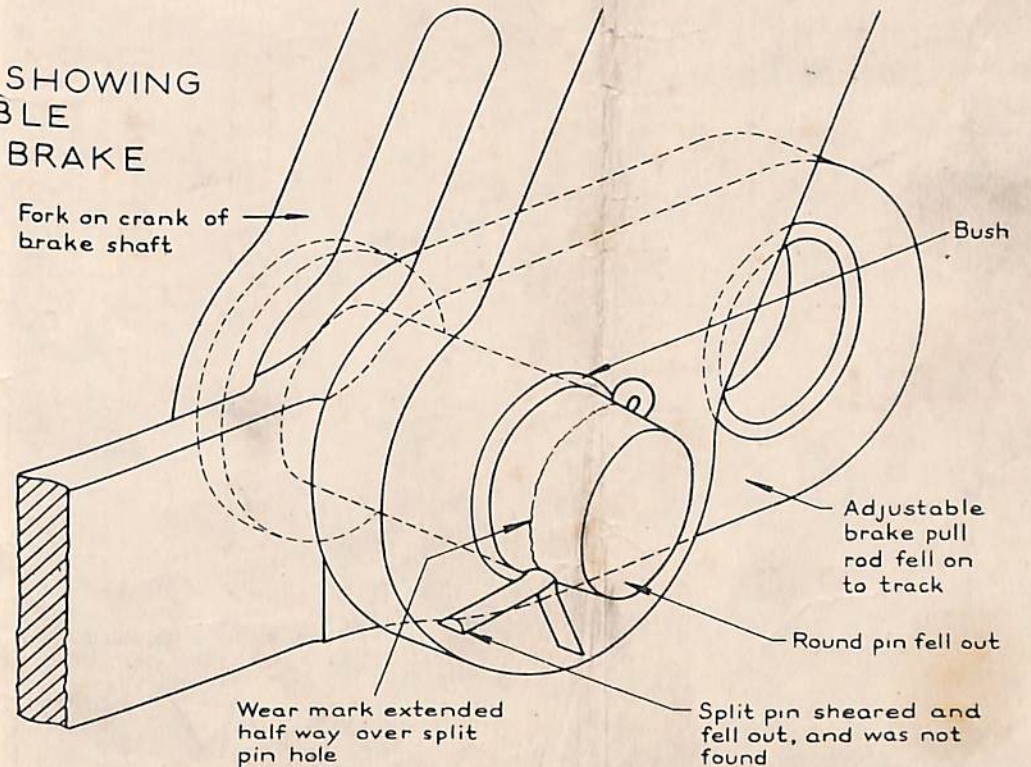
SKETCH SHOWING LAYOUT OF BRAKE GEAR ON THE TENDER OF CLASS 4P ENGINE No. 41040

8. As shown in the sketch, the forward end of the right hand fixed brake rod was fractured. The rod was flawed at the point of fracture but the flaw could not have been noticed in a normal inspection. This fracture was the result of the leading end of the adjustable rod striking the track, and it did not contribute to the accident in any way.

21. The brake rod came adrift because of bad maintenance of the engine. The round pin holding the rod to the brake shaft became displaced, and this can only have resulted from the securing split pin having dropped out of position. The split pin was not found and it may have come out many miles back. It is not possible, therefore, to say in what way it was defective. There can be no doubt however, that there was some defect, for a well fitting split pin with correctly splayed legs will not fall out of its own accord. The wear marks on the round pin concerned indicated that the split pin could not have been a good fit, and that its condition was like that of the equivalent pin on the other brake rod, which was far from good. It seems probable, therefore, that one leg of the missing pin sheared, and that the pin fell out because the other leg was straight or inadequately splayed. On the other hand both the legs may have sheared.
