YORKSHIRE VERNACULAR BUILDINGS STUDY GROUP

YORKSHIRE
VERNACULAR BUILDINGS
STUDY GROUP 1516

Newhouses -Horton in Ribblesdale Newhouses Farm
Parish or township Name of building

DESCRIPTION

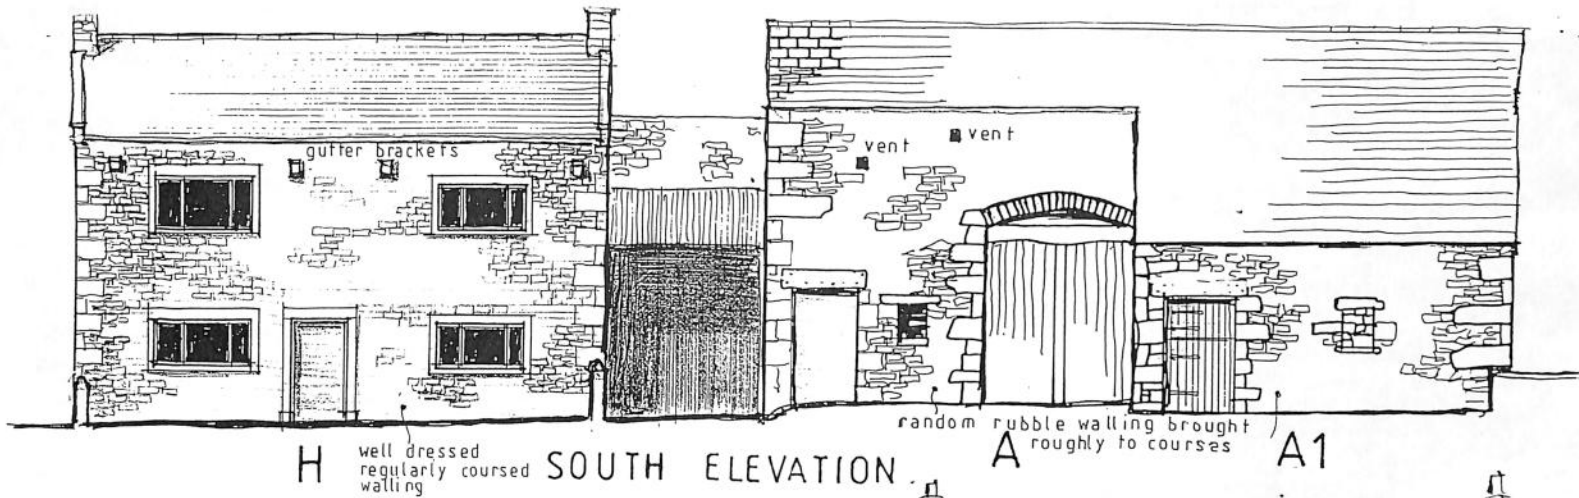
H well dressed regularly coursed walling SOUTH ELEVATION

A random rubble walling brought roughly to courses A1

Barn A South elevation A, A1, have door lintols with a 'picked' dressed finish.
House H South elevation. Some later alterations of heightening to window lintols.

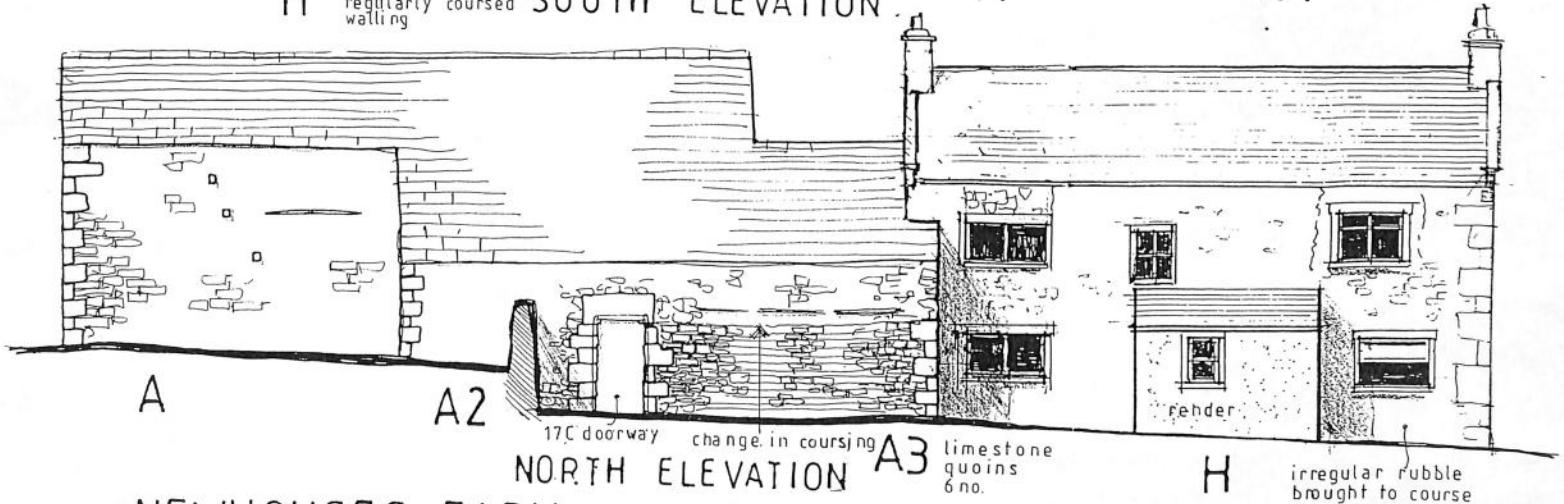
A A2

17C doorway change in coursing NORTH ELEVATION

A3 limestone quoins 6 no.

H irregular rubble brought to course

Barn A The north facade indicates earlier walling around a late 17C doorway that is bonded into the door and west corner quoins. This wall thickness needs to be checked as it may have been part of the earlier house containing the 17C window !

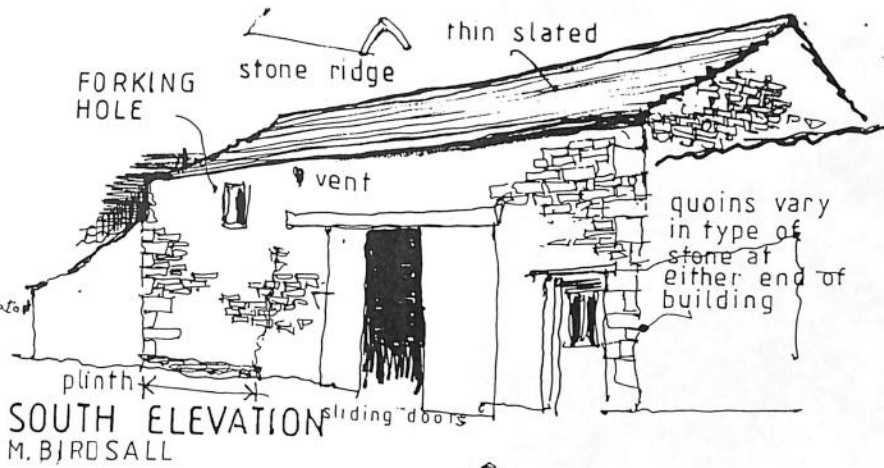
SOUTH ELEVATION
M. BJRSALL

SECTION A. PACEY
(not to scale)

The drawing also shows the profile of the earliest phase as seen in the west gable and in thicker lower walls.

A cruck frame with narrow aisle at the back could produce this profile.

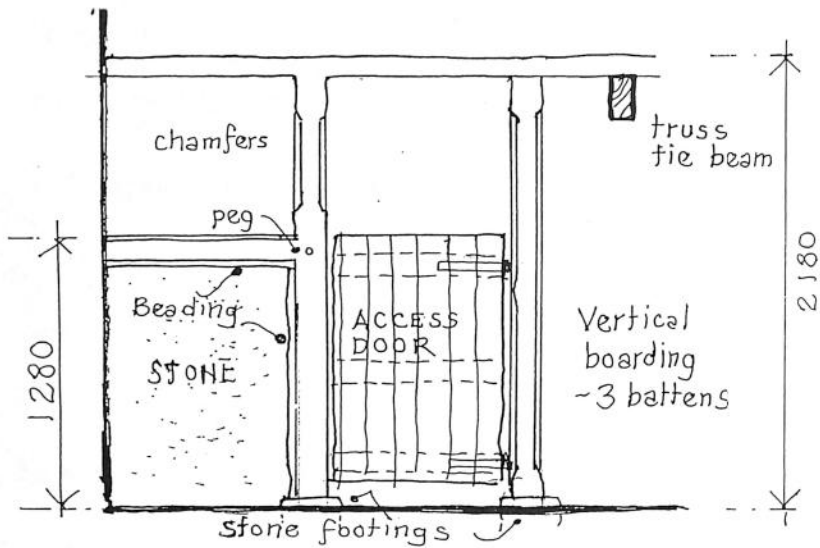
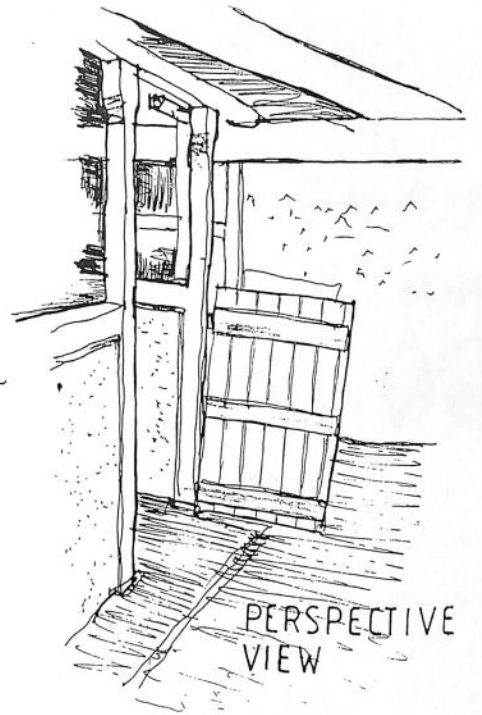
NEWHOUSES FARM
 NEWHOUSES
 BOSKINS AT C

PART ELEVATION

PERSPECTIVE VIEW

Horton flag divisions to boskins. Ash timberwork to boskins. Areas of stone pebbling.

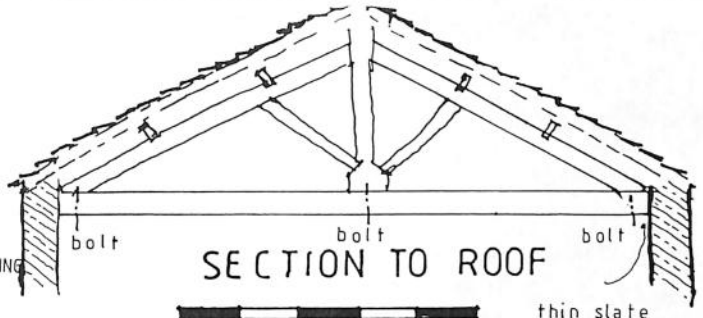
thin slate bearings for trusses

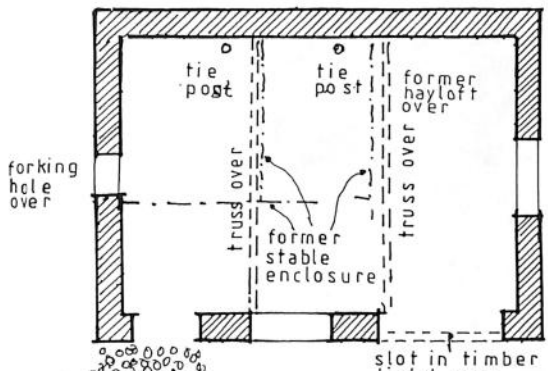
BARN J - FORMER STABLE NEWHOUSES FARM

LAYOUT PLAN

Barn J is a puzzle as it does not appear on an early photograph or the maps. It is likely that the present earlier lower portion of the barn was in a dilapidated state prior to 1850 ! and was rebuilt after 1910 to a stable with hayloft over, although this does appear very late for the type of heightened walling and the roof truss. It is more likely that it was originally built late 18C and heightened mid to late 19C. This was overlooked on the map of 1910.
