Group: Rose Cottage outbuilding, Rose Cottage, Lychgate cottage, cart shed outbuilding, Burnside. SD 810720-1

Rowe End SD 805725

The Shaws, Selside

YORKSHIRE (W.R.) HOYLE COTTAGE, HORTON IN RIBBLESDALE. SD 808727

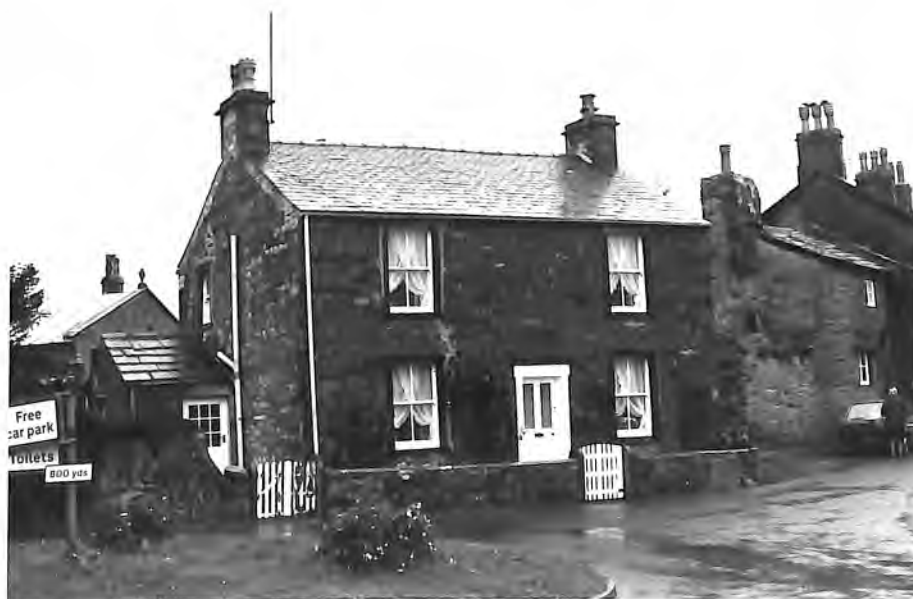
Rose Cottage, larger photograph held in file.

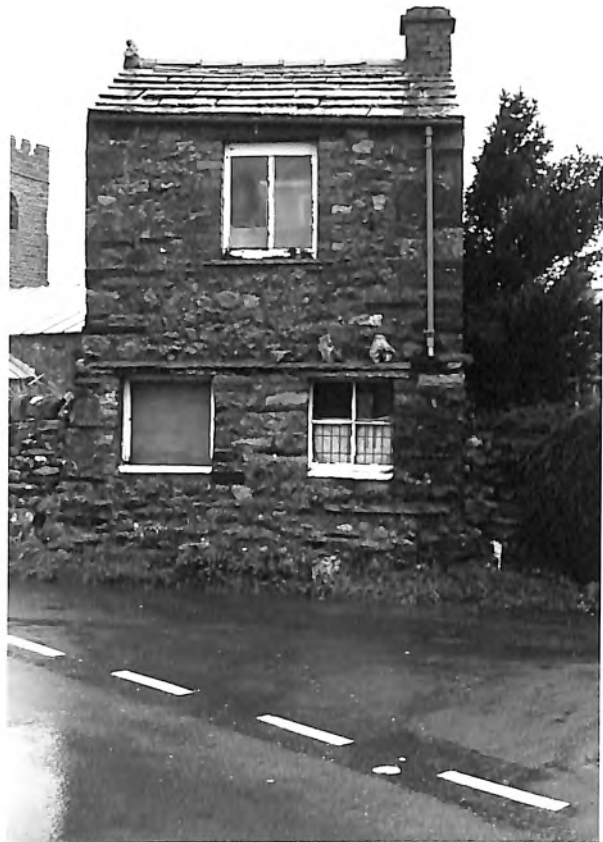
Outhouse at Rose Cottage, Horton.
Larger photograph in file.

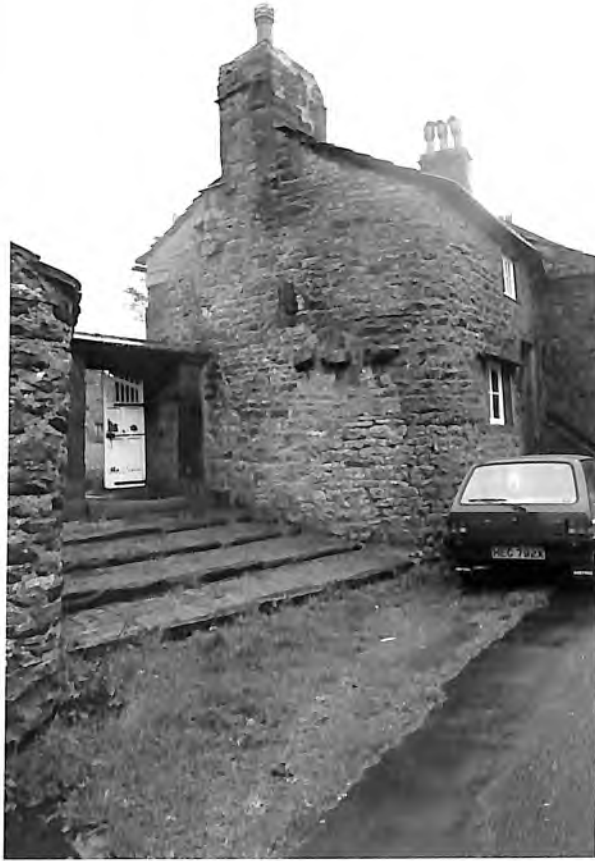
Lynchgate Cottage, by Burnside.
Larger photograph held in file.

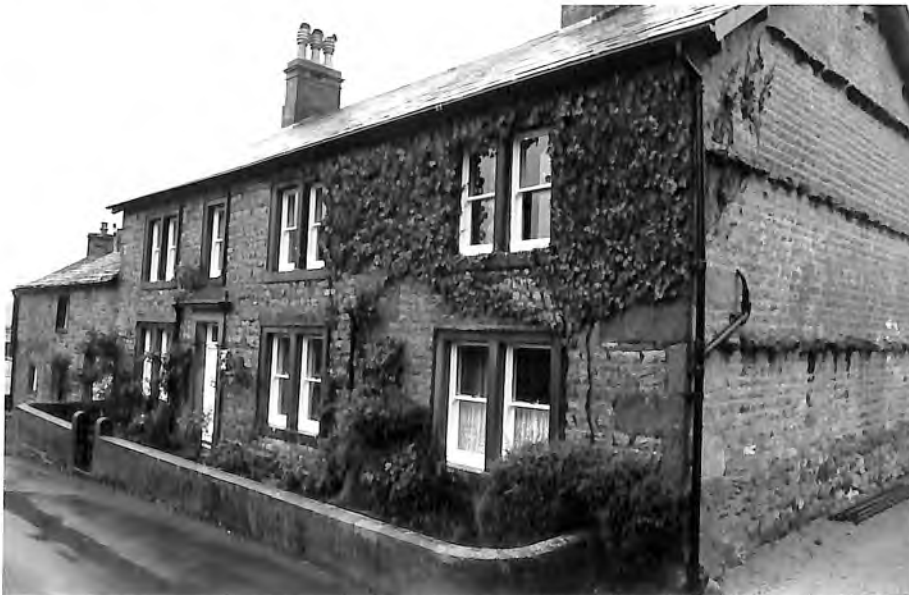
The only building of architectural merit in this group is Burnside which has a handsomely detailed 19th century front with six large two light windows and one single light, all with moulded architraves and flat mullions. There is a classical stone doorcase with a rectangular faulight over the door. The house has flush quoins at each end and between the two northern pairs of windows showing that it has been extended. It may easily be earlier in origin than the present facade. The outbuilding linking this house to Lychgate Cottage has superb squared and coursed masonry with a cartshed or trap-house arch at one end and a modern garage door at the other. Lychgate cottage is a tiny one-up, one-down house with rounded front corner and high internal chimney, of considerable visual attractiveness. Rose Cottage is a typical double-fronted end chimney house, and has an unusual two-storey outbuilding in the garden linked to the house by the stone garden wall. The whole forms an important visual element at the beginning of the village as seen on crossing the bridge.

Burnside, larger photograph held in file.

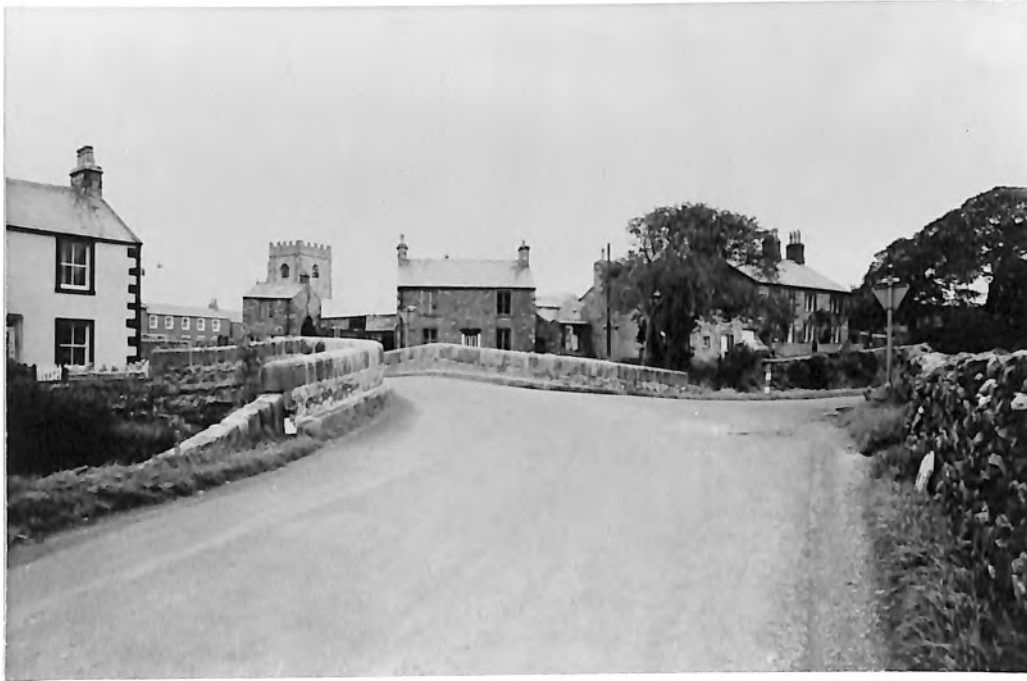
Showing all the above on approach to the village from the south, larger photograph held in file.

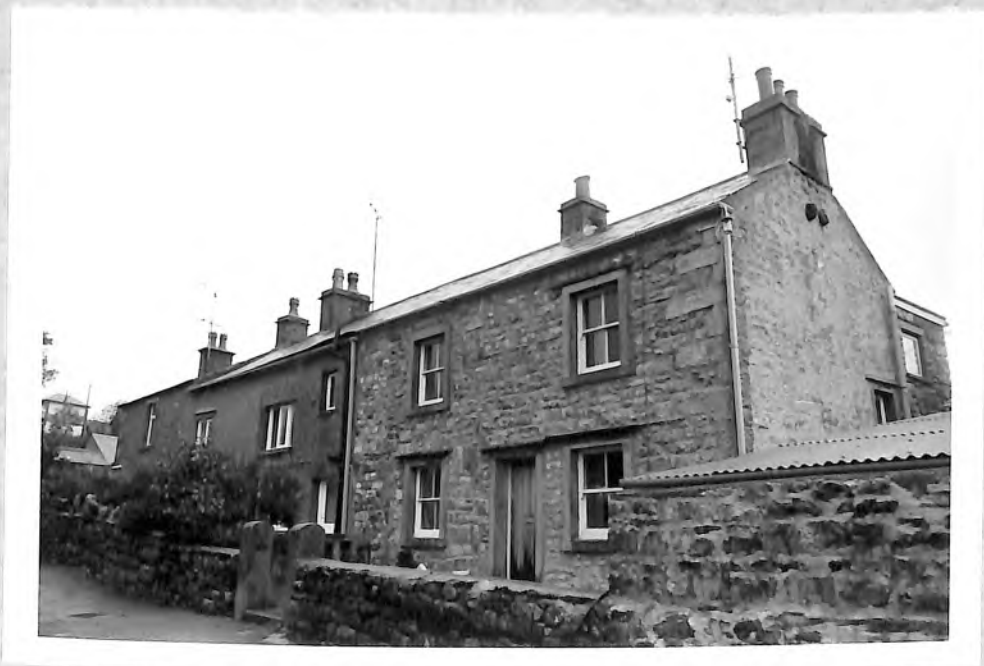
The hamlet of Rowe End is submerged in modern housing, and there only remains a much-altered farmhouse with an excellent barn behind it, and a row of cottages with other farm buildings. The House has been of considerable interest but is so no longer, having a modern porch and new windows. The farm buildings are unaltered. The row may have originated as a 17th century farmhouse with extensions at each end (c.f. South View) but the central house has all new doors and windows in a rendered front wall; the western end is a c. 1900 addition; the eastern end has four tall, late sash windows and a doorway, all framed in flat stone blocks, and a row of quoins to the left of the door marking the end of the original house, as well as more quoins at the present east end. This part is in excellent condition but its appearance is damaged by the loss of all original detail in the central house of the row.

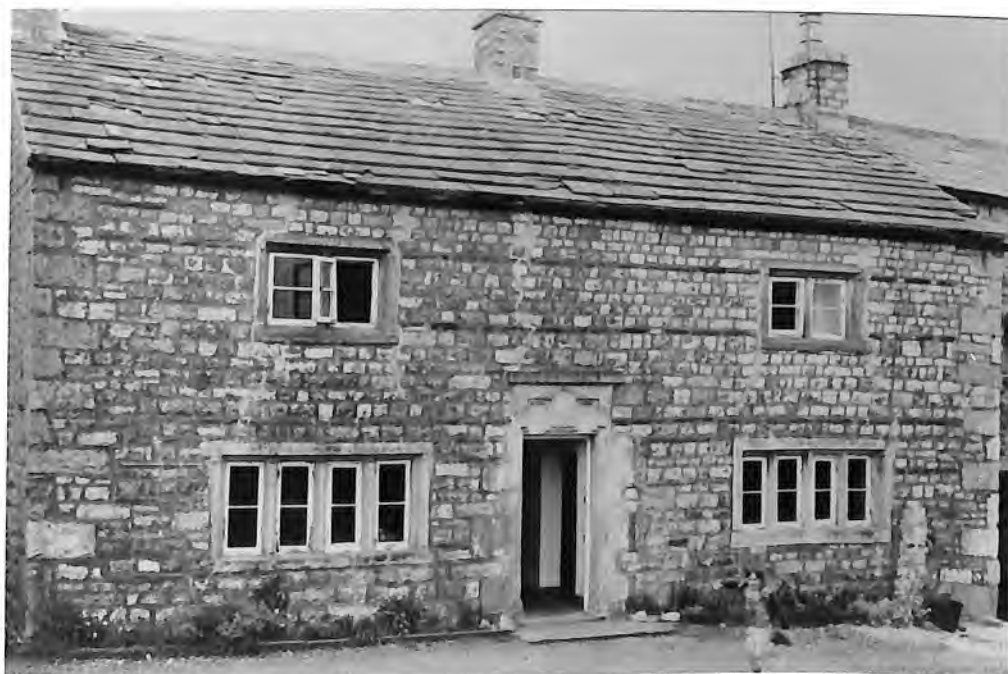
Standing near to the road but facing southeast, this house is well built in coursed and squared limestone with regular slate through-courses; there is a stone roof with three chimneys. The front door has a deep carved and moulded lintel and jambs formed of five moulded quoins. The lintel is of the design common in Lunedale, inscribed IL 1723, and has a plain dripstone over it. The two upper windows in splayed frames have a central splayed mullion where originally there are two. The lower four-light windows have ovolo-moulded mullions. The end walls of the house include some watershot masonry, suggesting a later repair. At the rear there are twin gabled wings (c.f. Cowside at Buckden or Town Head Farm, Austwick) and modern additions which have not damaged the house's appearance. A handsome early 18th century farmhouse.

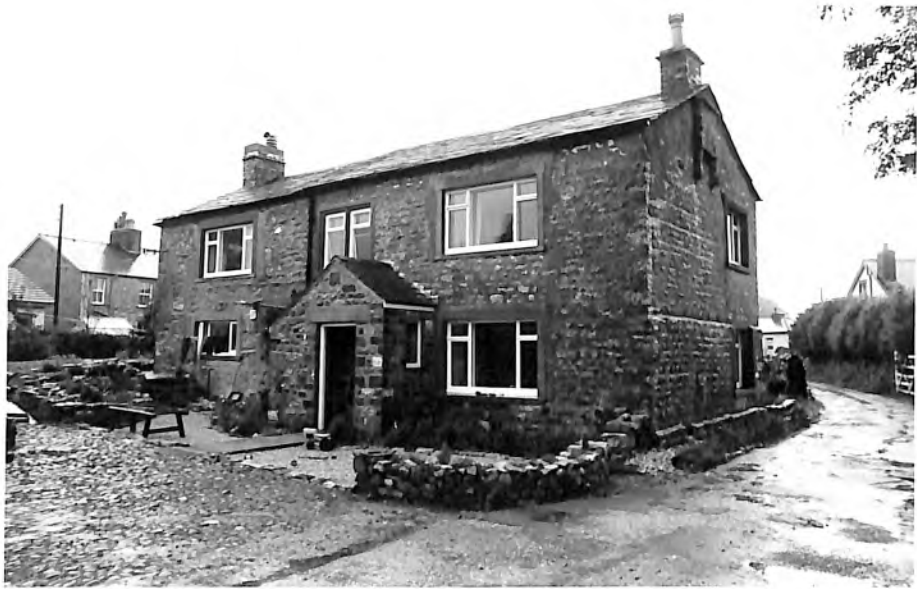
Rowe End Farm.

Front of House, larger photo in file.

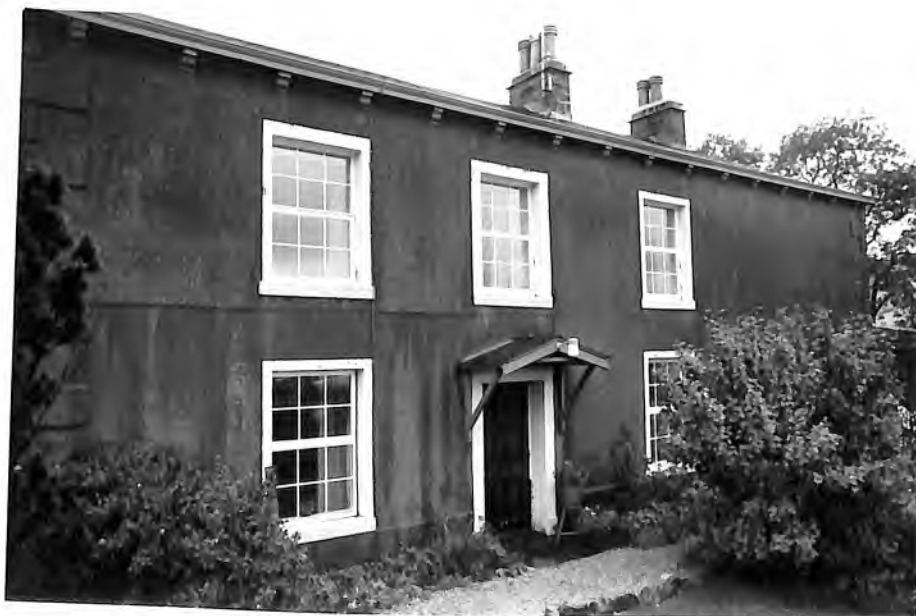
This house, well sited among trees and facing south-east, has a stuccoed 19th century front with tall stone-framed windows with the original sashes and a plain doorway. There are proud quoins under the stucco at each end and moulded gutter brackets. At the back the well squared and coursed stonework with flush quoins is exposed, and shows an irregular break to the east of the staircase window. This window has a stone frame with a round arch on imposts, and Gothick reticulated glazing bars. The two upper windows are squareish stone-framed sashes; below, there is a similar window placed to the right of each but to the right of the stair-window there is a blocked doorway and under a greenhouse to the left of the left hand window is a doorway in use. The date is probably about 1770 or 1780, with the front later 'improved'. A good example of its kind, which is fairly common locally.

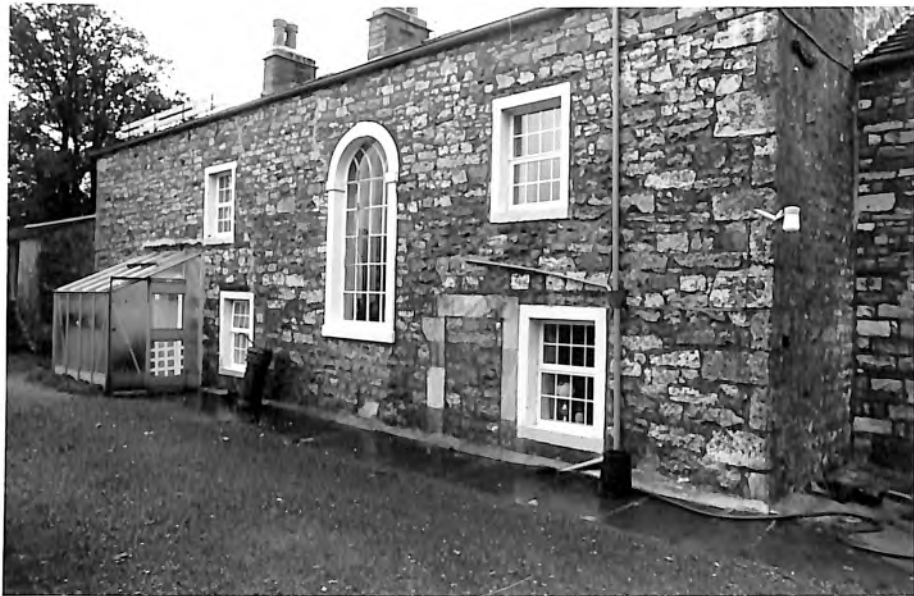
Rowe House (2).

Back of House, larger photograph in file.

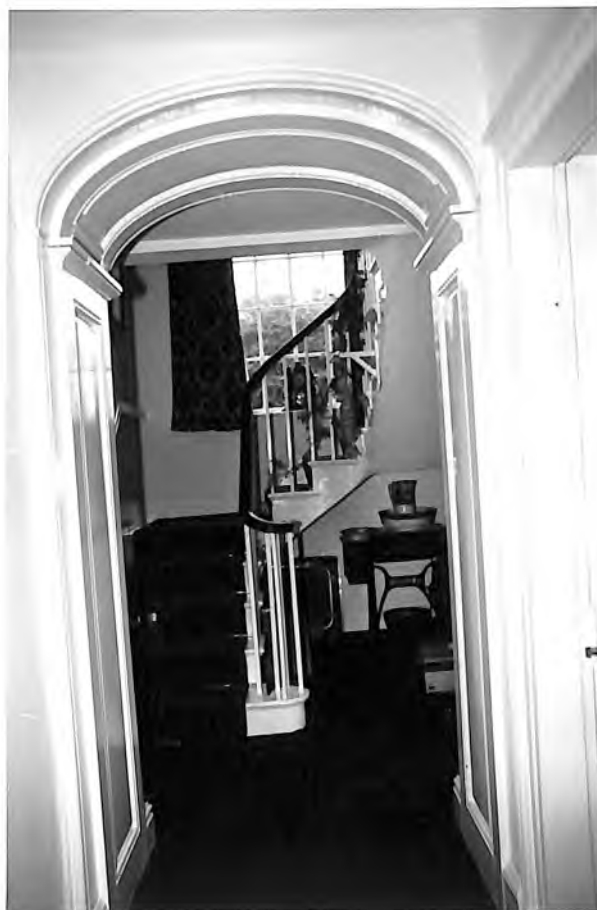
Staircase in Rowe House, larger photo in file.

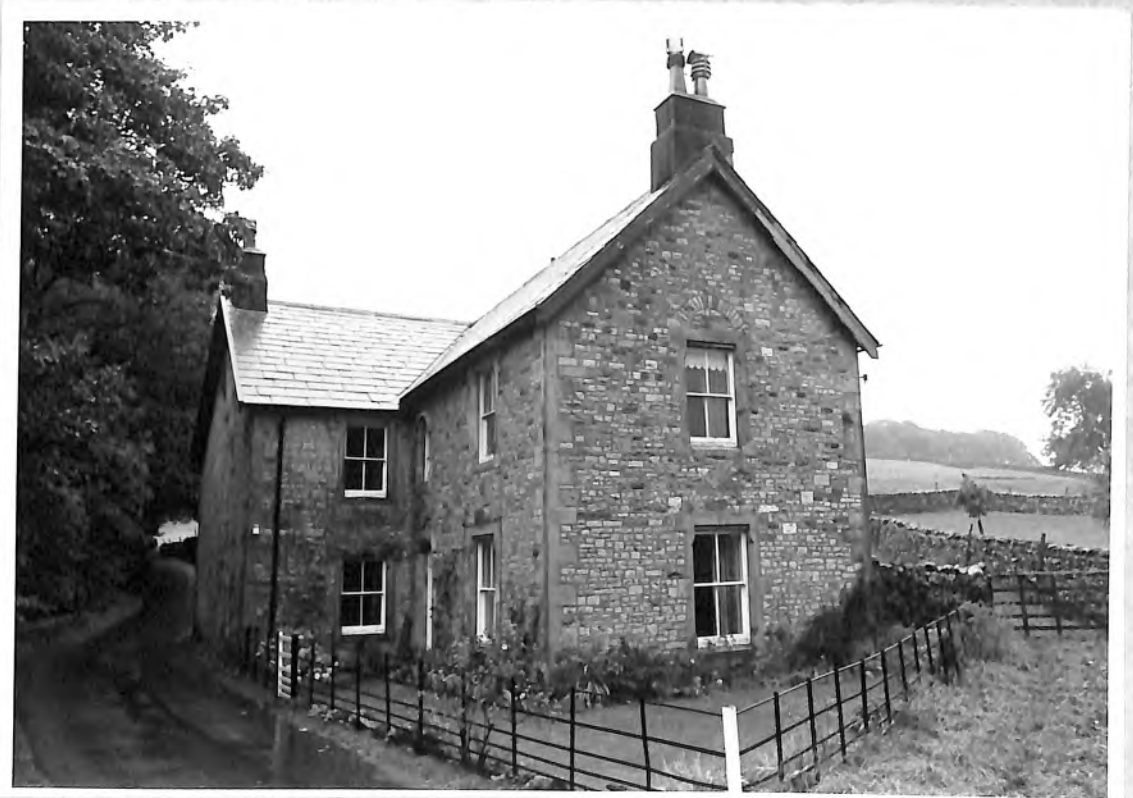
A very handsome Victorian L-shaped house on the east bank facing west towards the school. It has squared rubble walls with regular flush quoins, and beautifully detailed tall sash windows, the upper one in the front gable with a pitched-rubble relieving arch over it. The doorway is arched and has a round headed window over it with moulded label, and there is a plaque with base-relief urn over the door. Well sited to close the view on this side of the beck.

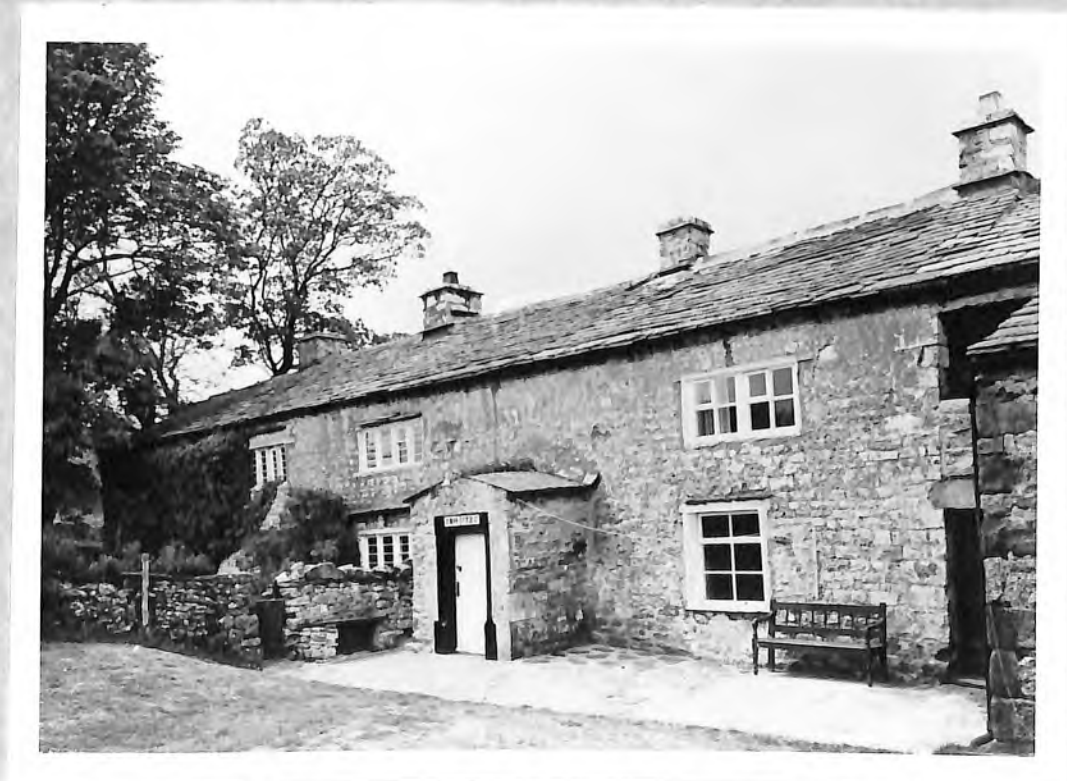
Top Farm, Selside.

A long, low house lying end-on to the road facing southeast. To the west of the porch there are four 4-light splayed mullion windows with idiosyncratic horizontal glazing-bars. To the east there is an upper window formerly of four lights with two of the mullions removed and there was a similar one under it now blocked and replaced by a tall window. The porch has a plain chamfered doorway inscribed 11 H 1726. At the west end of the house is a length of building with no front openings; at the east end is a large laithe. Behind the house is a dairy outshot and outshots behind the farm buildings. The house was built in the late 17th century and enlarged perhaps into an existing outbuilding, with the addition of the porch in 1726, it is particularly attractive for its long, low line and siting.

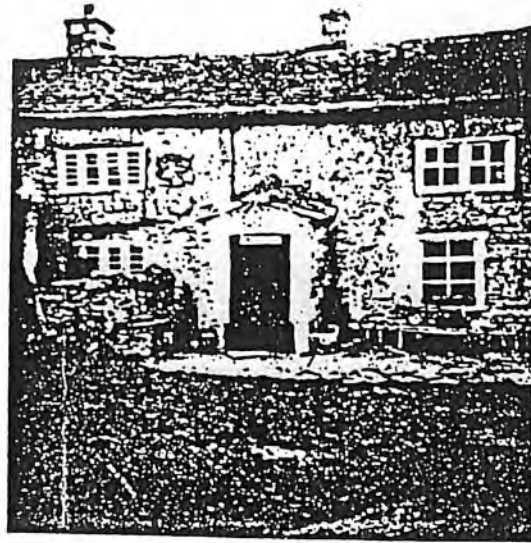
The house faces south at a bend in the road just north of the hamlet of Selside, and has a large laithe attached at the east end. There is indication that the lean-to buildings at the back formerly extended further north or had a walled yard on their north side, since a parallel row of footings can be found in the grass. The walls of the house are of limestone rubble and the roof is stone.

At the west end of the house is a single room open to the roof without fireplace or windows except for a tall sash window in the gable wall that may be an addition. The walls are unplastered and the roof has a central truss consisting only of principals and tiebeam with two pairs of overlapping purlins and a ridge-piece. There is a straight joint at the back where this room meets the main part of the house, with quoins at its east side. In front the wall is shrouded in creepers. The house proper consists of three rooms in line, and above each of the cross walls is a chimney serving alternately upper floor and ground floor fireplaces. The main fireplace is in the central living room and has a handsome classical frame with panelled pilasters at each side and a bold moulded cornice. The stairs go up against the north wall of this room. The ceilings are formed from paired beams and have timber girders set in the side walls and held in position by corbels which carry stepped wooden supports for the girders.

The laithe is four bays long and has principal trusses with tiebeams and collars, carrying three pairs of overlapping purlins and a ridge-piece. There is a byre attached in front of the laithe to the west of its porch, and a mucking-out hole in the east gable of the laithe indicates that this end had standings for cattle. Not all of the laithe could be drawn: it measures 15 x 7.5 metres approximately.

The house porch carries the inscription I * H 1726. The house may be as much as a generation earlier than this and has a plan resembling the Oxnop type to some extent, though as it is not possible to be sure where the original front door was this is not certain. Three positions are possible - where it is now, to the west of this or to the east. The central room has always been the principal living room or hall, west of this were two rooms, perhaps parlour and dairy, the back one now reduced in size to allow a way through to the later west end room. The east parlour may possibly be an addition, having its windows at slightly different levels, but with this kind of stone it is difficult to tell. If an addition, it was converted from an outbuilding as at Harber Farm.

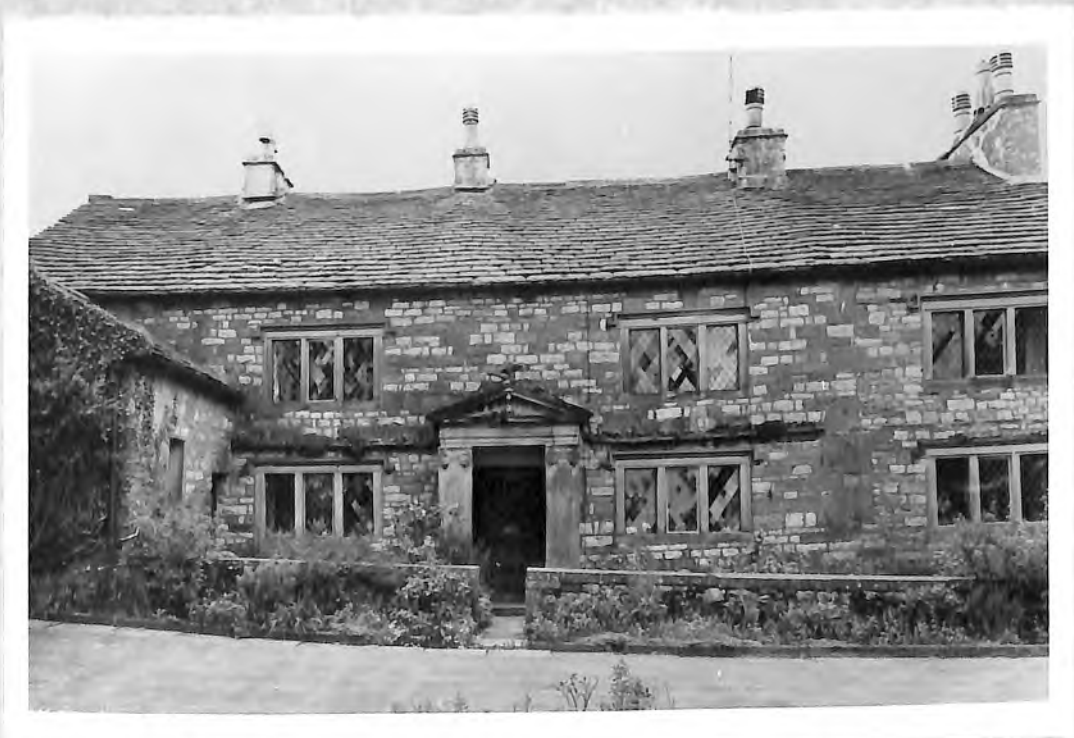
This house, set back from the road and facing east, is built of squared sandstone and limestone blocks with a stone roof and four chimneys. It is two-storeyed throughout, and one and a half rooms deep. In the middle is the main house with a pedimented Ionic porch dated 1738, but the plank door with an over-frame of lugged panels is some half a century earlier. At the south end there is a single room open to the roof, with an outhouse built against its front wall, now used as a garage. At the north end is a late 19th century addition of one bay.

The six front windows each have three large lights with leaded diamond quarries, and all are late 19th century with flat mullions, moulded frames and hood moulds. On the central, older, part of the house there is a plain slate drip course as well.

Inside there is an altered staircase with late 17th century balusters, and the ceilings are carried on twin spine-beams with corbelled sleeper-beams in the long walls. The house probably dates from the second half of the 17th century, with a later porch, and was improved in the late 19th century when the northern extension was built. It is extremely handsome and impressive, immediately catching the eye on approaching Selside from the south.

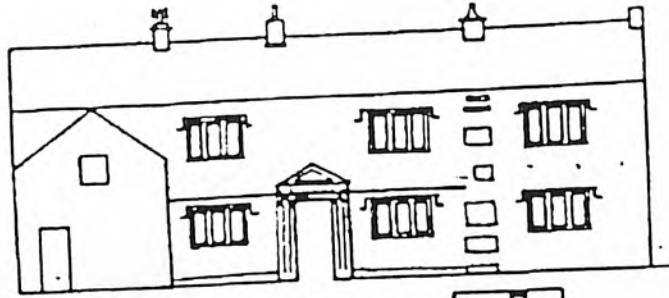
raised roof
& re made
truss.

earlier 1 1/2
storey house
with outshot

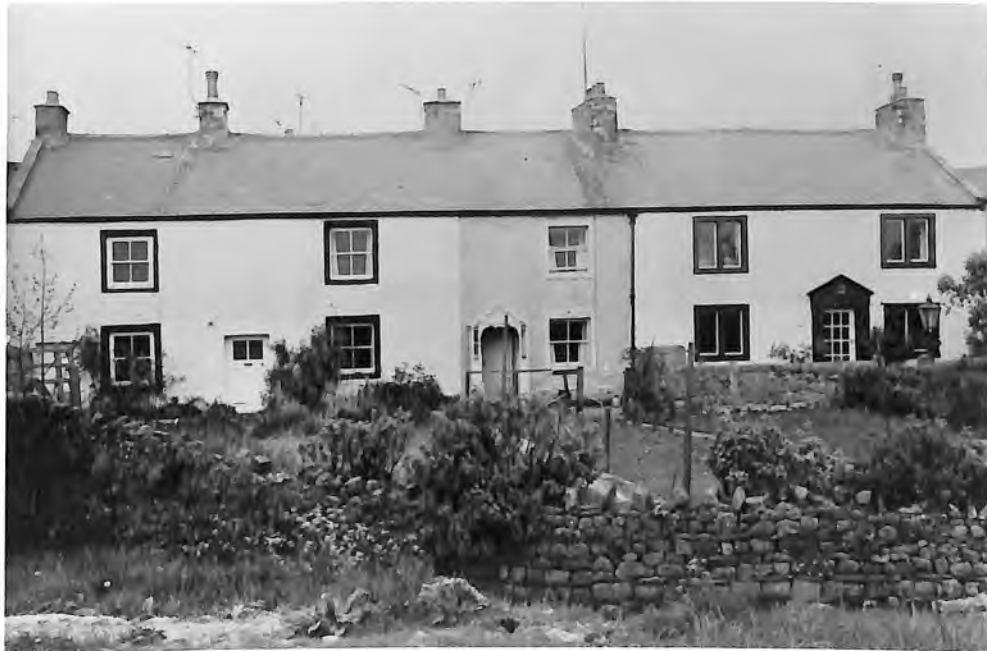
South View, No.4, (2)

A row of cottages with gardens running down to Brants Ghyll, originating from a three-cell 17th Century in the middle, extended at the eastern end in 1801 to make a double-fronted house, no. 4, and at the west end to make no. 1. The original splayed mullion windows have been blocked or converted; no. 4 has been fitted with flat stone mullioned windows and doorway dated J.G. 1801, and another bay added to the west end, perhaps at first as an outbuilding but now the first cottage.

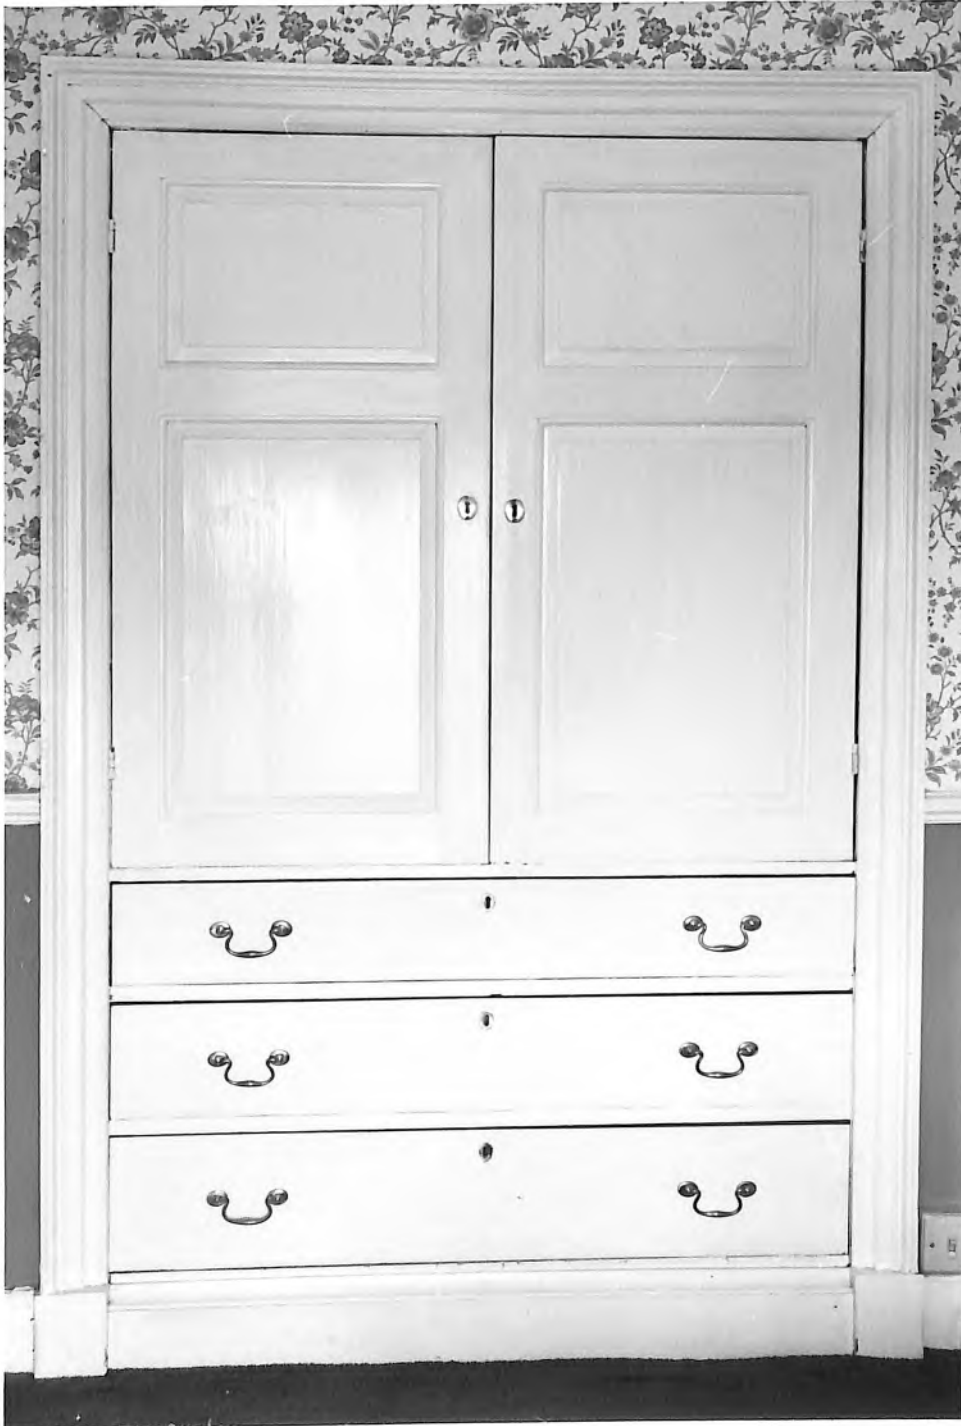
Cupboard at 4 South View, Horton.

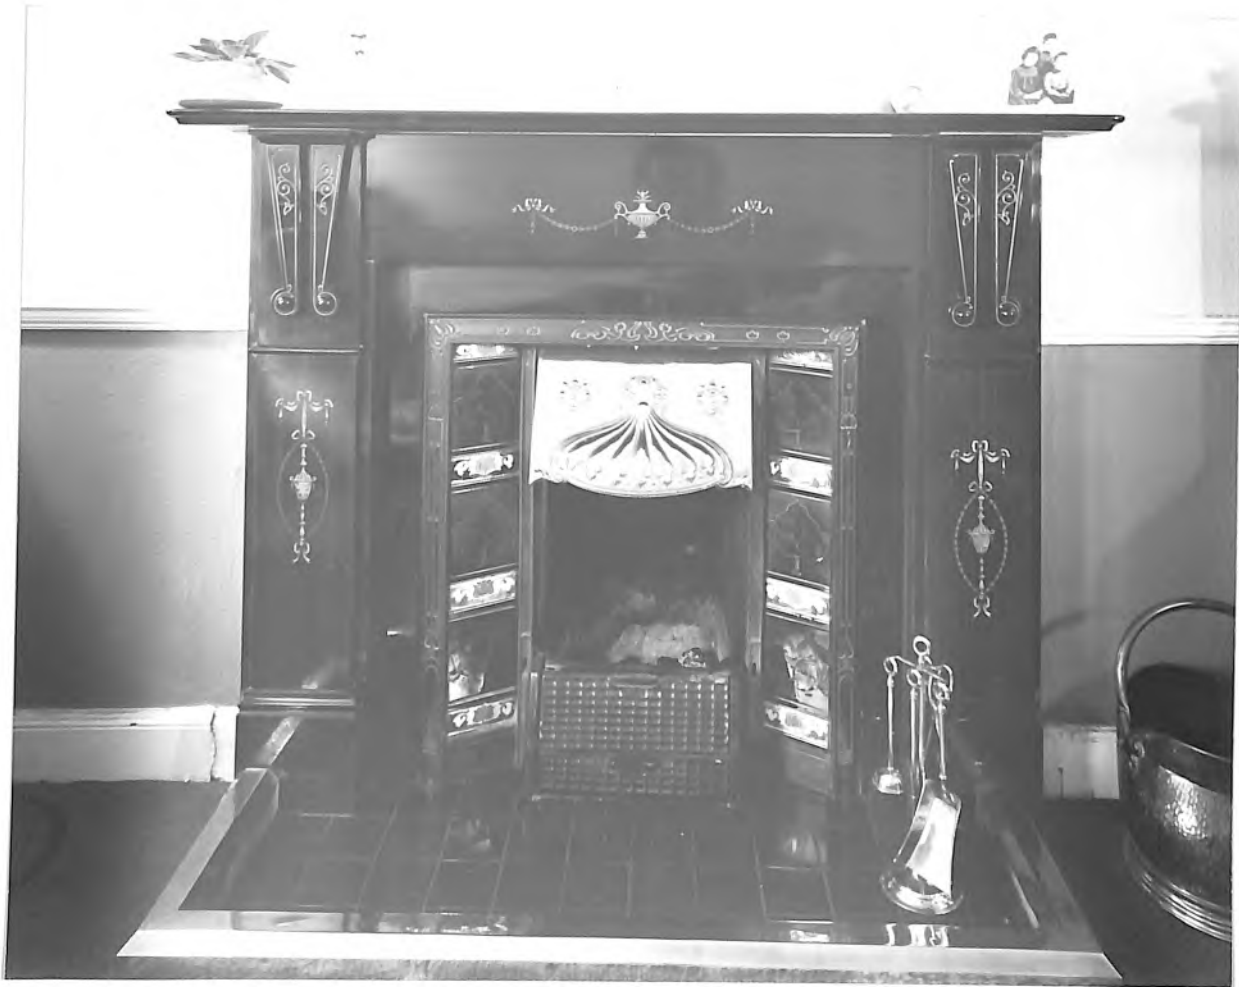
Fireplace at 4 South View, Horton.

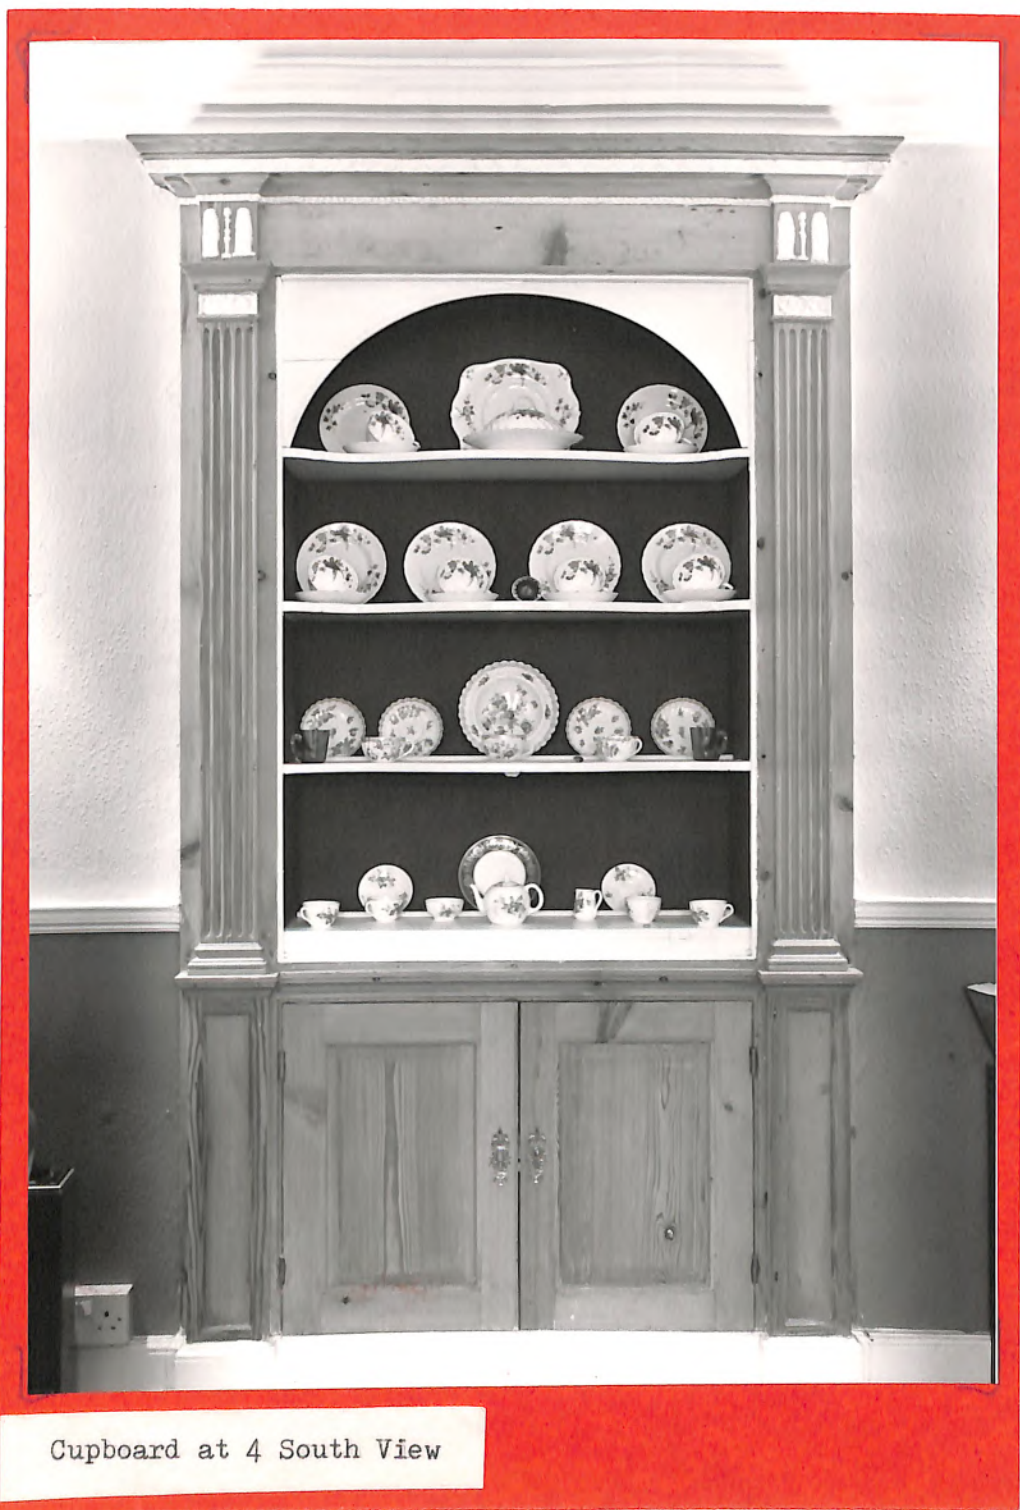
Cupboard at 4 South View
