BARN K
 NEWHOUSES FARM
 NEWHOUSES
 M BIRDSALL A.R.I.B.A.
 DECEMBER 1995

YORKSHIRE
VERNACULAR BUILDINGS
STUDY GROUP 1519

BARN L (North of Newhouses
Name of building Farm)

BARN L
 NEWHOUSES
 FARM
 NEWHOUSES
 HORTON-IN-
 RIBBLESDALE

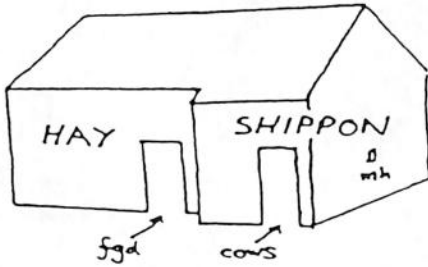
TWO-DOOR BARN
(Dales type; evolved in 18th century as a field barn.)

[mh = mucking-out hole
fgd = foddergang / doorway]

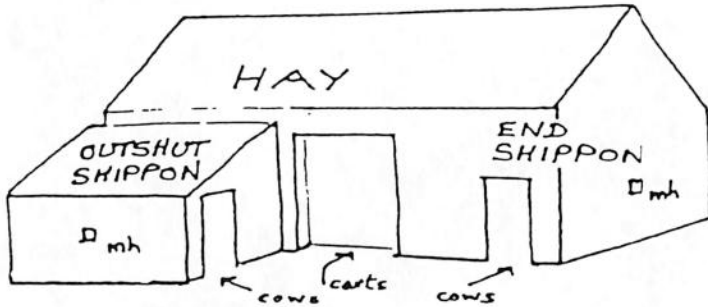
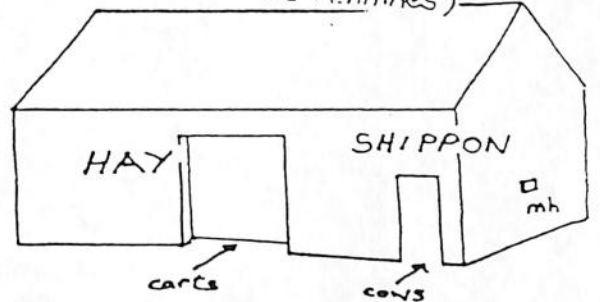
STANDARD LAITHE (widespread in the Pennines)

OUTSHUT-SHIPPON BARN

(Usually formed by adding an outshut to a standard laithe; common as a field barn south of Horton.)

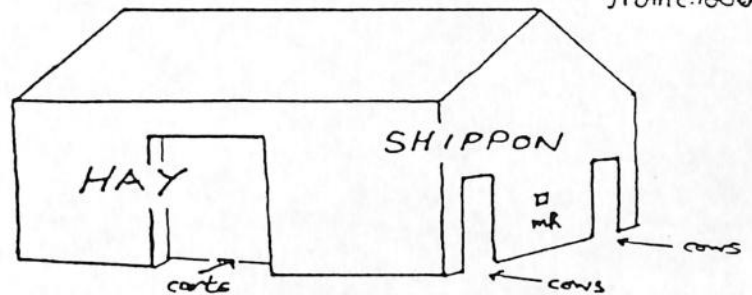
GABLE-ENTRY BARN (dated examples from c.1680)

Gable entry barn with no cart entry.

Gable entry barn built partly into hillside. One entrance only for passage of animals and removal of hay. Evidence of wall enclosure to entrance incorporating gateway and trough.

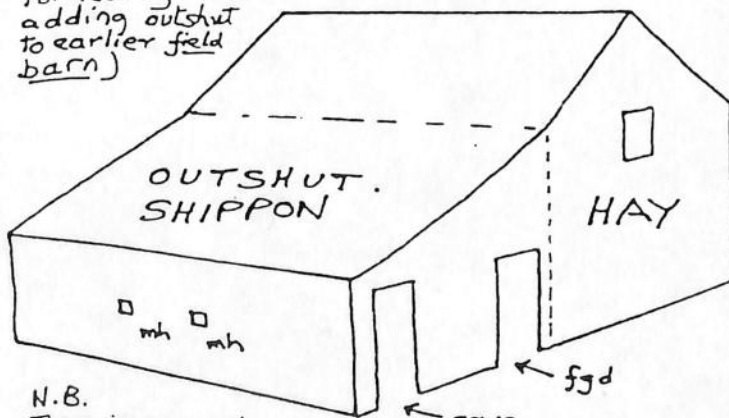
LONG OUTSHUT BARN (OR CONTINUOUS OUTSHUT)
(19th century type, often formed by adding outshut to earlier field barn.)

N.B. There is no cart entrance on the other side.

This identifies different types of barn layouts in the Horton-in-Ribblesdale area. Barn 'M' falls into the Long Outshot Barn category. There is no cart entry. Hay would have been stored at high level (mew stead) and cattle housed below-entry being from two openings in the former gable wall (where the outshot shippon has been added)

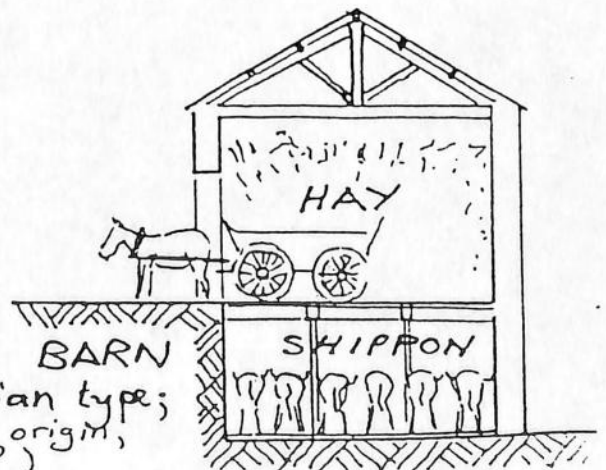
BANK BARN
(Cumbrian type; German origin, c.1600?)

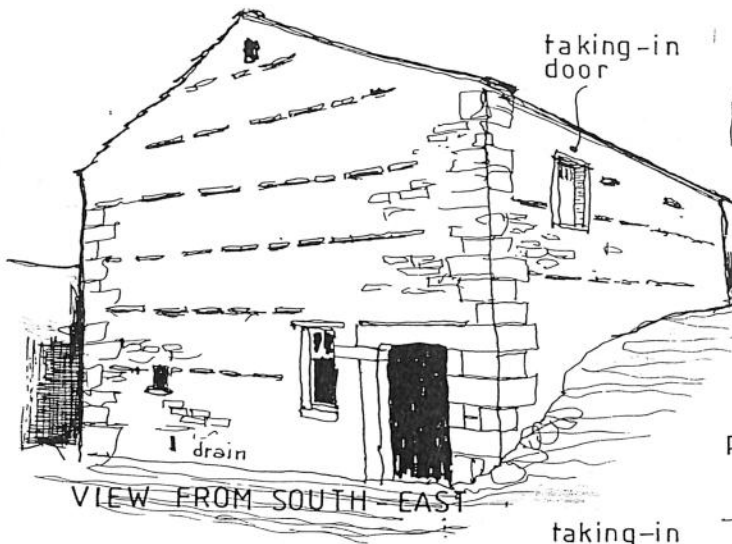
VIEW FROM SOUTH-EAST

It is an outstanding barn in terms of the high quality of workmanship in stonework, and also in the carpentry of boskins and the panelled door.

- 1) The walls have very regular projecting string courses of 'slate' instead of having the rough limestone throughs of many 18th century barns.
- 2) The king-post trusses are of Baltic pine, which was not commonly used until the later 18th century, and is more characteristic of the 19th century. The barn appears to have been built with these trusses. They are not a replacement for an earlier roof, as in so many other barns.
- 3) The door lintel is of a distinctive shape described as a "flattened basket handle". If it were chamfered, it might be dated to c.1750 by comparison with similar doorheads in such places as Lancaster or Addingham. Without a chamfer, it is unlikely to be earlier than about 1780 or 1790.

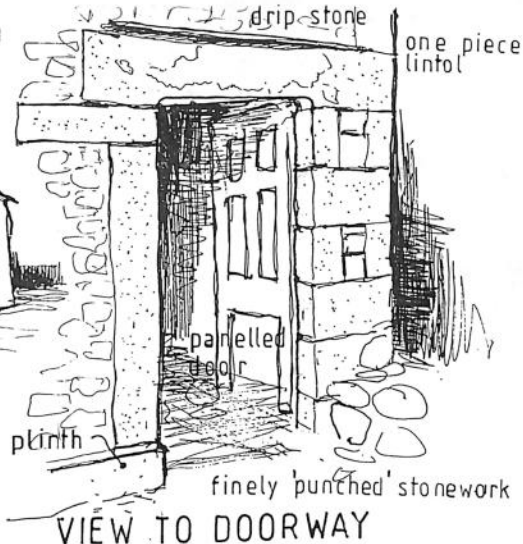
VIEW TO DOORWAY

There is only one door into the barn and this opens onto this yard. The steeply sloping ground would have made a separate foddergang doorway impossible.

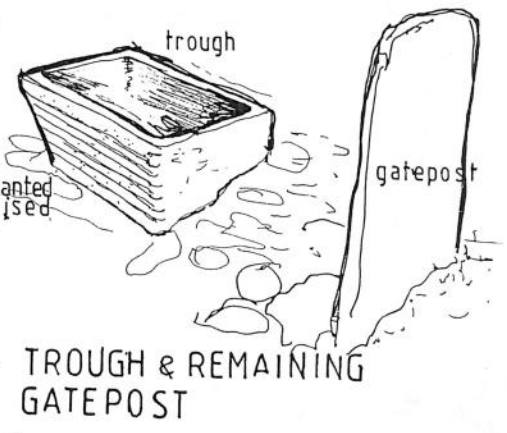
TROUGH & REMAINING GATEPOST

In the yard or fold on the south side is a water trough, also of excellent workmanship, carved from sandstone (rather than assembled from slabs of local 'slate' like many other troughs).

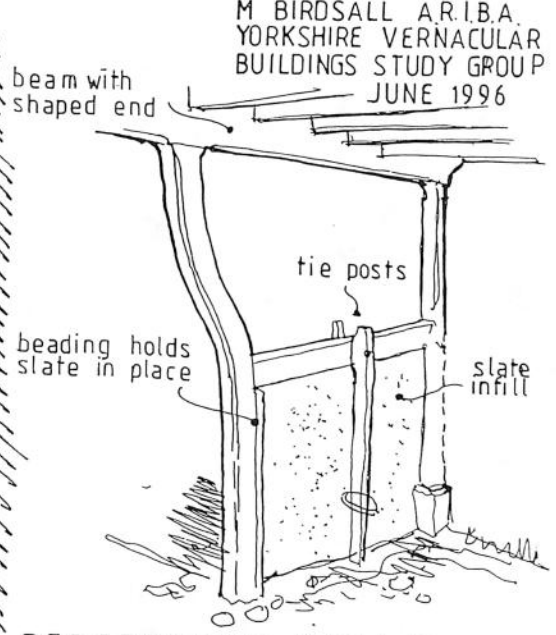
PERSPECTIVE VIEW TO BOSKINS

Boskins partly dilapidated.
