NORTH YORKSHIRE  
AND CLEVELAND  
VERNACULAR BUILDINGS  
STUDY GROUP 947

HORTON IN RIBBLESDALE, Studfold Farm. Mr and Mrs Campbell. visited  
SD 813702 29-9-83

NORTH YORKSHIRE  
AND CLEVELAND  
VERNACULAR BUILDINGS  
STUDY GROUP. 959

HORTON IN RIBBLESDALE, Studfold Cottage (dem), SD 813701. 1984.

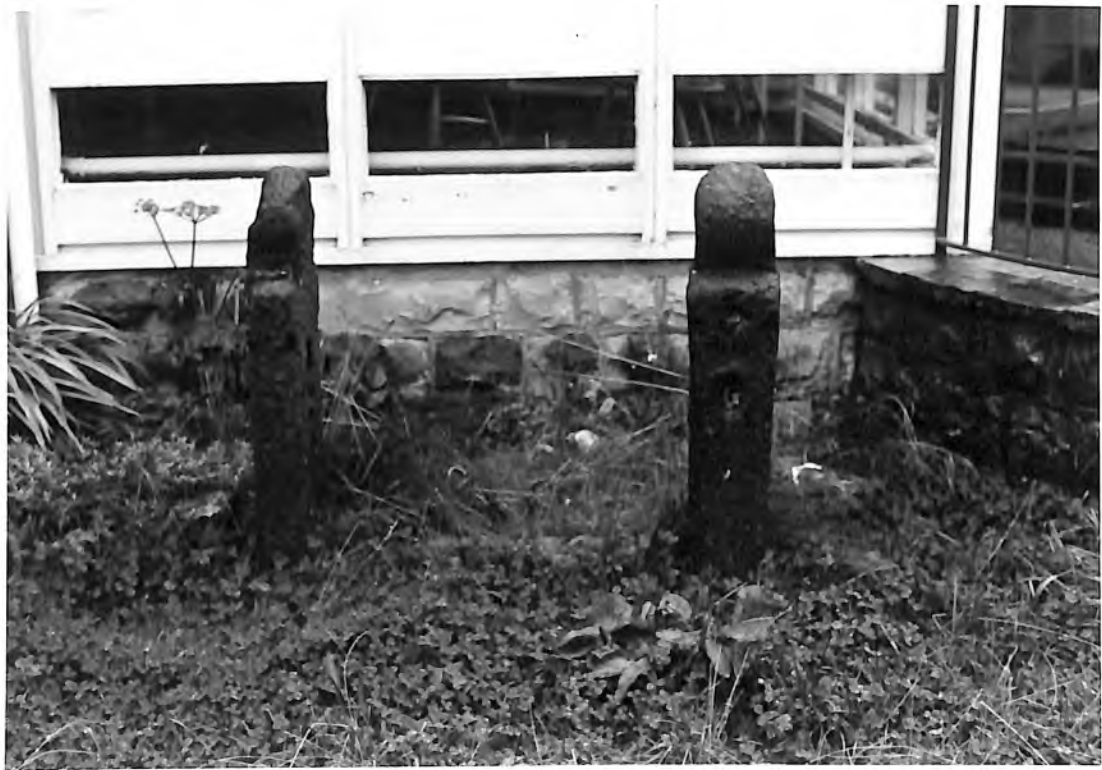
STOCKS, Horton in Ribblesdale.

Now situated in front of Horton School, though this was not their original siting.

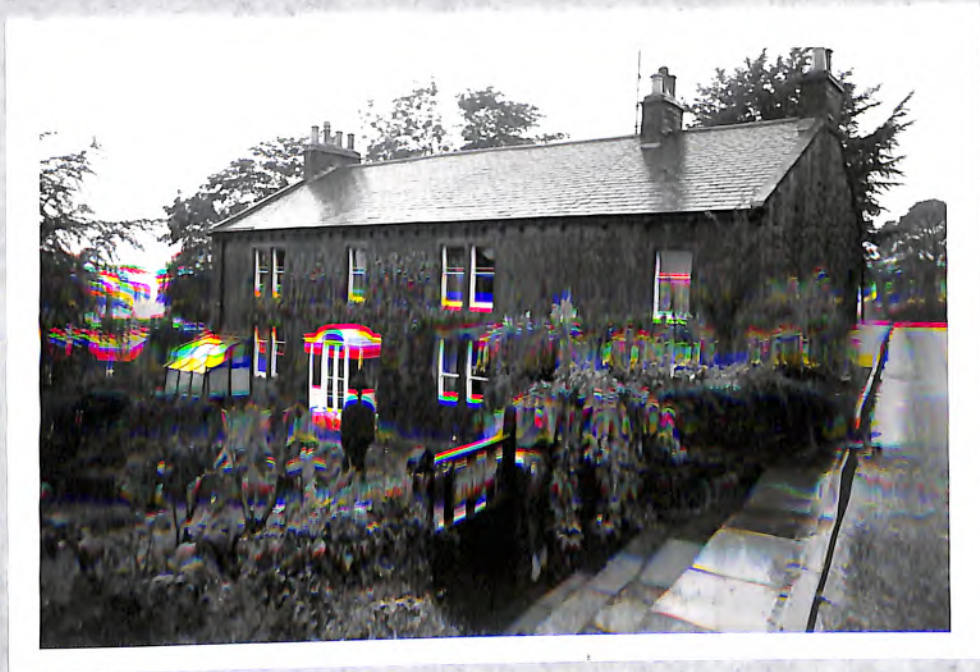
6-29  
Studfold SD 813702

Stuccoed stonehouse lying lower than the road and end-on to it, facing southeast. It has tall sash windows framed in stone blocks and an arched doorway covered by a wooden porch. New rainwater goods. No particular architectural value, but prominent site. A better house of the early 19th century is found at Dry Beck.

Below Studfold House is a plain, rendered stone farmhouse, group value.

Studfold Cottage demolished for road widening, datestone said to have been built into a garden wall but now lost.

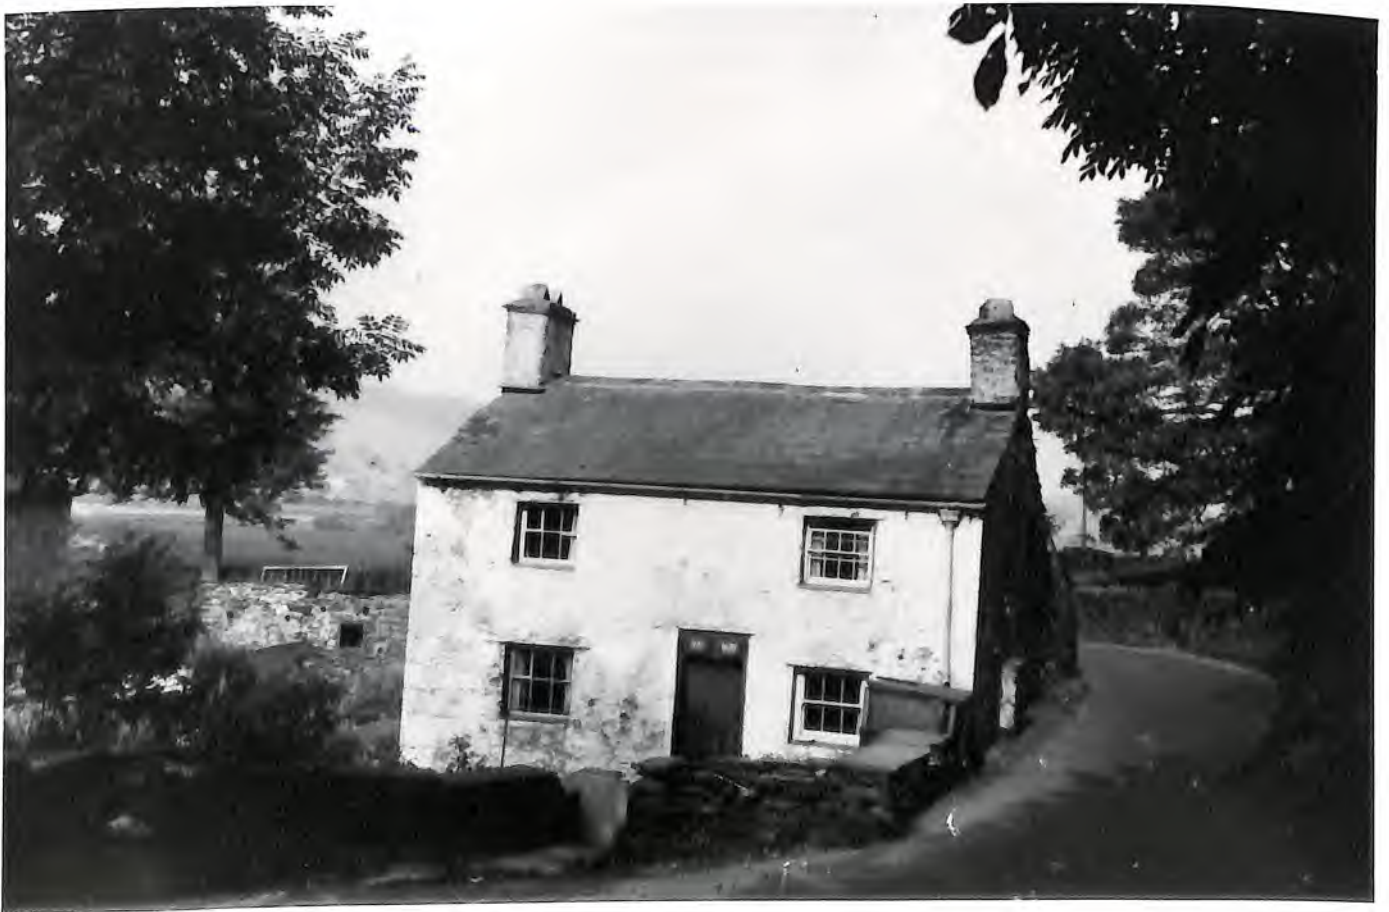
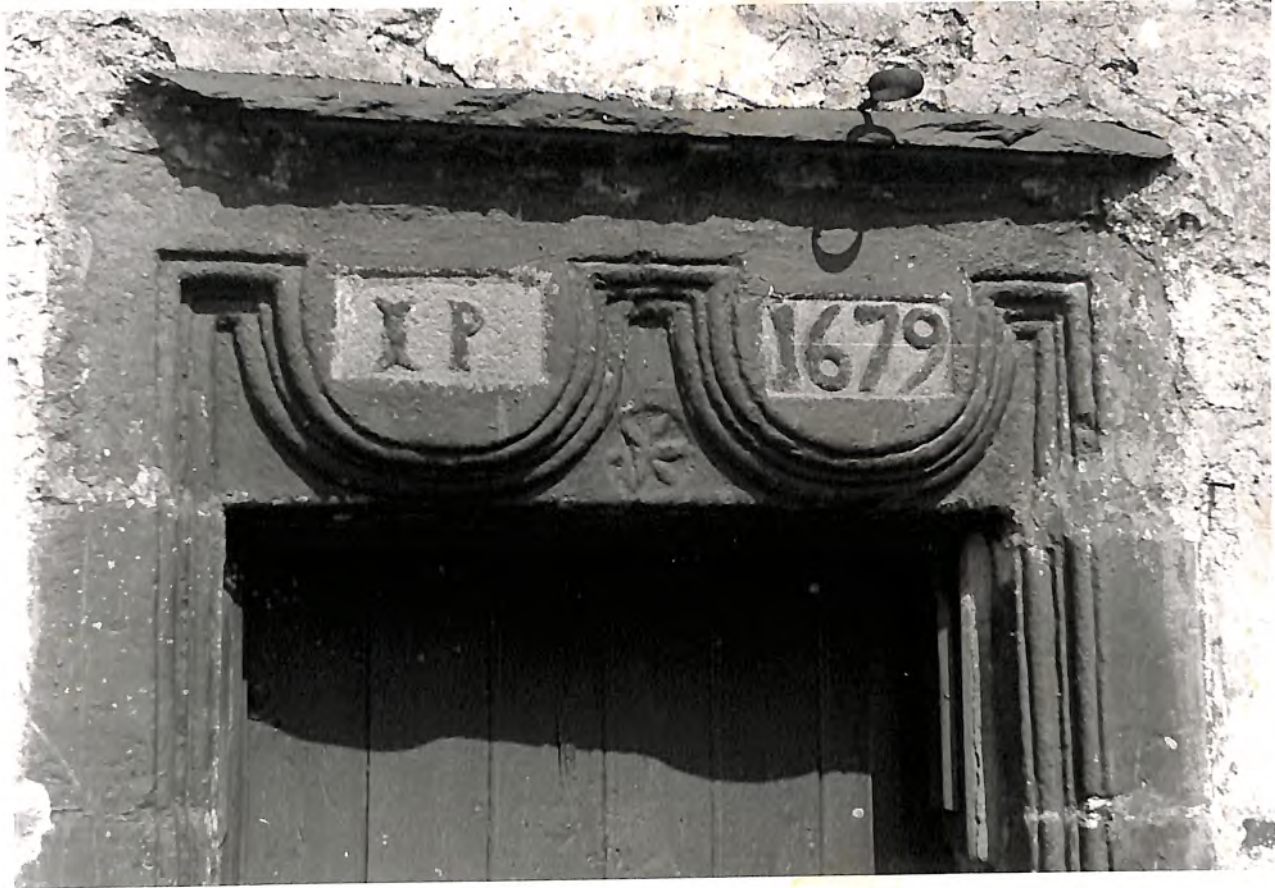
Dated doorhead over cottage at Studfold. Removed for road widening in the 1960's.

The datestone IP. 1679 seem to refer to John PROCTOR who left a will dated 1707. He does not mention the house but a later will, that of Matthew PROCTOR proved in 1782 gives details which would fit the house.

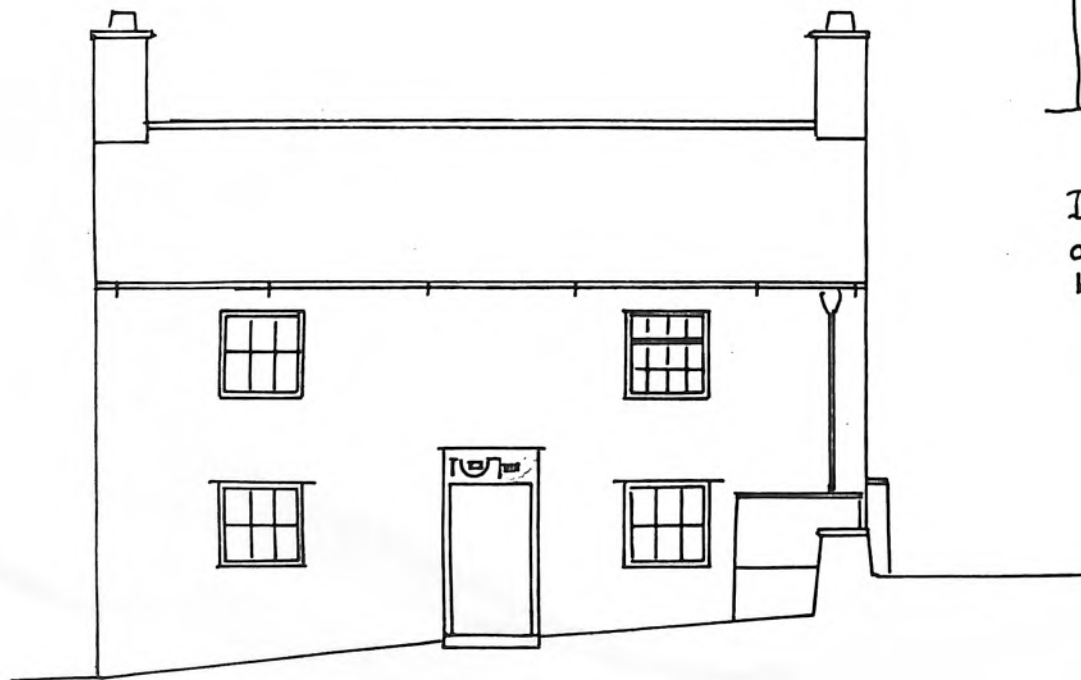
Cottage at Studfold (Roche's) from two photographs 1963

This cottage, which was demolished some years ago although a listed building, stood close up to the main road which curved round it on the east side. The house faced south and stood on a sloping site so that the road was at a higher level than the house floor. It was built of stone rubble mortared over and limewashed, with a slate roof and a ridge and chimneys of stone. The plank-built front door was set in a moulded frame under a carved lintel inscribed I.P. 1679. John Procter of Studforth whose will was proved in 1707 seems a likely candidate. There were four front windows and the door was slightly off-centre to the east, whilst the space between the eastern windows and that end wall was wider than at the west end, suggesting that the eastern room had the larger fireplace and the front door may have opened straight into that room. A downpipe from the gutter led into a large trough built of stone slabs to collect rainwater.

On the road end there seems to have been one upper window towards the rear, and a rectangular projection at ground level behind the hearth area possibly indicating the position of a bread-oven. A leanto outshot of one storey appears to have been added along the rear or part of the rear wall, its eastern end not quite in line with the main part of the house. The back and western end do not appear in the photographs

Doorhead measured 7-3-84

drawn to a scale of 1:100 approx.

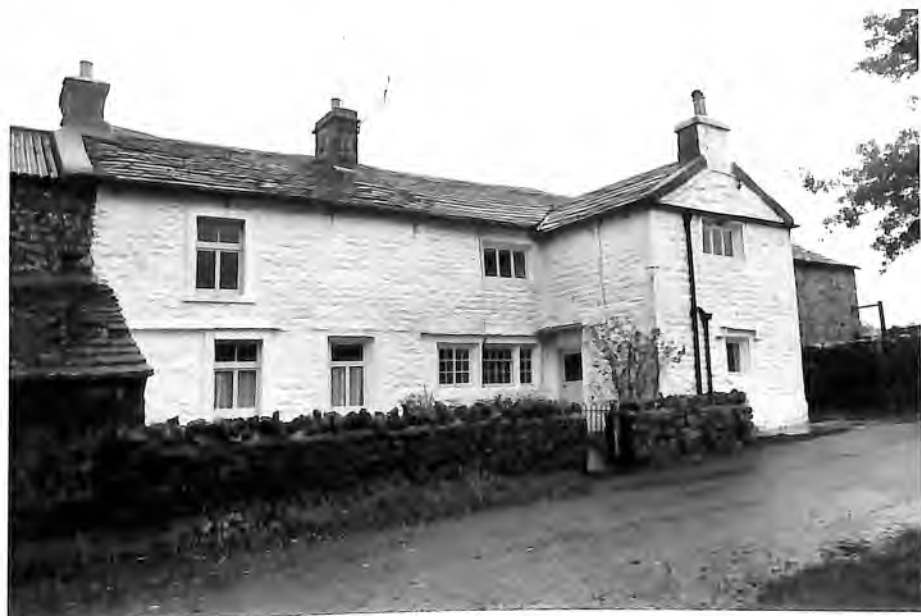
Townhead Farm SD 812722

This substantial, low-set farmhouse has a storeyed porch in front incorporating a dairy, which has an ovolo-moulded doorway in the side facing south, and rebated splayed mullion windows in the gable-end facing east towards the beck. The lower porch window has one light with a dripstone over it returned down each side, the upper is a three light 'West Riding' window with a taller central light. On the house itself, the window of the houseplace next to the porch has a king-mullion with two-lights south of it and three-lights north, all rebated splays but two of the mullions missing. The glazing is well arranged in small panes, and there is a dripstone over. The window above this has three-lights and was similarly framed but has lost both mullions. South of this is a plain vertical window in a frame adapted from a two-light mullioned window like those described and a blocked two-light window over it; beyond are two tall windows framed in flat stone blocks. The drip course continues intermittently. On the north side of the porch there are two doors and an upper window in the house, all late, and a further bay of outbuilding, all under a continuous stone roof. At the back there is a staircase wing with rebated splayed window. The barn attached at the south end is sunk into the bank behind, and has an iron roof but is of considerable group value.

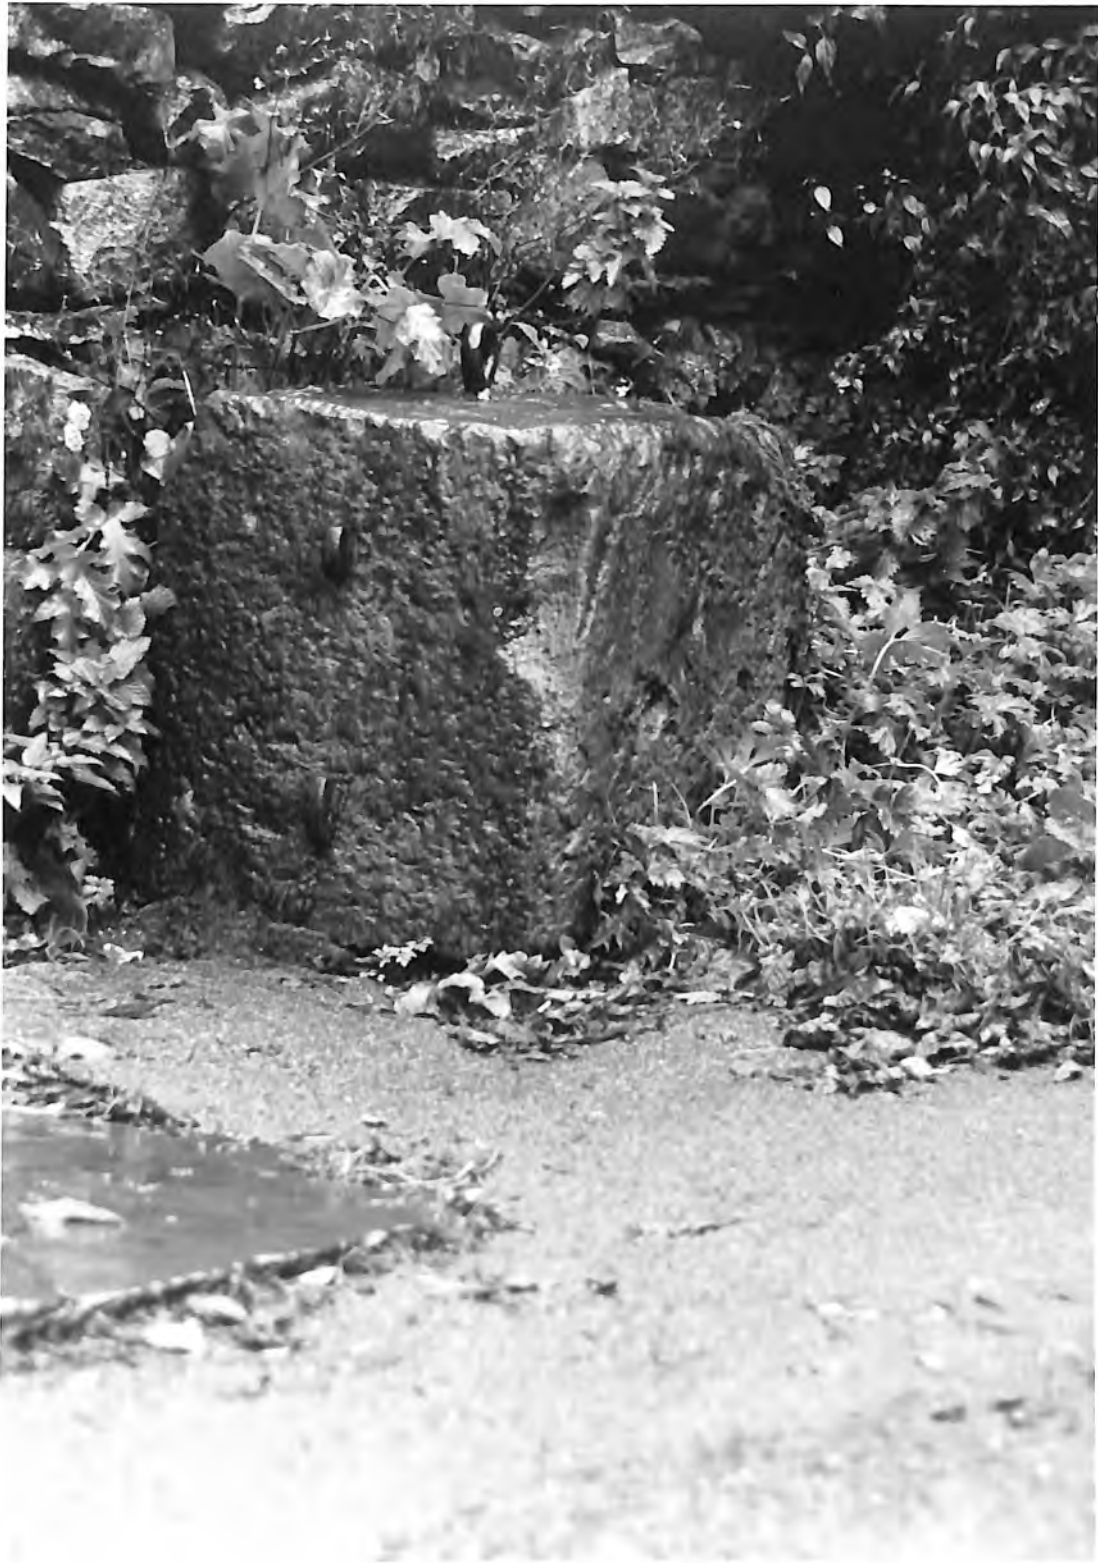
Cheese Stone at Townhead Farm.

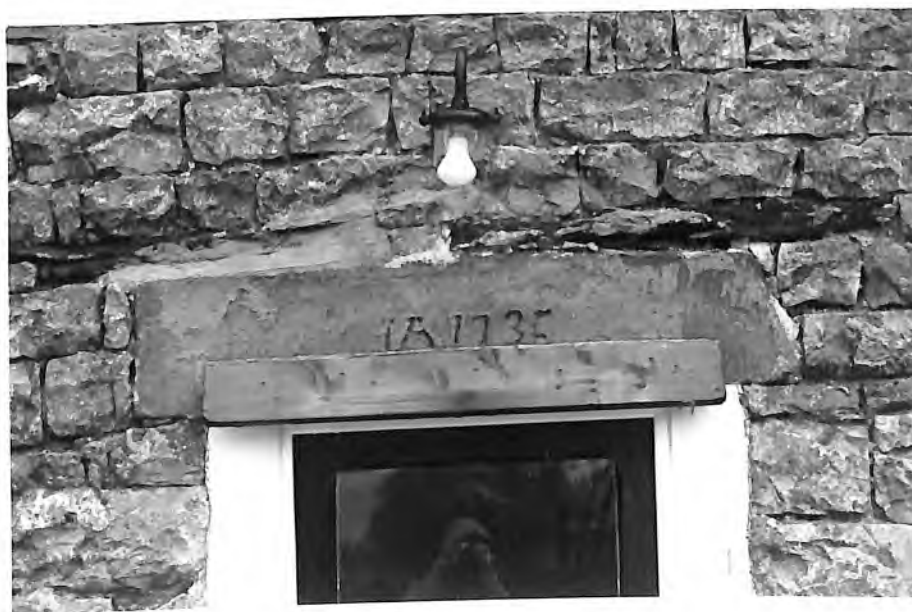
Town End Farm SD 810720

The house stands at the southern end of the church town (i.e. central settlement) of Horton, facing southwest with a laithe built onto its east end. It is a two-room wide house built of coursed limestone rubble with a central doorway inscribed <sup>A</sup> 1735 and a handsome stepped external chimney on the west end. The windows are framed in reused stone blocks and the doorcase is plain with a plain lintel. The roof is stone. The laithe is largely built of Horton flags. Behind the house and barn a modern bunkhouse has been sensitively added as a leanto.

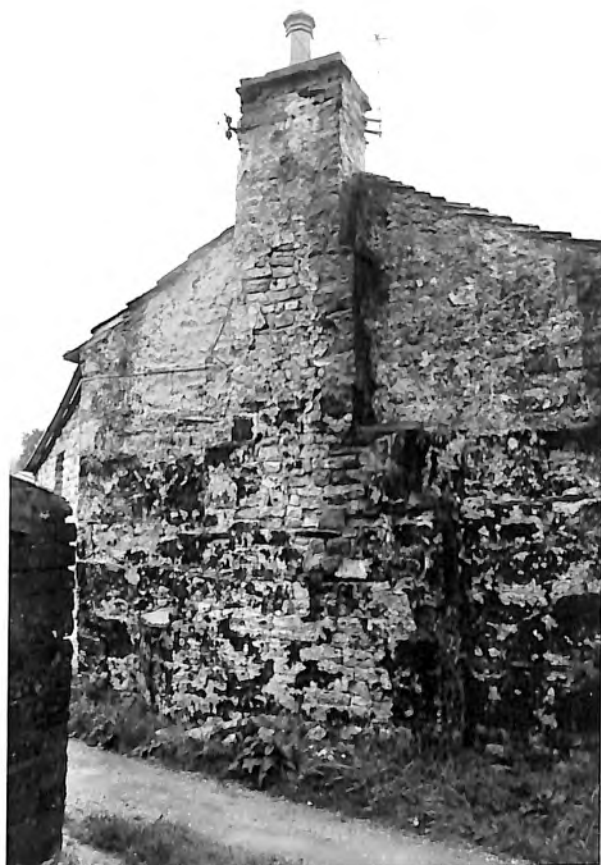
Chimney Stack, Town End Farm.  
Larger photograph in file.
