YORKSHIRE
VERNACULAR BUILDINGS
STUDY GROUP 549A

LAITHE AT FAWBER

YORKSHIRE
VERNACULAR BUILDINGS
STUDY GROUP 520

BARN P (east of Newhouses)
Name of building

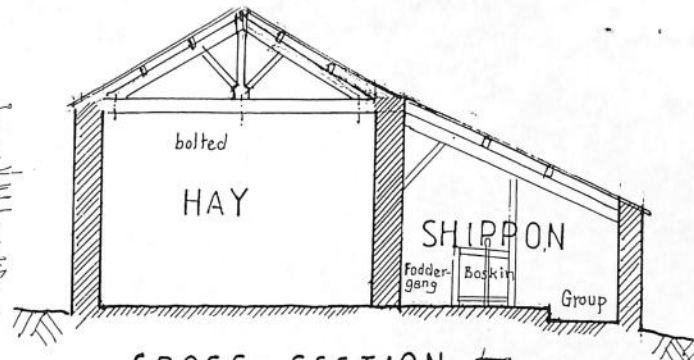
CROSS SECTION

The Laithe now in existence would have housed two rows of cattle at the south end, and have had a hay loft over them. Access to the boskins at the north end (now no longer in existence) would have been via a feeding walk (foddergang). A central slated floor is likely to have been used for threshing corn.

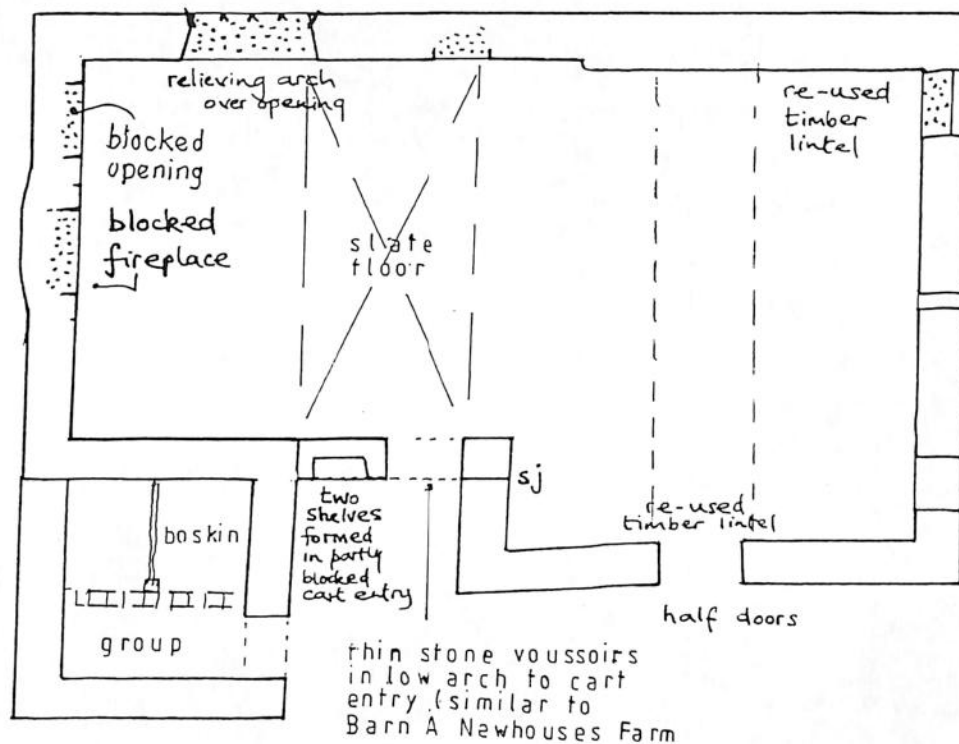
Ground Floor Plan

The outer face of the north wall shows only the faintest indication of the former doorway, but inside are clear straight-joints and a monolithic lintel. Also on the north elevation the only evidence of the former chimney stack is indicated by a cluster of projecting stones at high level mainly. Nearby to this cluster is a blocked single light window at first floor level of 17C appearance.

An earlier house existed, that would have had at least two ground-floor rooms, with Bedroom Chambers over. The 4-light window was probably that of the Housebody. The blocked north doorway may not be original to the building (see Report No. 549).

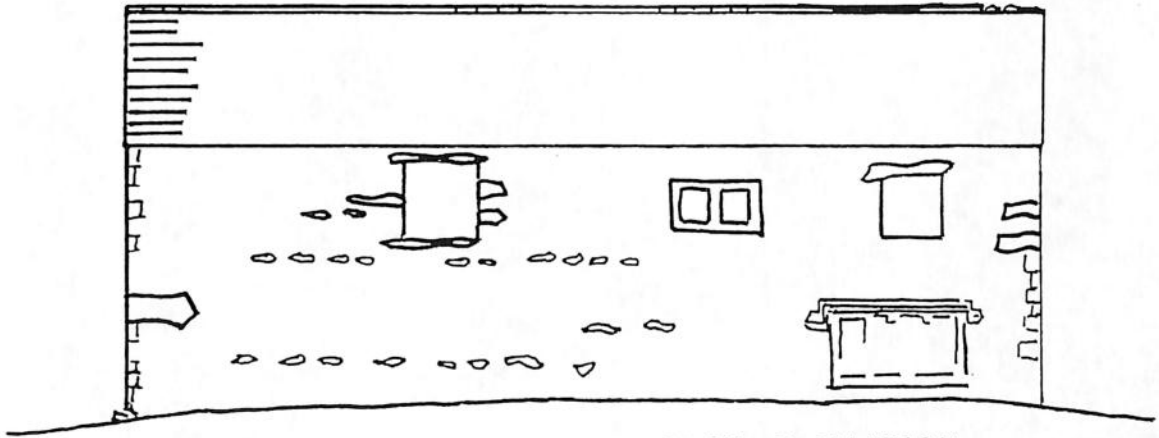
EAST ELEVATION
(C Small J Wood)

4-light double chamfered window (now blocked) with hood mould to East Elevation, also a blocked two light of similar construction on the same elevation at high level.

The plain openings in the upper part of the east wall are forking holes, though one may have traces of an earlier window.

The relieving arch over the four-light window to the East Elevation is made-up of narrow bedded pieces of individual stone

The former house is dated by its chamfered-mullioned hood-moulded window on the east window to the 17th Century.

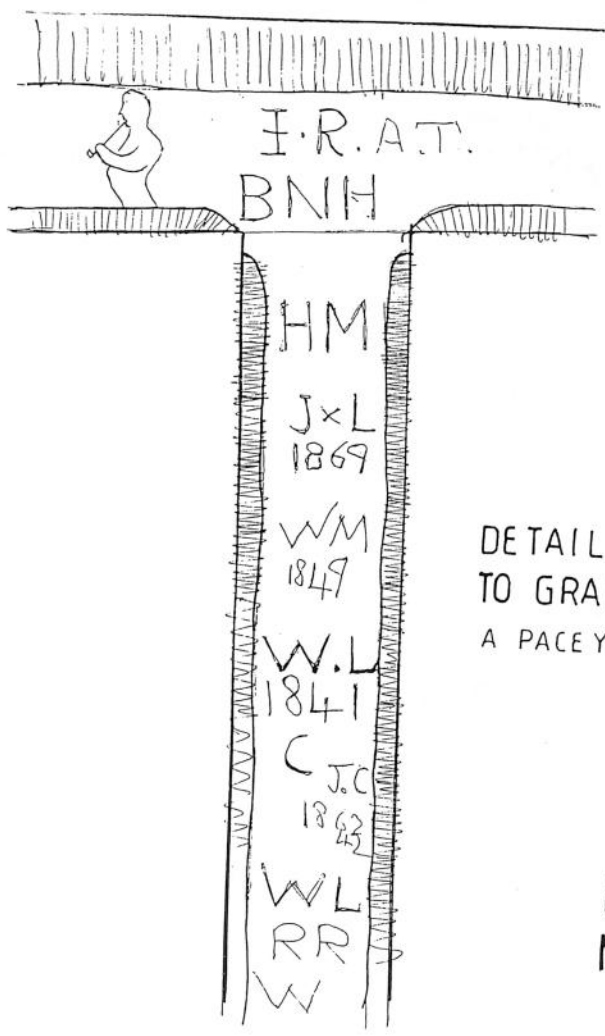
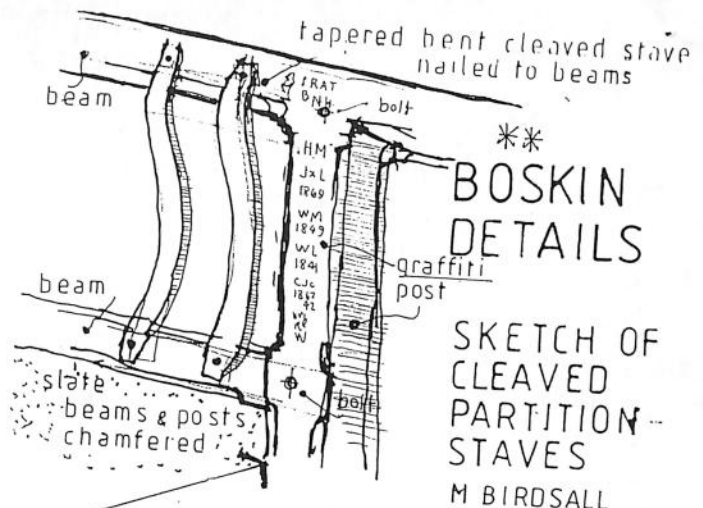
**
BOSKIN
DETAILS
SKETCH OF
CLEAVED
PARTITION--
STAVES
M BIRDSALL

The graffiti on the post to the foddergang from the barn (see layout plan & sketch) is a man smoking a pipe.

There is a date painted on a joist in the shippon to the west WR 1832 (see location plan). All other inscribed initials and dates are scratched onto the timbers.

DETAIL SKETCH
TO GRAFFITI *
A PACEY

WTJ WI 1847 RWI
JBR { GRAFFITI NOTED
FURTHER ALONG
BEAM **
WH LBA { ALSO ALONG
FODDERGANG BEAM

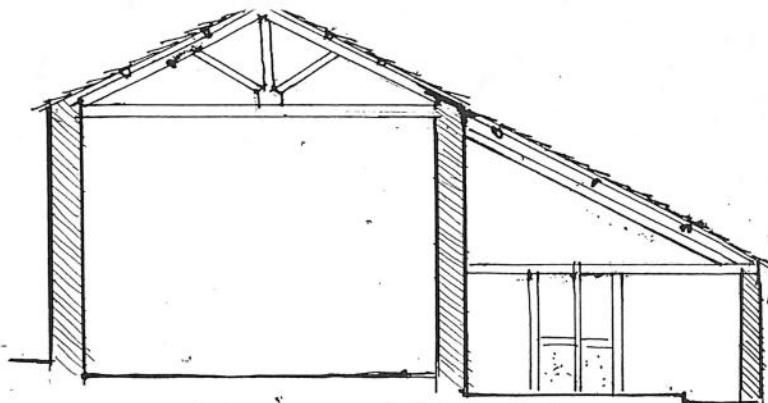
CROSS SECTION M BIRDSALL

Rud stake carries through to tie beam in outshot to boskins

The gable entry barn for cattle has been heightened, in the late 18C/early 19C. The earlier phase possibly dating to the mid 18C,

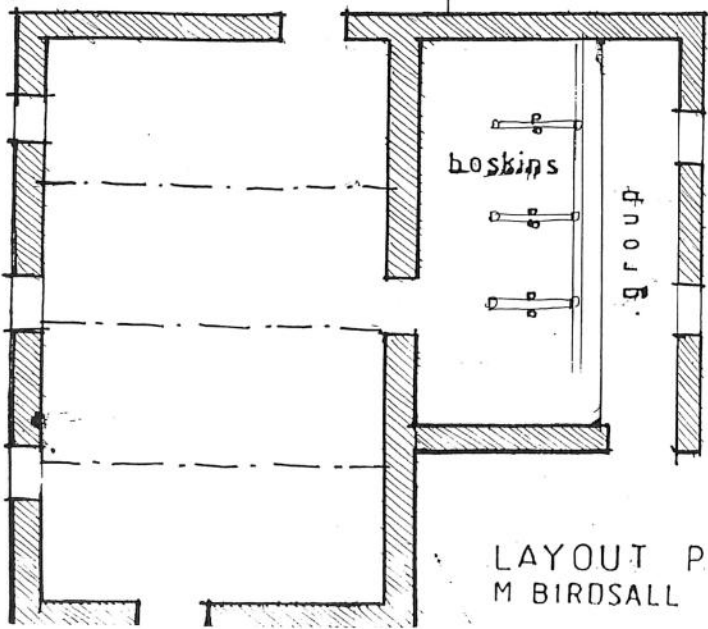
LAYOUT PLAN M BIRDSALL

Gable entry barn with outshot shippon

The outshot shippon has been added much later - perhaps as late as 1890 or 1900, but certainly before 1910, judging by the map of that date.

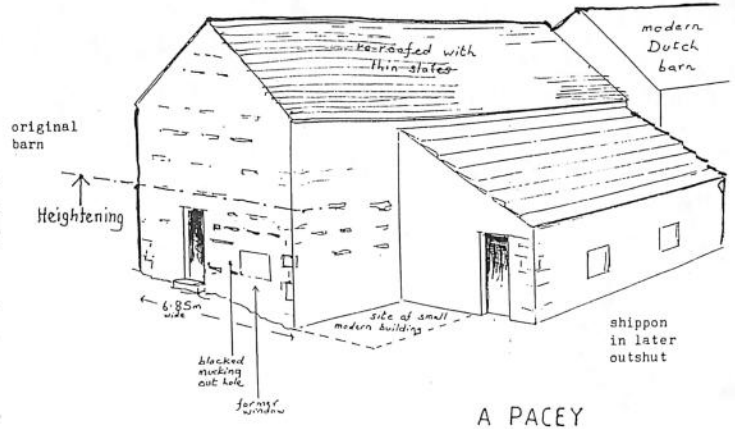
BARN Q FAWBER BOTTOM
 NEWHOUSES FARM
 NEWHOUSES
 HORTON IN RIBBLESDALE

Roofs are of flagstone except where otherwise marked.
