YDNPA traditional farm buildings census record sheet

Building ID
HR
117

NGR (8 figs)	Building name (if known)
SD 8139 6972	NEAR INTAKE BARN

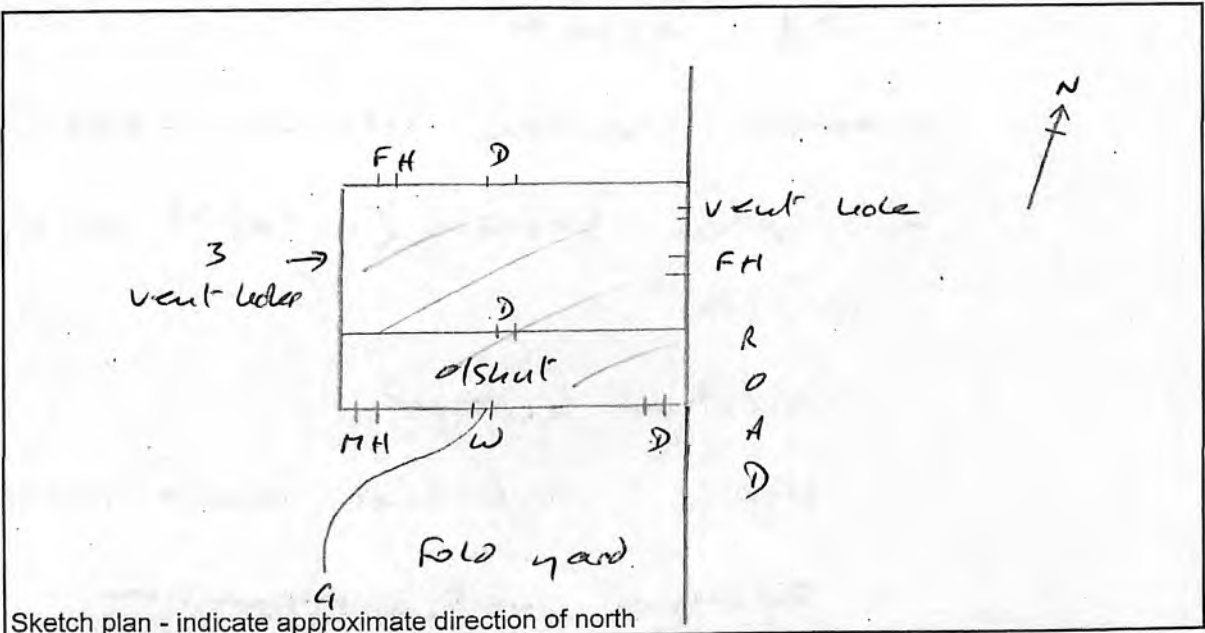
- SPAB no. 7091
- isolated field edge position
- rdg : asbests
- walls : random Silurian rubble
- wooden boshier (in tact) in o/skirt
slipper
- condition : sound
- use : informal sheep shelter
- surveyed with permission

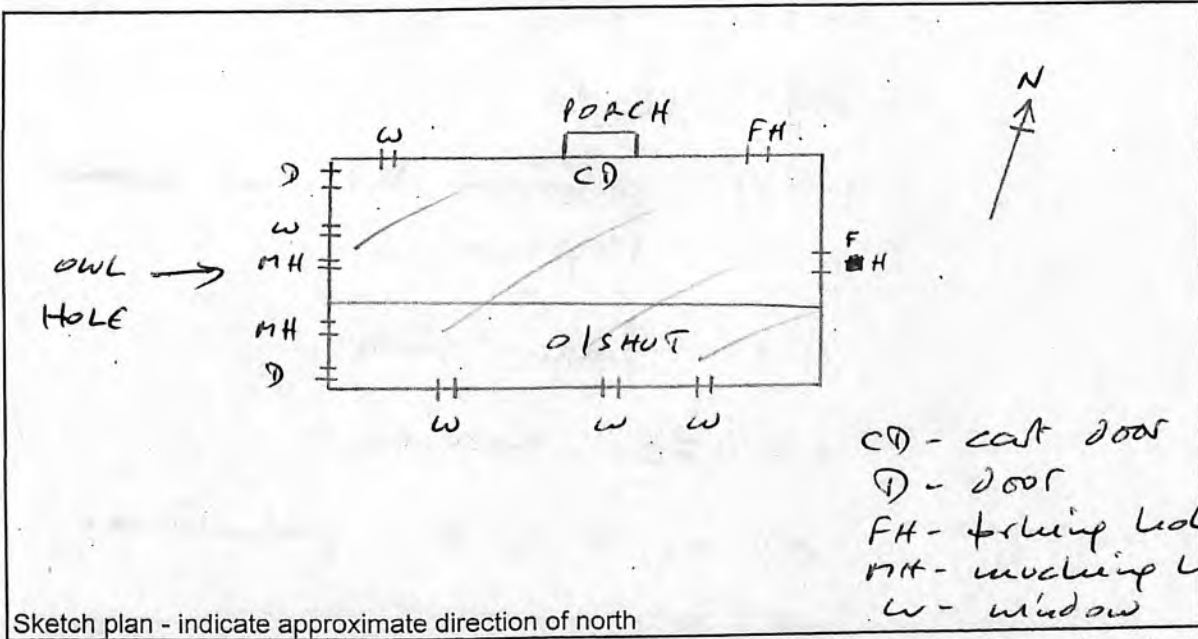
Building ID
HR
120

- within farm roof
- roof: slate
- walls: ~~covered~~ covered Silurian ~~table~~ flagstone
- use: farm store
- condition: excellent
- surveyed with permission
- 7 vent holes on W gable
- 2 rows of 4 vent holes on N elevation E of the cart door;
- § 2 rows of 8 on the W side of the cart door

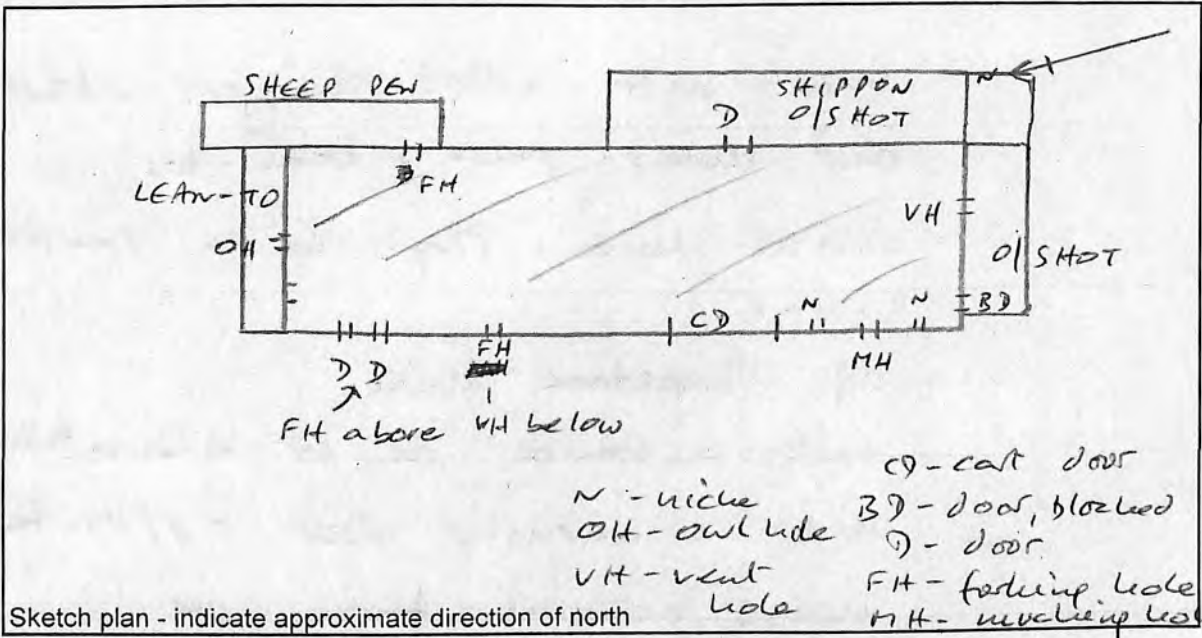
Building ID
HR
123

- SLAB no. 7086
- within farm group at Higher Studrod Farm
- barn with added slipper & shed and sheep pens & lean-tos
- Walls: Horsham flaps with sandstone quoins
- rd: ~~flapstone~~ slate
- east entrance on W elevation with windowing door opposite
- use: general farm use
- condition: sand through the S end of the rd is sapping
- surveyed from road

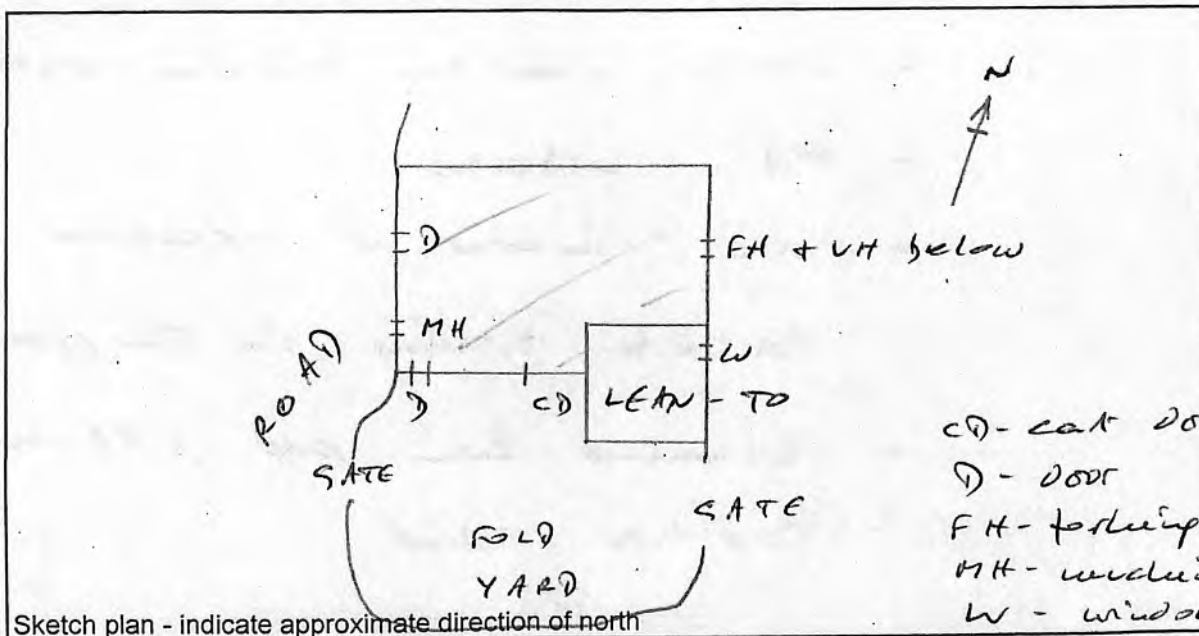
Building ID
HR
125

- isolated roadside position
- walls: random Silurian rubble
- roof: asbestos
- use: interior not accessed
- concrete bashing in skipper
- surveyed from road + PLOW
- condition: sound

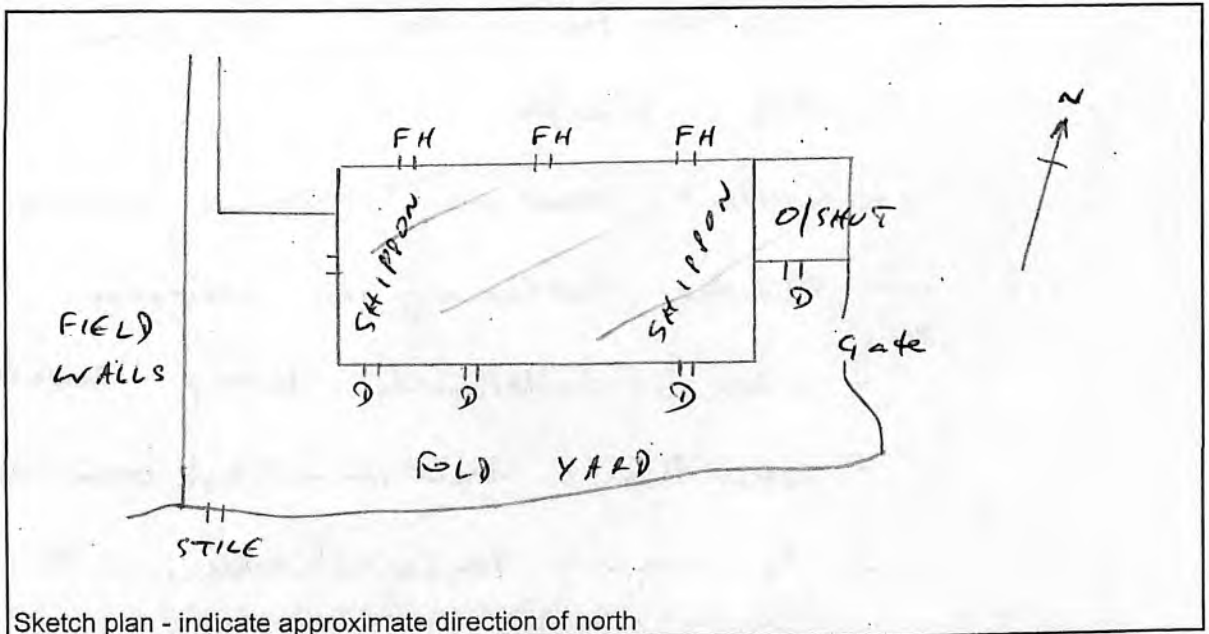
Building ID
HR
126

- isolated field edge position
- rdg: slate
- walls: random Silurian rubble
- slate boshing in slippage
- use: informal sheep shelter
- condition: excellent, but some loose slate
- surveyed ~~for~~ ~~with~~ with permission

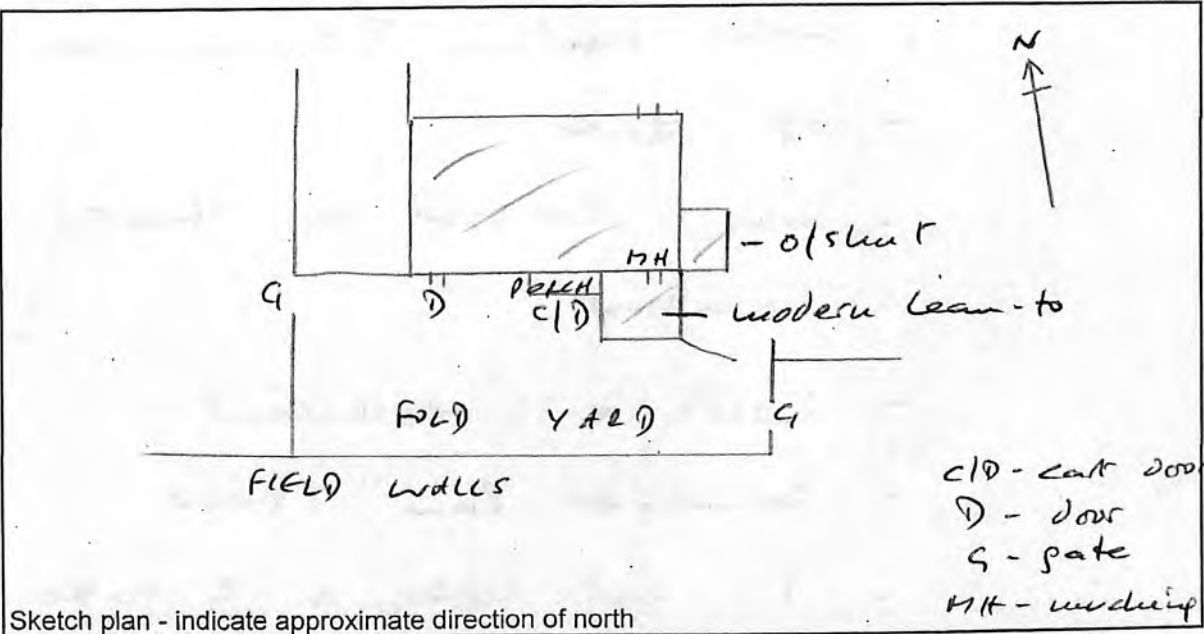
Building ID
HR
127

- at E edge of barn group
- walls: random Silurian rubble
- roof: slate
- use: hovel for sheep / lambing
- condition: excellent
- surveyed from P row
- 3 vent holes at E gable

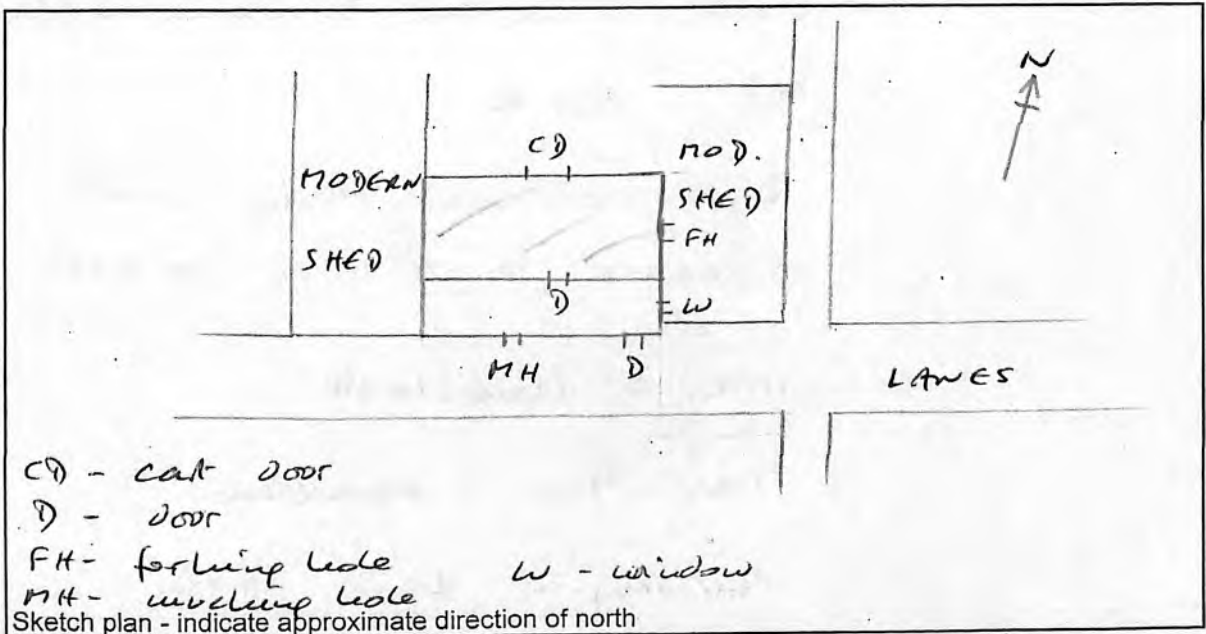
Building ID
HR
128

- within farm group
- walls: random Silurian rubble
- roof: slate
- two modern stock sheds attached to E & W gables
- uses: livestock
- condition: excellent
- surveyed from PROW

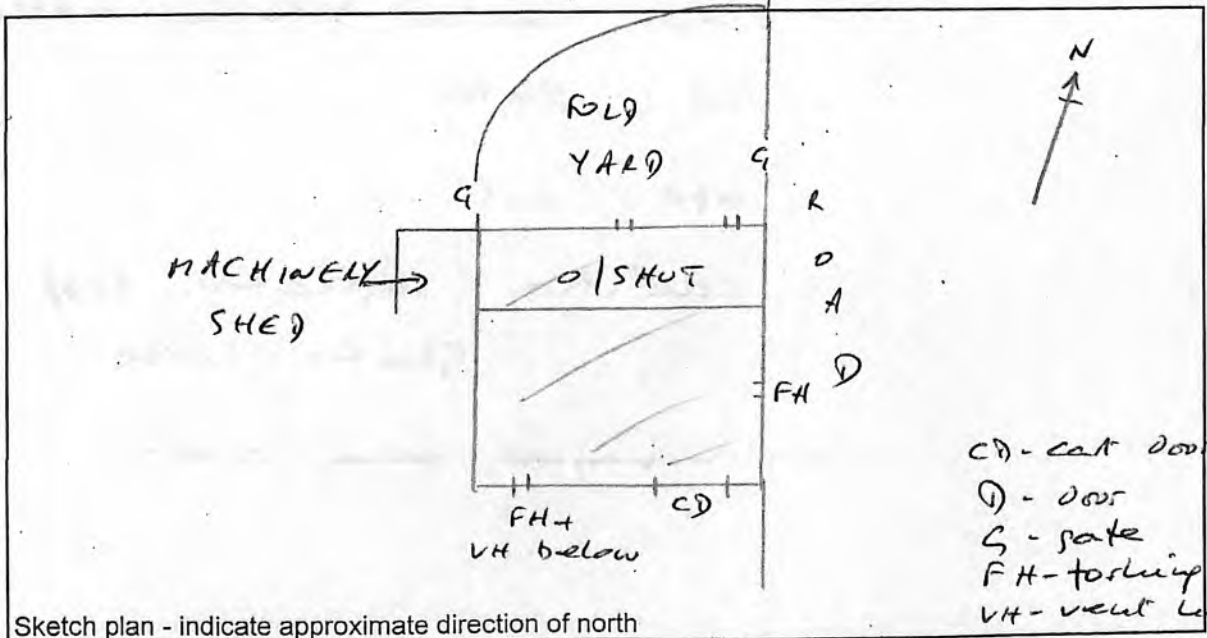
Building ID
HR
129

- isolated roadside position
- walls: random Silurian rubble
- roof: slate
- use: kiln
- condition: neglected. Roof
slates loose
- surveyed from road

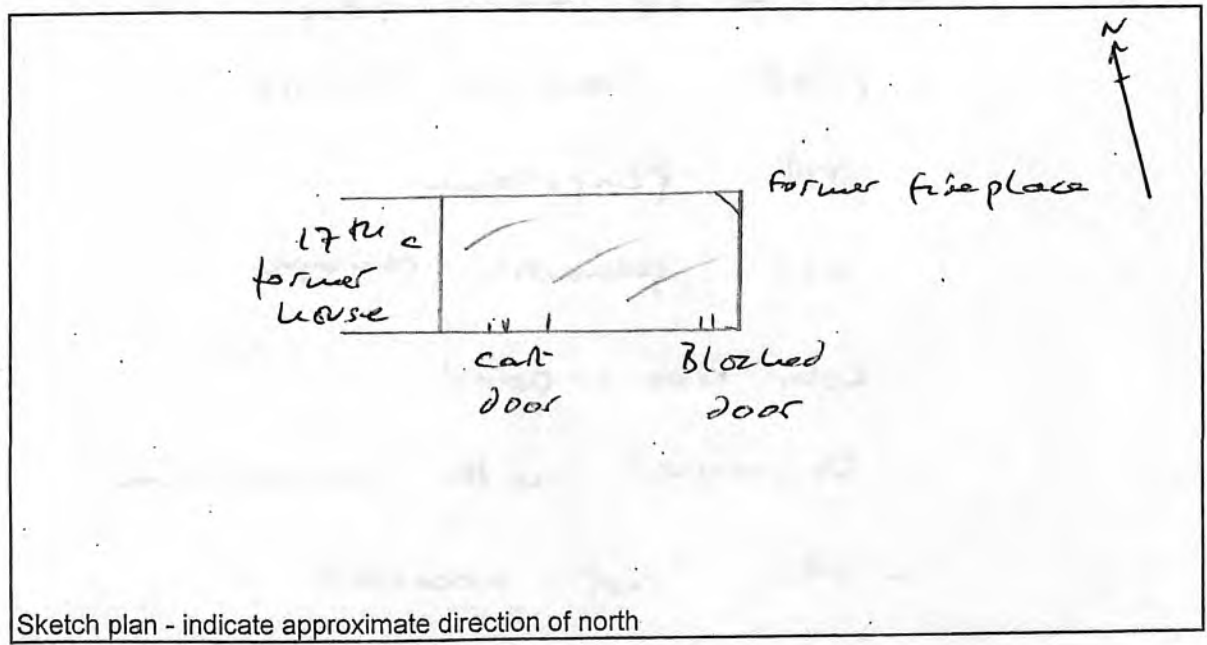
Building ID
HR
130

- in former farm shop
- walls: random rubble
- roof: flagstone
- use: general storage
- condition: good
- surveyed with permission
- rear not accessed

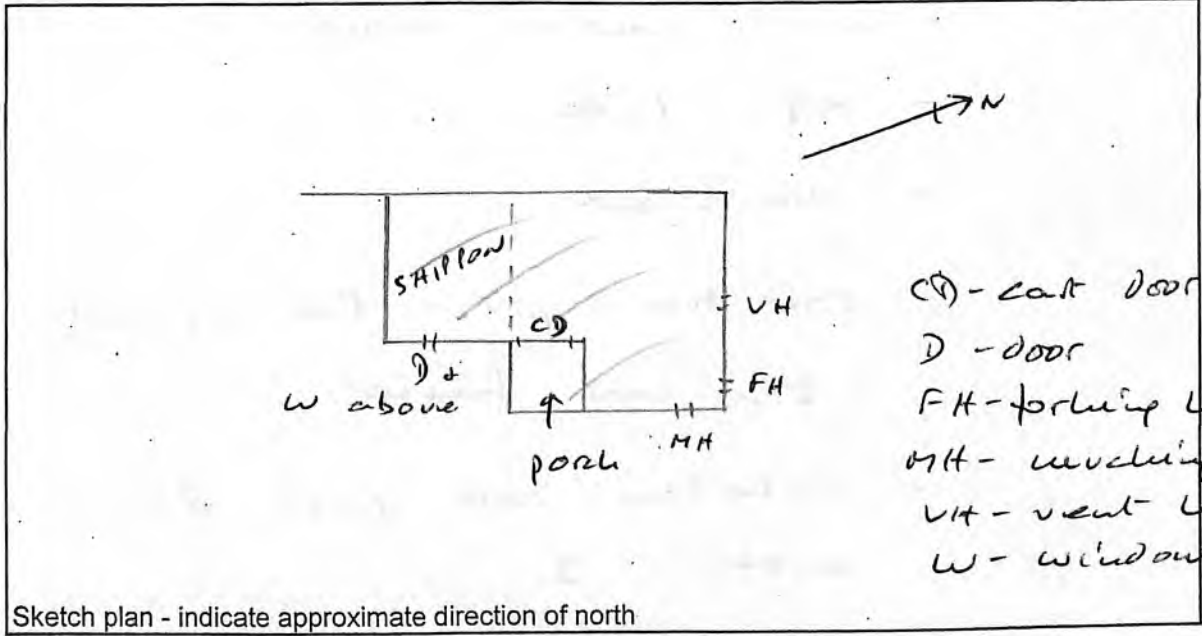
Building ID
HR
131

- in former farm shop
- walls: random rubble
- roof: slate
- use: nil
- condition: poor - the o/skint
of was failed.
- datestone over porch door
arch I
AN
1843
- surveyed from road
- rear not accessed

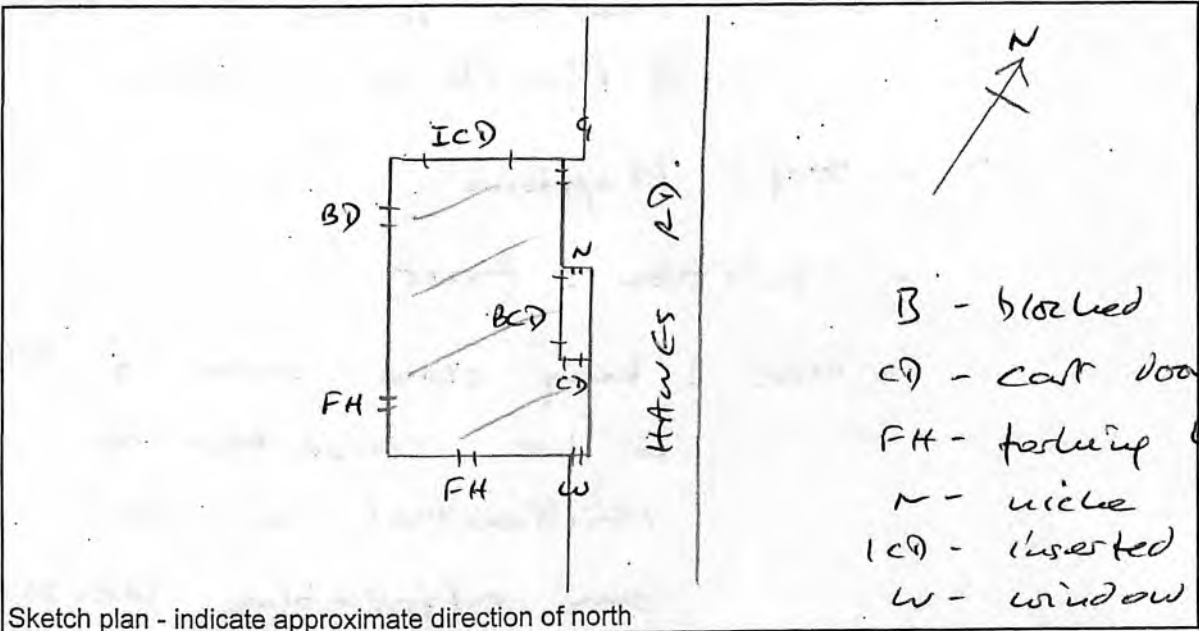
Building ID
HR
132

- roadside position opp. farm group
- walls: random rubble + 4 courses of flagstone through
- roof: flagstone
- condition: fair
- use: lay stone now + soon to be converted to residential as part of an affordable housing

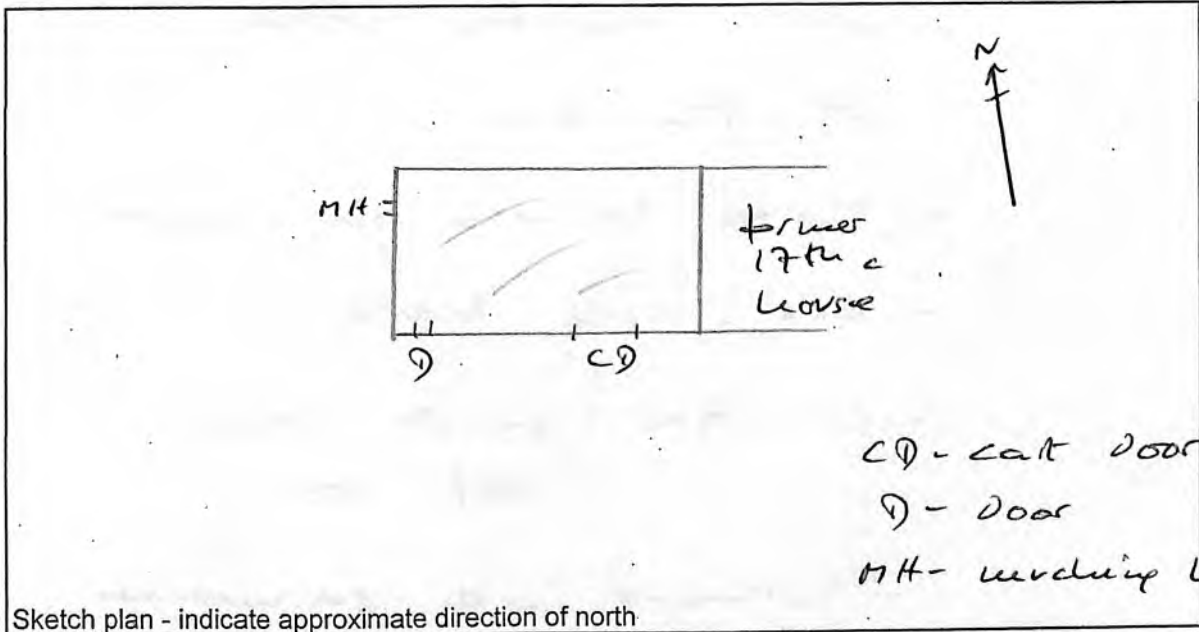
NGR (8 figs)	Building name (if known)
SD 8124 7236	DOUGSHYLL

- in former farm shop
- walls: limestone rubble
- roof: flagstone
- slate boshies in chimney
- use: calf house
- condition: walls sound
roof poor
- surveyed with permission
- rear not accessed
- 4 vent holes in W gable

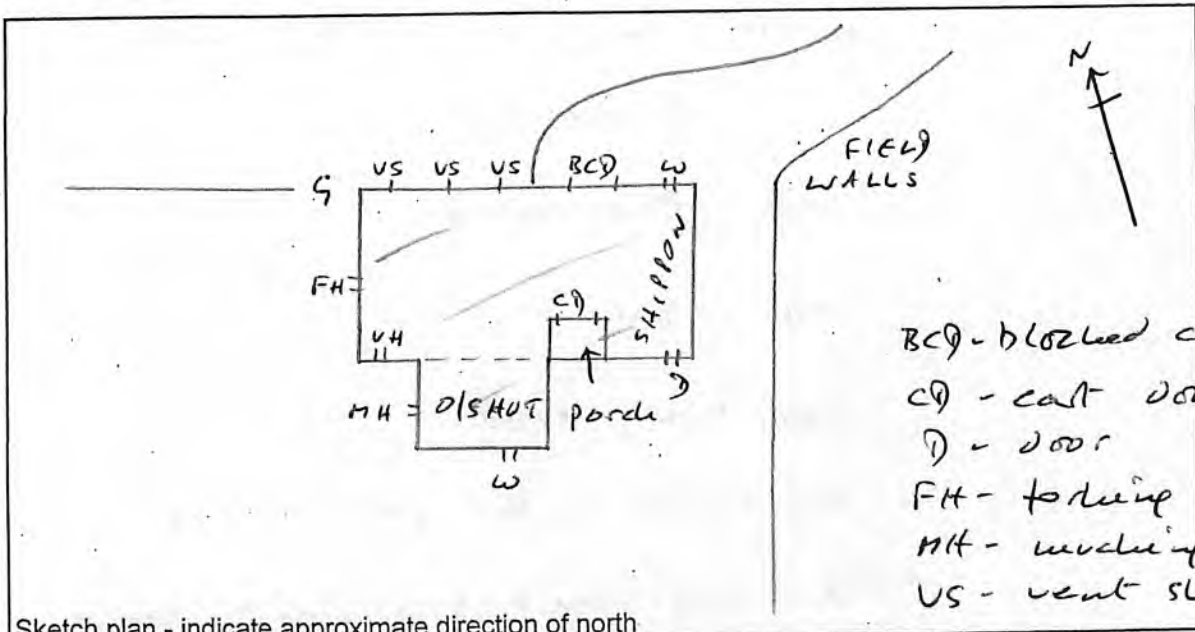
NGR (8 figs)	Building name (if known)
SD 8127 7218	RAINHEAD BARN

- isolated field edge position
- walls: random rubble with limestone squares
- roof: flagstone
- use: mil?
- condition: good
- surveyed with permission
- 3 vent slits + 5 vent loops
du W gable

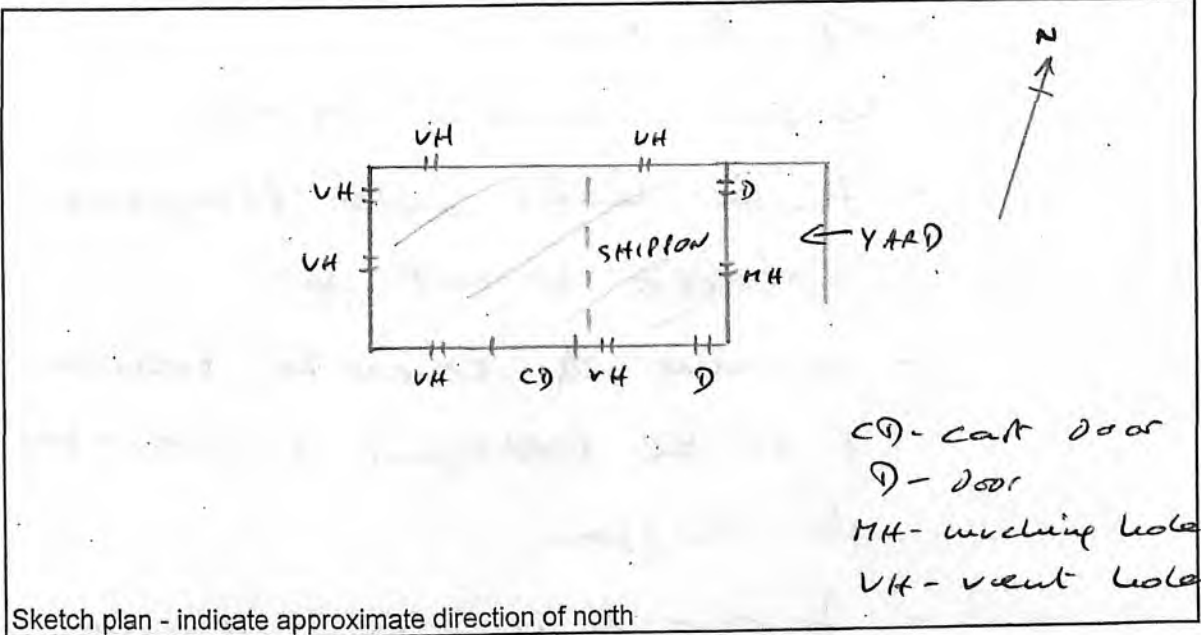
NGR (8 figs)	Building name (if known)
SD 7902 7571	NEW CLOSE BARN

- isolated field edge position
- roof: flagstone
- walls: limestone coursed
- timber lintel under flagstone
voussoirs to cut door
- remains of concrete base
& timber foddergang & mewshead
in slippen
- 7 rows of limestone through
in E gable; 6 on the W gable
& N elevation
- 2 vent holes on E gable
- use: in formal sheep shelter
- condition: 2 structural cracks
at E end of N elevation.
otherwise sound
- surveyed with permission

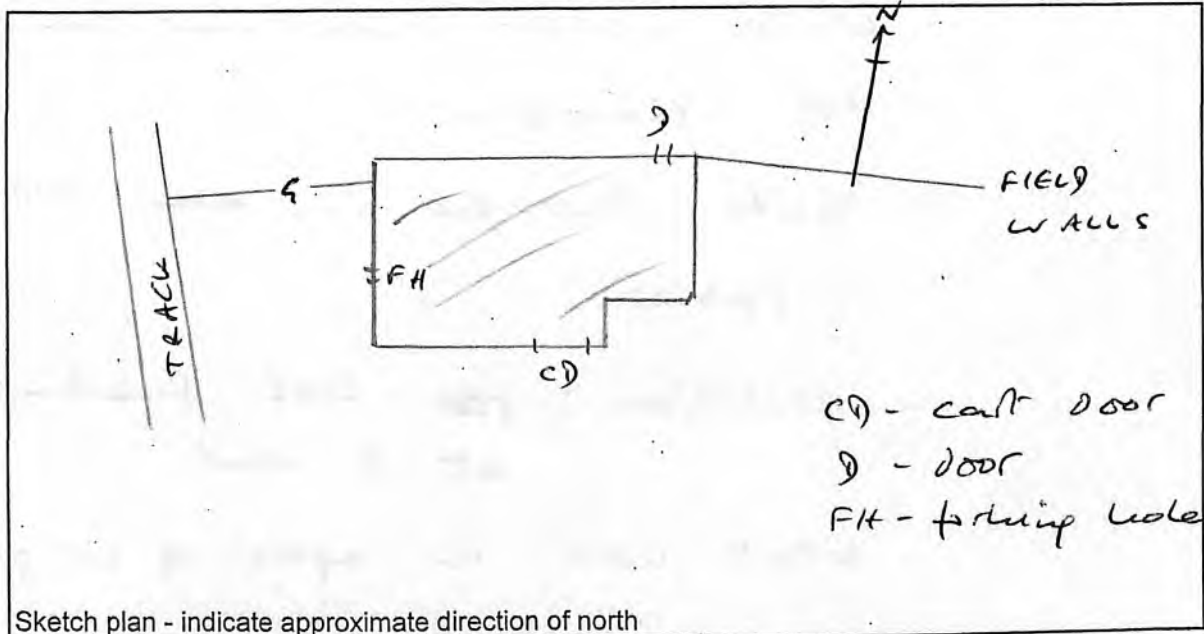
NGR (8 figs)	Building name (if known)
SJ 8094 7286	SALBERS BARN

- isolated field edge position
- walls: coursed lime - and sandstone
- roof: flagstone
- slate through in elevations
+ gables
- condition: poor. Roof failing
at E end
- vent hole in apex of W gable

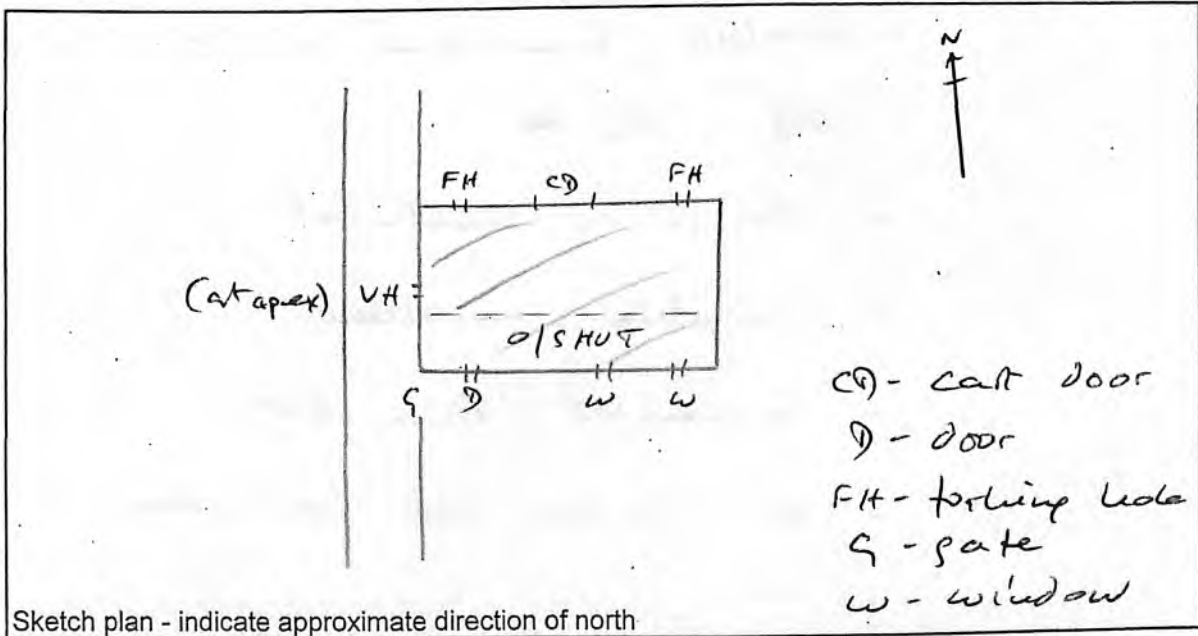
NGR (8 figs)	Building name (if known)
SD 8050 7247	ROWE END

- in farm group
- walls: limestone rubble
- roof: slate
- use: agricultural
- condition: excellent
- surveyed from road
- e. gable not accessed
