YDNPA traditional farm buildings census record sheet

Building ID
HR
140

NGR (8 figs)	Building name (if known)
S9 8024 7298	BLIND BECK

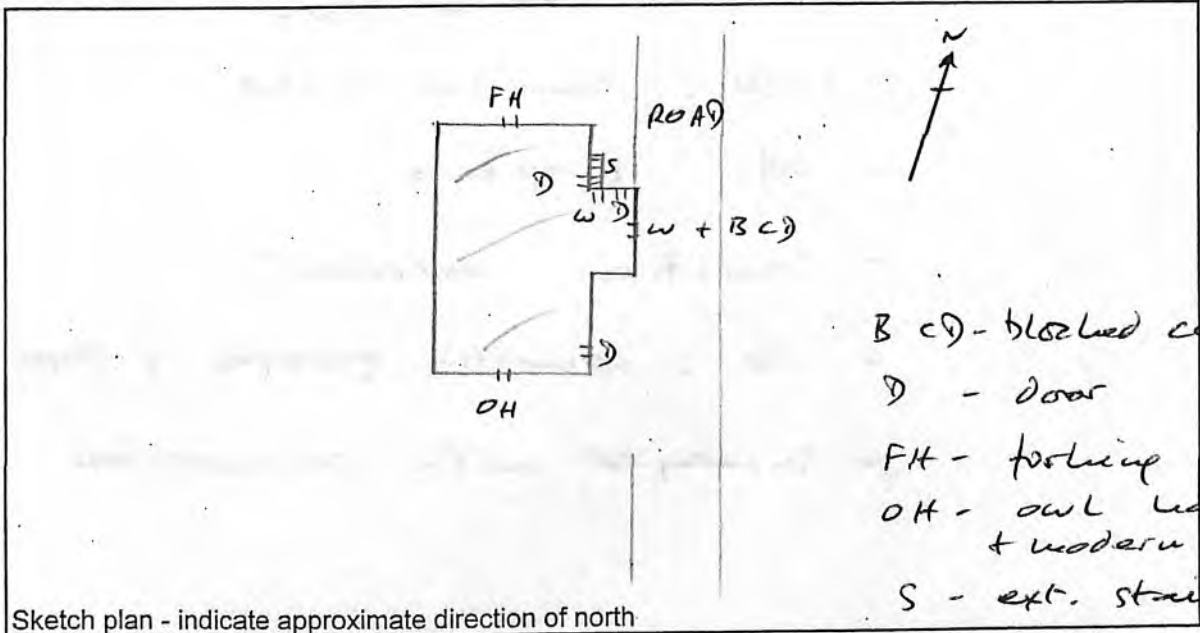
- in former farm group
- walls: random rubble
- roof: flagstone
- condition: excellent
- use: domestic garage & store
- surveyed with permission

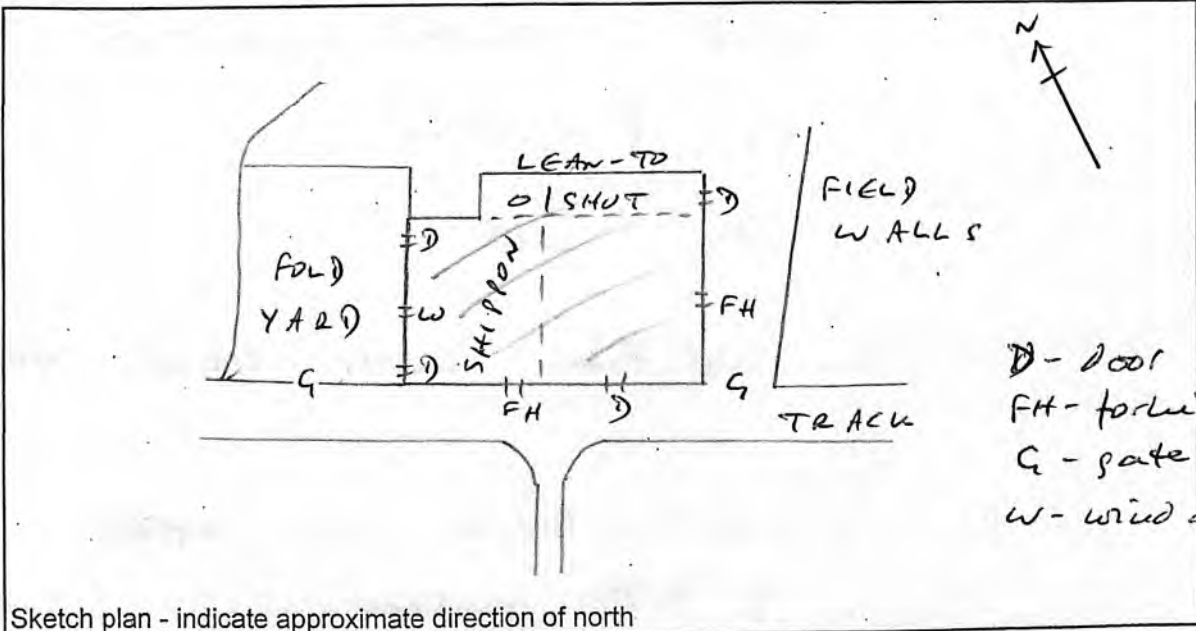
Building ID
HR
141

- isolated roadside position
- walls: coursed limestone
- roof: flagstone
- use: well
- condition: walls sound, roof sagging
- vent hole in apex of both pables
- surveyed from trackway

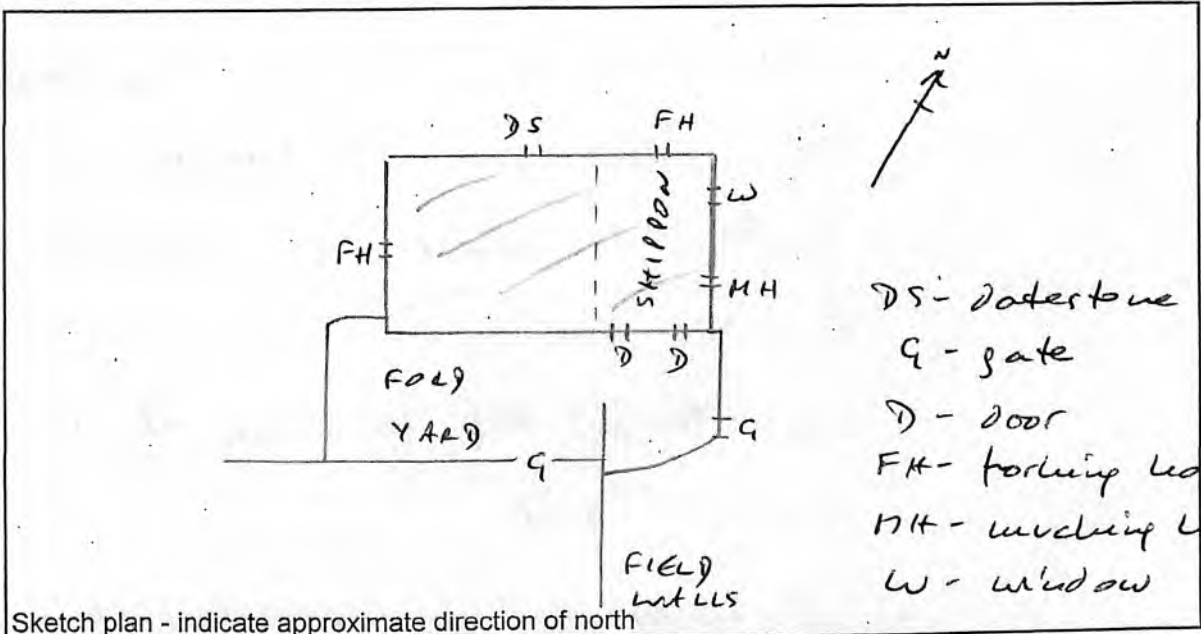
Building ID
HR
142

- isolated field edge position
- walls: coursed Silurian flagstone
- roof: Silurian flagstone
- slate boshing in skipper at N end
- condition: roof failing at W gable
- use: util
- datestone on N elevation
RC
1848
- Surveyed with permission

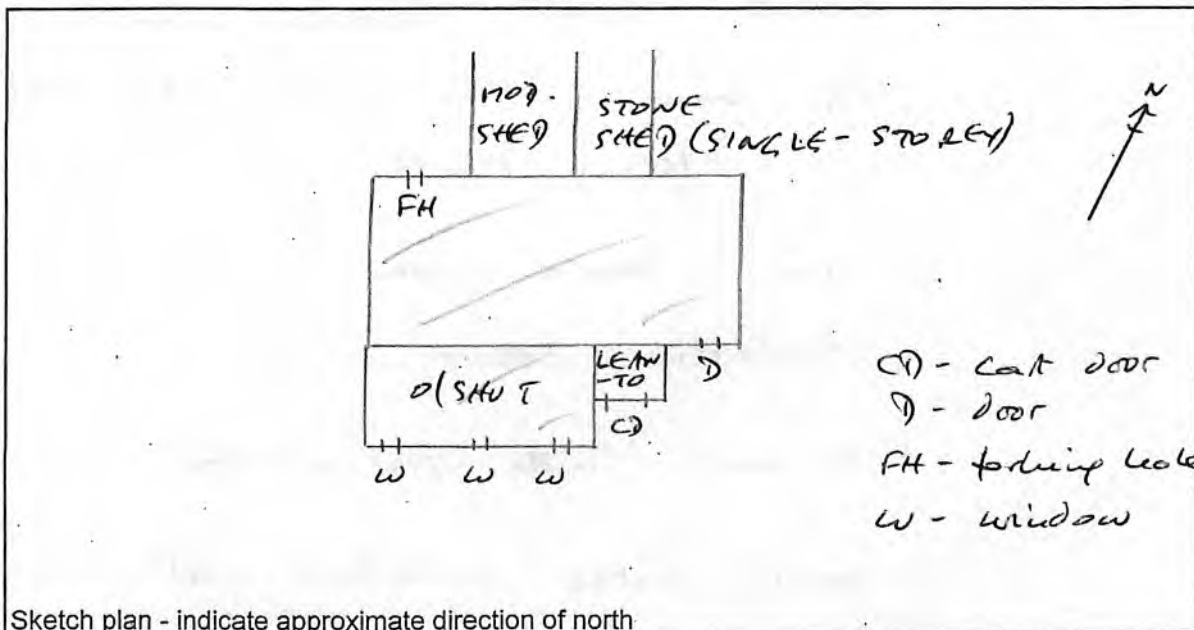
Building ID
HR
143

- within farm group
- walls: covered Silurian, mixed
- rd: main base + lean-to corrugated
o/slnt slate
- use: farm use
- condition: sound
- surveyed with permission
- east gable + interior not seen
- 3 vent ledges above door in
NW elevation

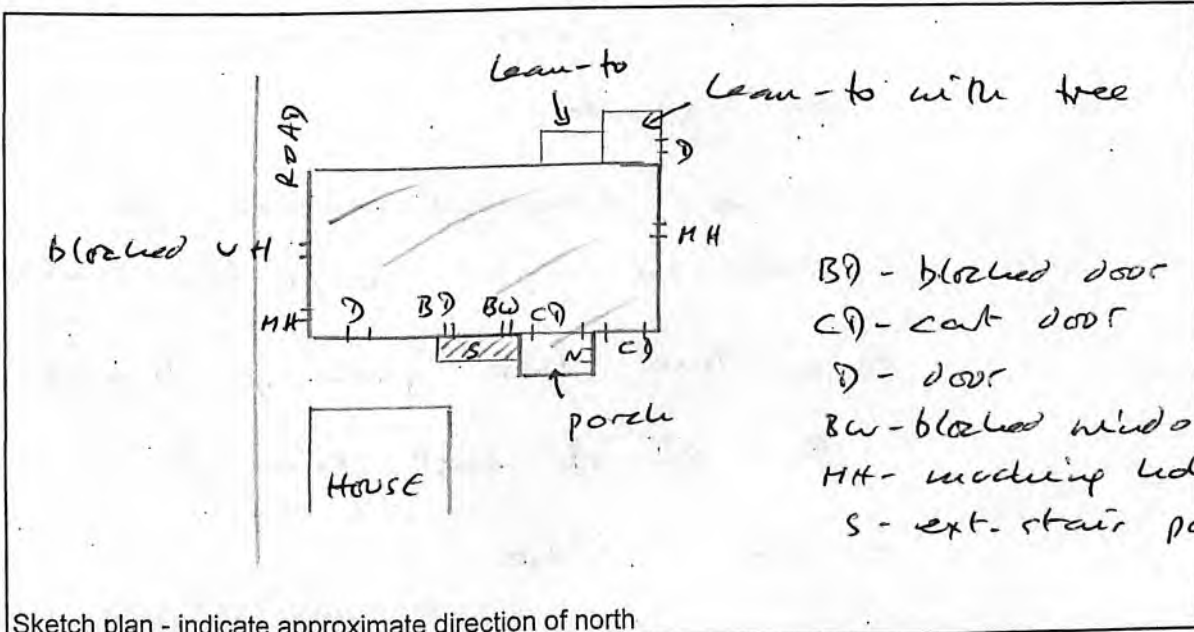
Building ID
HR
144

- within farm pump
- walls: mixed Silurian
- rd: slate
- former external access to door in upper level on S elevation
- mature tree growing through the rd of east lean-to
- use: store?
- condition: poor. Roof failing, serious structural cracks in E gable
- re-used timber to call door lintel
- Surveyed with permission

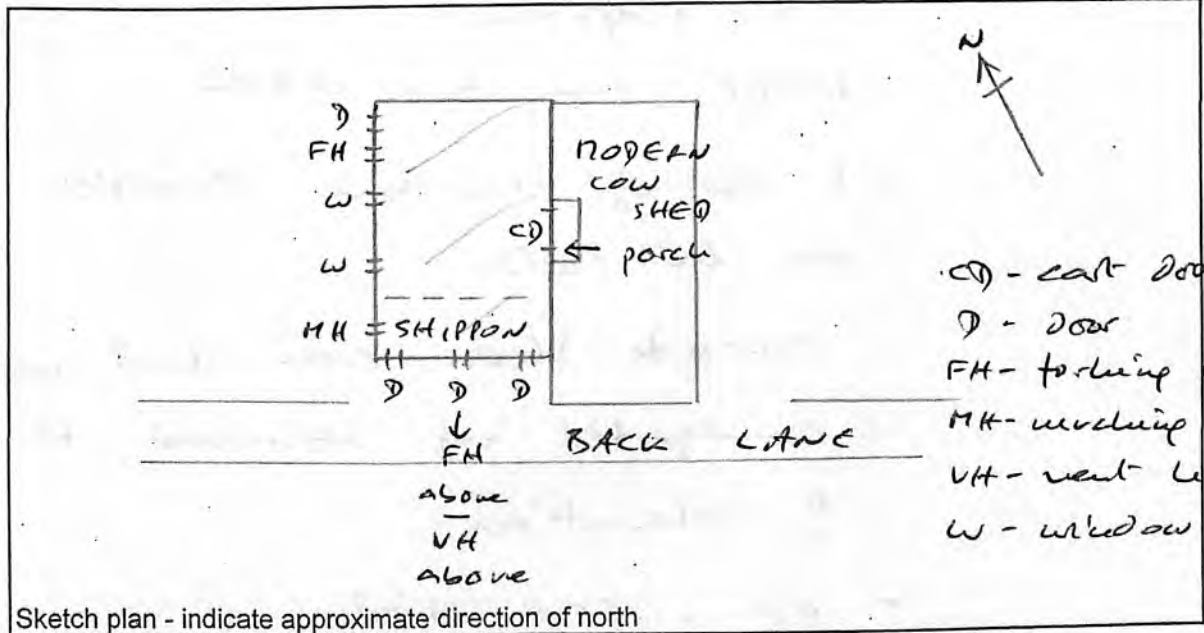
Building ID
HR
145

- isolated face edge position
- roof: flaps tone
- walls: limestone rubble
- 6 rows of limestone knoxtup on W gable
- concrete-block cow shed with corrugated roof attached to S elevation
- use: cow shed
- condition: sound
- not accessed internally
- surveyed from adjacent track, where I had permission to be

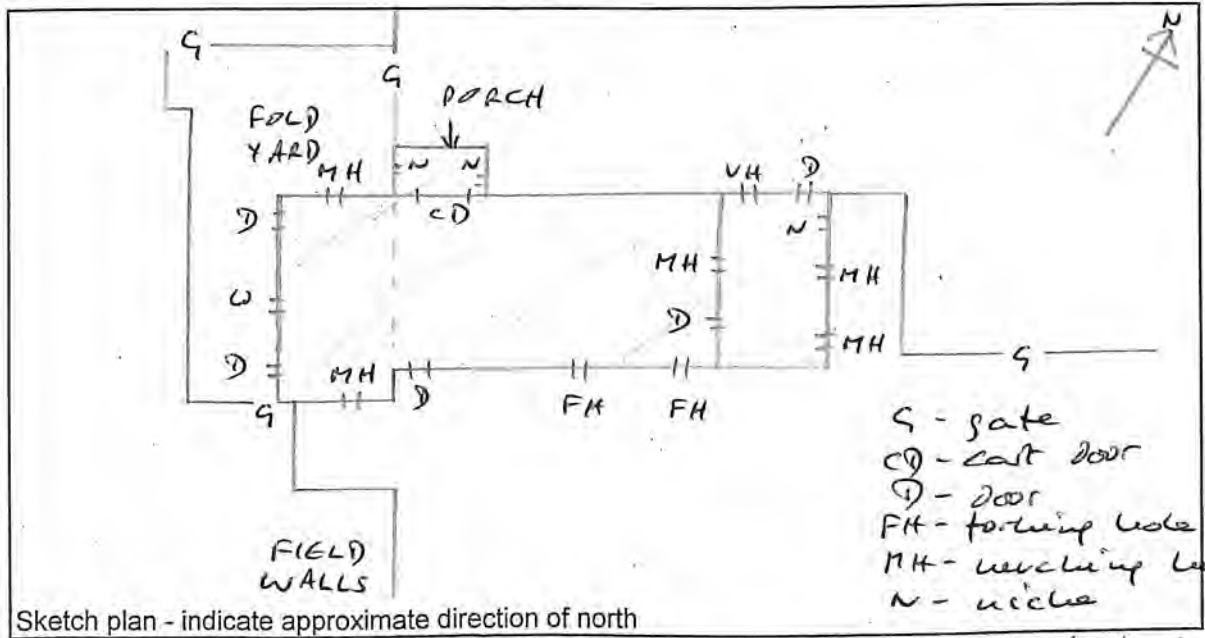
Building ID
HR
146

- isolated face edge position
- roof: flagstone
- walls: limestone rubble
- "AH" carved into a grain on the NW corner
- slate boshing in E skillion
- slate boshing + fendergang in W skillion
- vent hole in apex of W gable
) in apex of E gable
- use: none apparent
- condition: excellent. Recently consolidated
- surveyed with permission

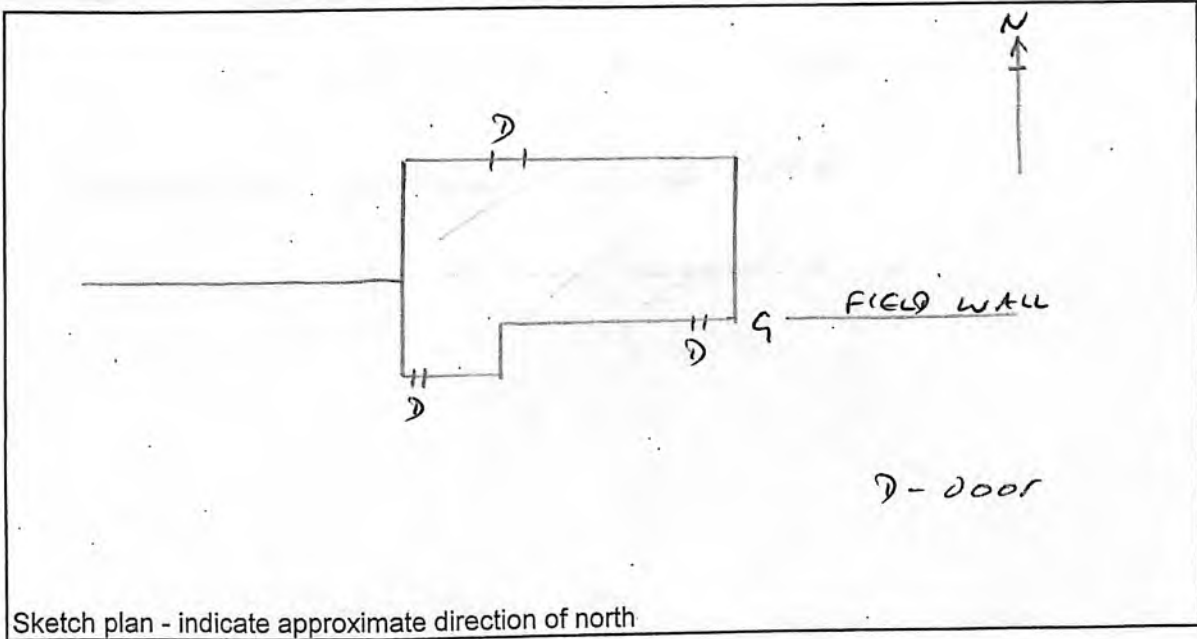
Building ID
HR
147

- walls: mixed sandstone + limestone
- roof: it was freestone
- total ruin - mostly collapsed
- surveyed with permission

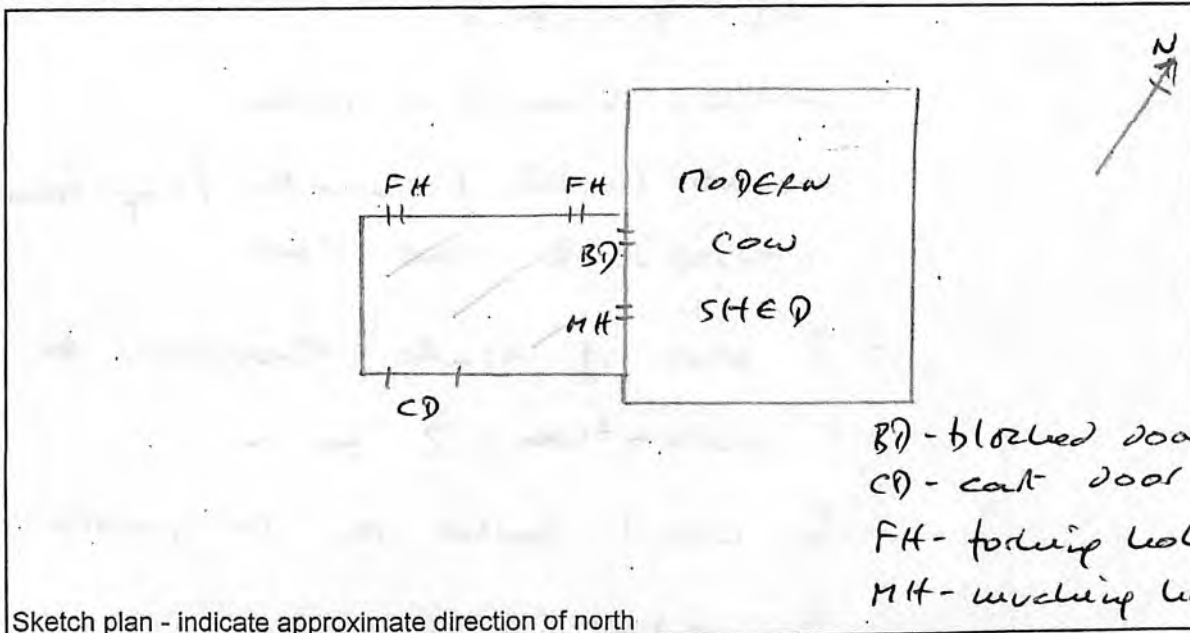
Building ID
HR
148

- within farm group
- roof: flagstone
- walls: limestone rubble
- timber lintel beneath flagstone
voussoirs to cart door
- 3 rows of slate through to
S elevation; 2 to N
- 8 vent holes on W gable; 1
in apex of E gable
- use: cow byre
- condition: excellent
- surveyed with permission

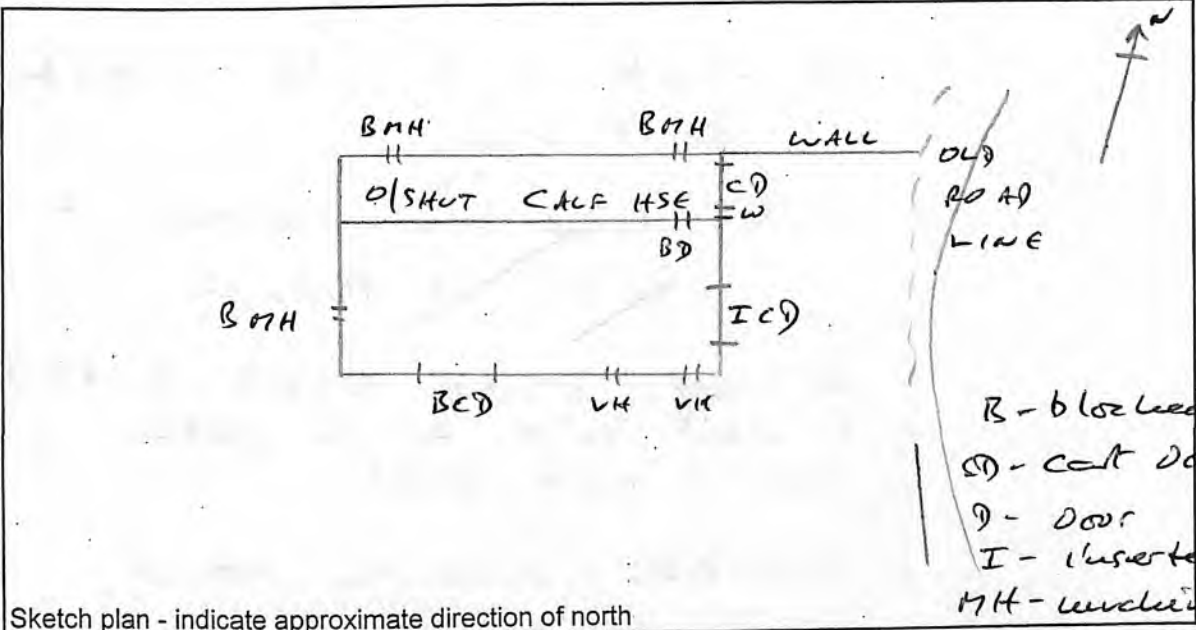
Building ID
HR
151

- field edge / roadside position
- roof: slate on N side, freestone on S side
- walls: limestone corbelled + quoins + rougher
- re-used timber lintel to BCD
- 3 vent holes to W gable
- use: cart shed
- condition: mainly sound
- surveyed with permission

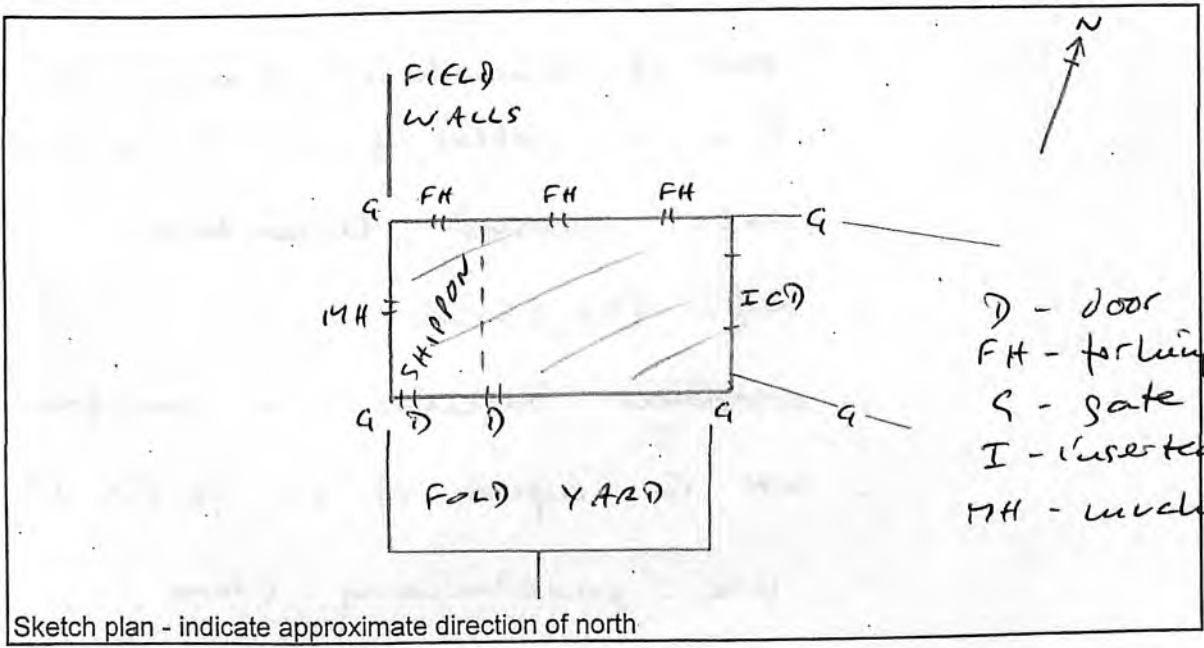
Building ID
HR
152

- isolated field edge position
- 3 rows of limestone through E + W gables; 4 in S elevation
- walls: coursed limestone
- roof: flagstone
- wooden boshine in skippan
- vM in apex of W gable + E gable
- use: machinery store
- condition: fair-structural crack at E end of N elevation, otherwise sound
- surveyed with permission

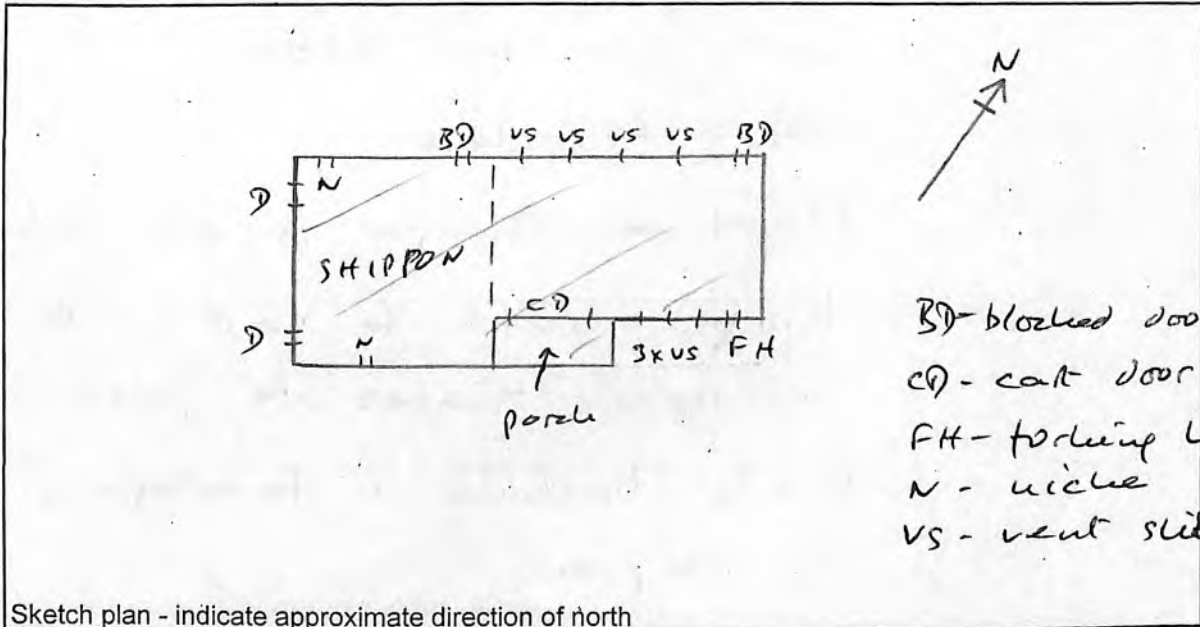
Building ID
HR
HR
153

- isolated field edge / roadside posn.
- walls: random rubble
- roof: flagstone
- flagstone through to all elevations
- timber lintel to cart door + re-used timbers to porch
- slate boshine + foddergamp in slüppen
- 2 VH in W gable apex; 11 VH in E gable + 1 owl hole
- use: nil
- condition: poor. E gable is braced internally, externally
- surveyed with ~~position~~ permission

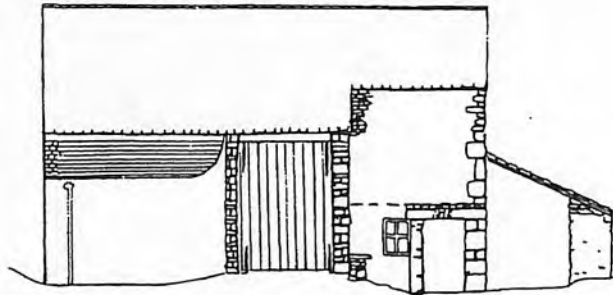
South elevation

- within farm group
- walls: limestone rubble/coursed
- roof: ~~stone~~ flagstone
- ~~leaving~~
- o/sluts to 3 sides
- datestone above small door
- slate bosline to skippan
- condition: good
- use cattle byre + sheep pens
- surveyed with permission

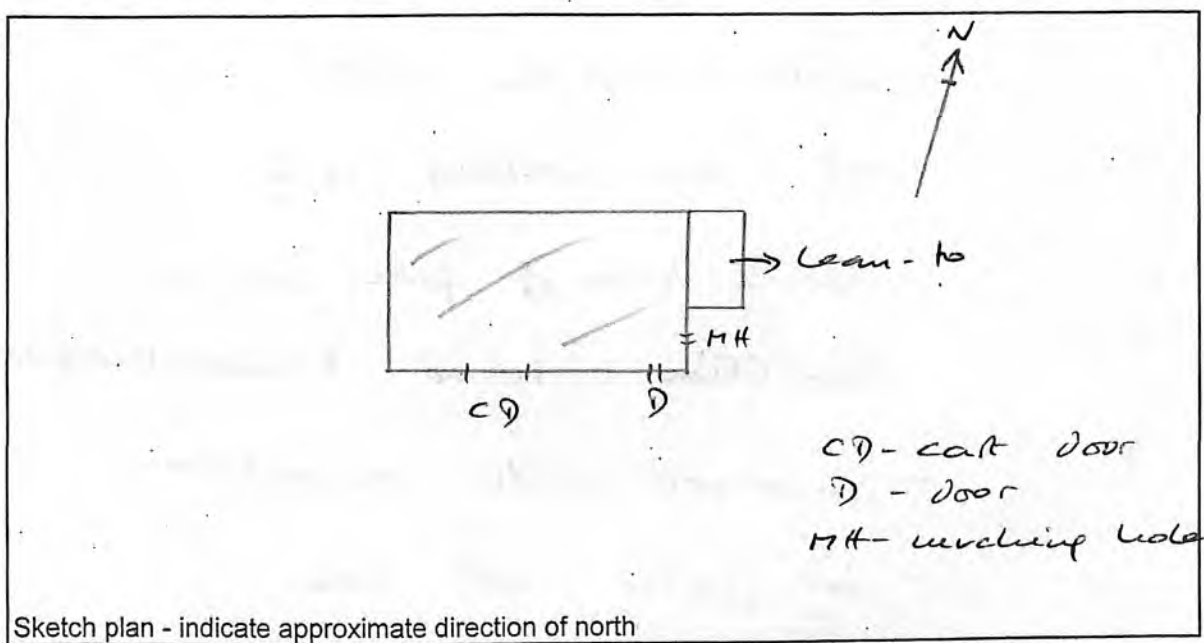
Building ID
HR
155

- within farm group
- walls: random rubble
- roof: completely gone
- use: birds of prey housing
- condition: sound & weatherproofed
- Surveyed with permission
- W. gable not seen

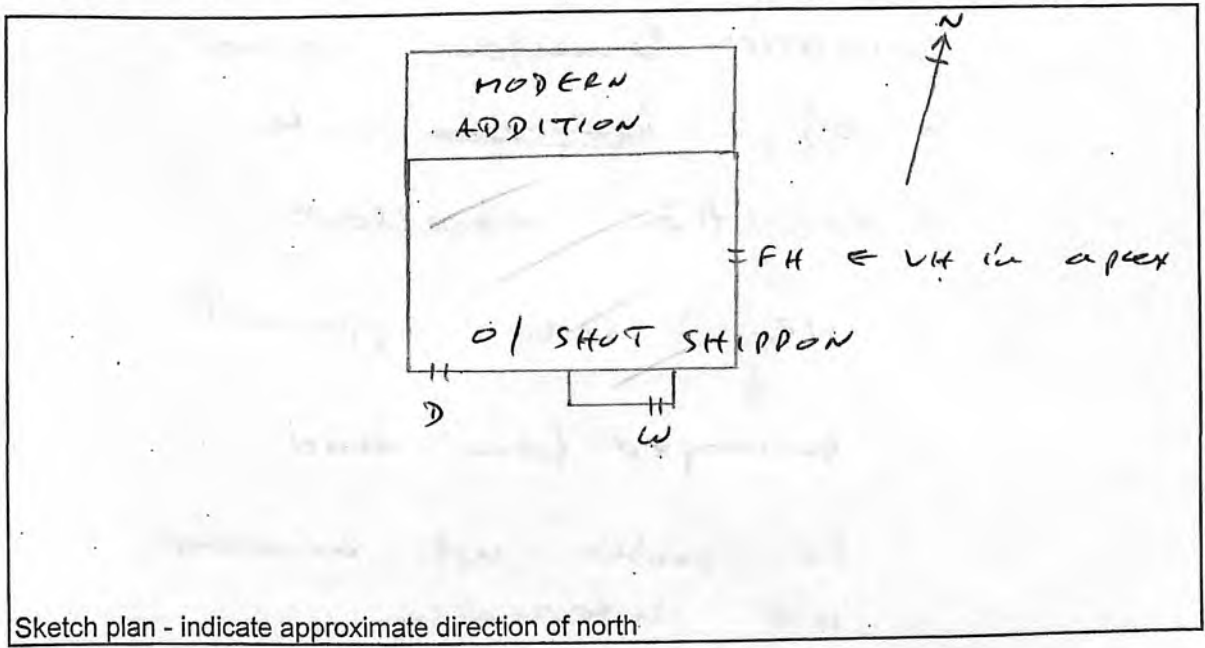
- within farm group
- walls: limestone coursed
- roof: ~~flagstone~~ slate
- condition: excellent
- use: none apparent
- surveyed from road
- w. gable not accessed,
was internally

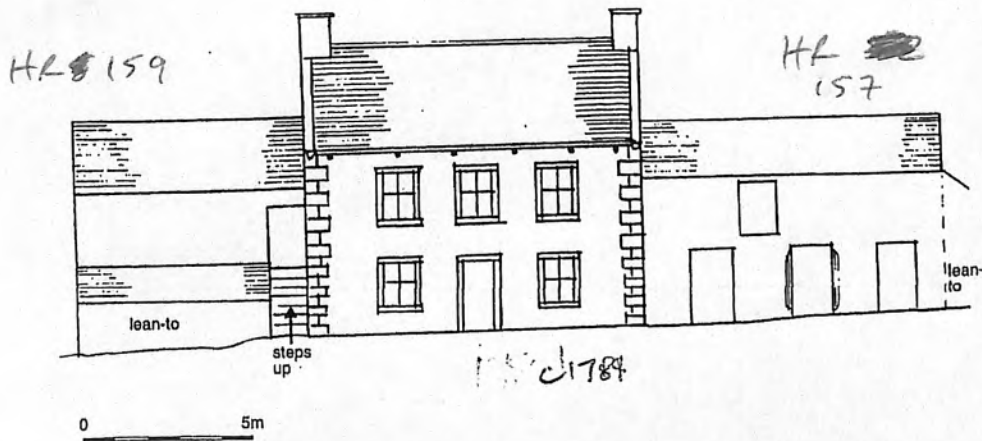
South-west elevation

- within farm group, attached to NW gable of house
- lean-to attached to SW elevation
- walls: random rubble
- roof: flagstone
- use: domestic store
- condition: good
- surveyed with permission

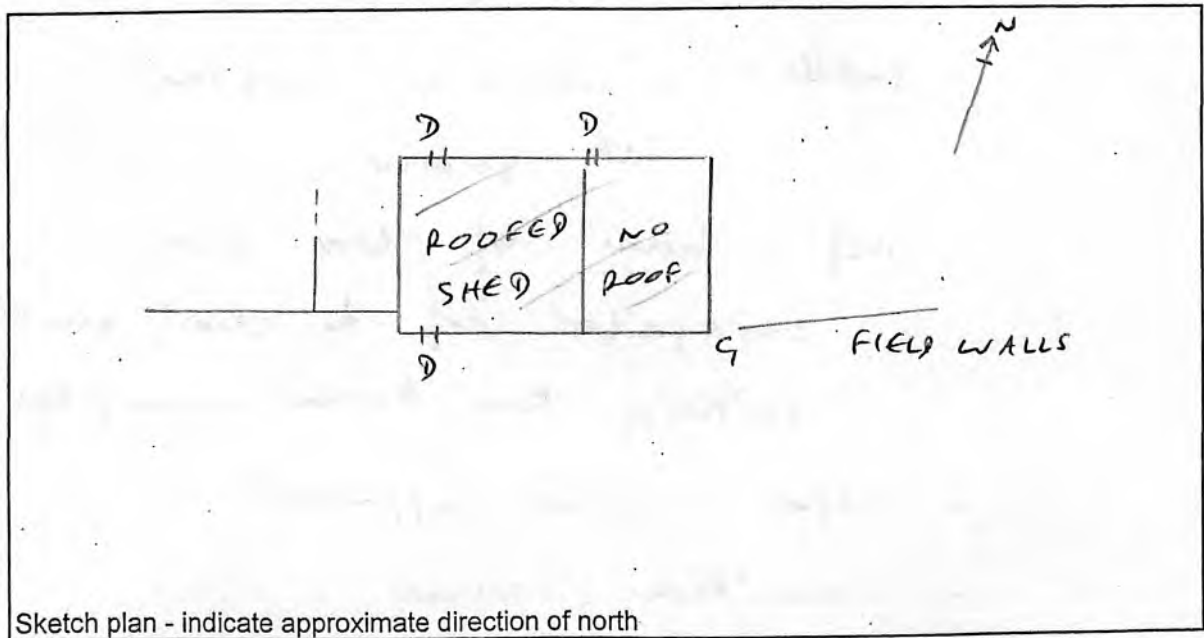
- isolated field position
- walls: limestone coursed + 1st course
- roof: barn roof like some; corrugated roof to shed built within the barn; monopitch roof
- use: none apparent
- condition: sound
- surveyed with permission
