**YDNPA traditional farm buildings
census record sheet**

Building ID
HR
163

NGR (8 figs)	Building name (if known)
S0 7796 7919	LOW FLAT BARN

Parish	Site visit date	Recorded by
HORTON IN RIDALE	8-4-11	D-Johnson

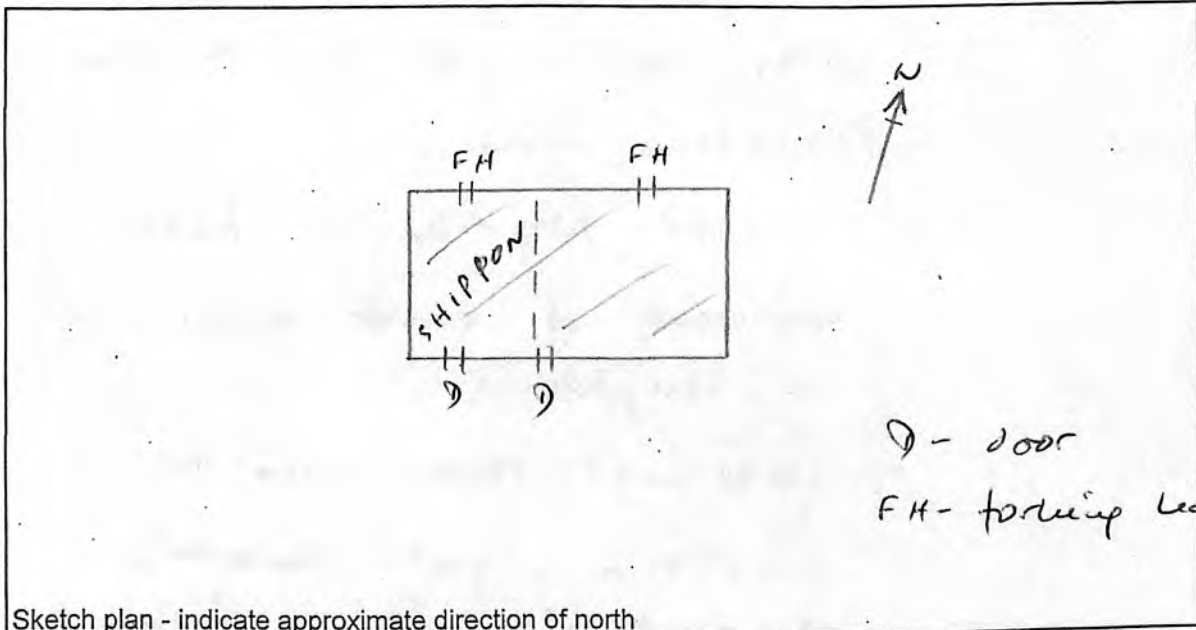
- isolated field edge position
- fold yard to south of bar
- cat door
- walls: random rubble
- roof: slate
- re-used timber to porch & CD lintels
- 3 VH & 3 vent slits to E gable
- slate boshing in both skippour
- condition: sound
- use: informal sheep shelter + machinery shed
- surveyed with permission

Length 8m
Width 5.6m

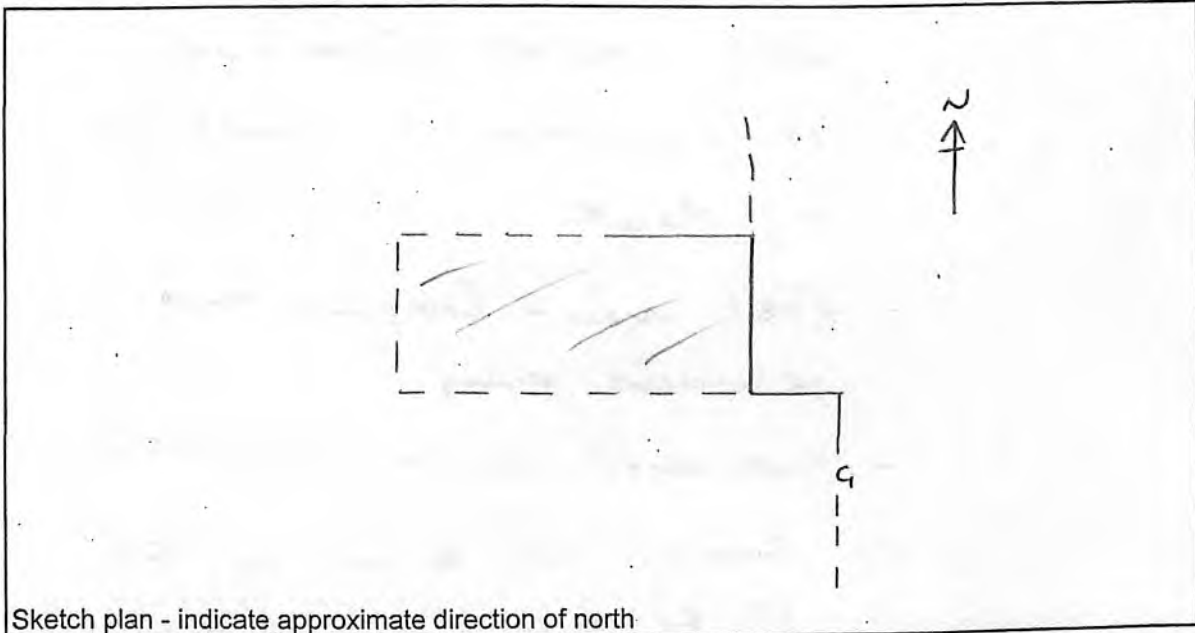
Building ID
HR
164

- limestone coursed wall
with occasional 1st through
- flagstone roof
- isolated position in field
- remains of slate boshier
in chimney
- informal sheep shelter
- condition: poor - several
structural cracks, a couple
of holes in the roof +
a bulge in the w gable
+ S elevation.
- surveyed with permission

Length c. 10 m
Width 4.50 m

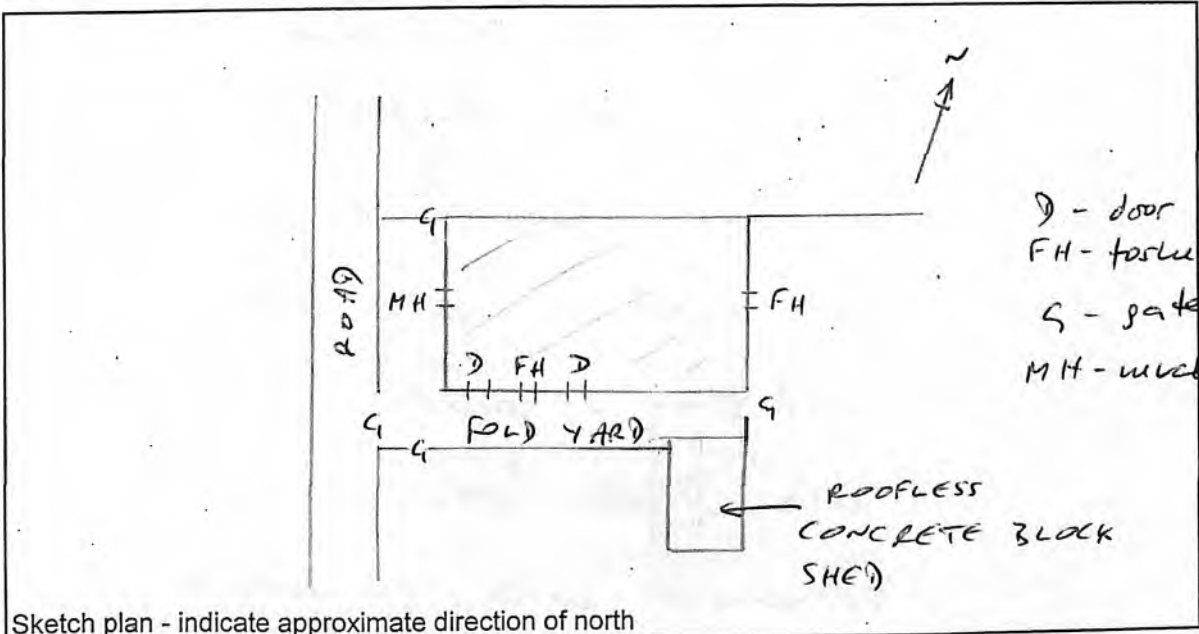
Building ID
HR
165

- edge of field position
- well coursed limestone
- N elevation is built on a plinth
- total ruin - fragmentary remains only
- surveyed with permission
- shown as ruined on OS (1st Ed. 6 inch)

Length 9.60m
Width 7m

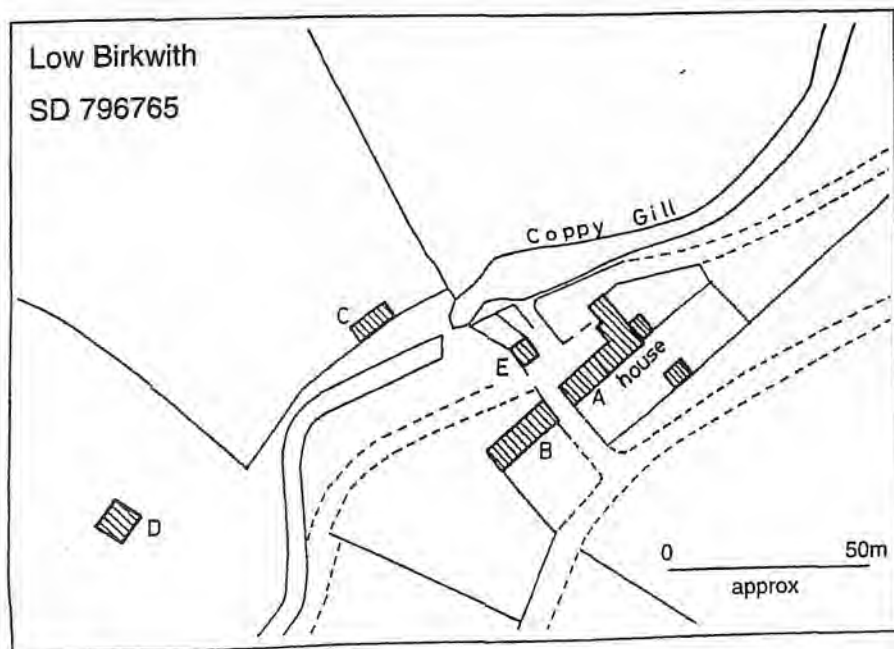
^{p. 8.} South-west of the house, and on the same alignment, is barn B (Report 1498), a large seven-bay barn with hay and crop storage and two cattle shippens at the north-east end. In the north-east gable is a dovecote with 47 flight holes. The barn is built of local rubble with pick dressed sandstone quoins, Horton slate roofs and sandstone ridges. It is all of one build, except for the added porch to the cart entrance, and is of 18th century date. The shippon end projects beyond the main part of the barn in the local tradition. This is one of the largest barns recorded at Horton, with space for up to 18 cattle and a capacity of 475 cubic metres of hay storage, calculated by Arnold Pacey (see the article on Horton Barns on pages 35-41).

A plan and elevation of Barn B can be found on page 39.

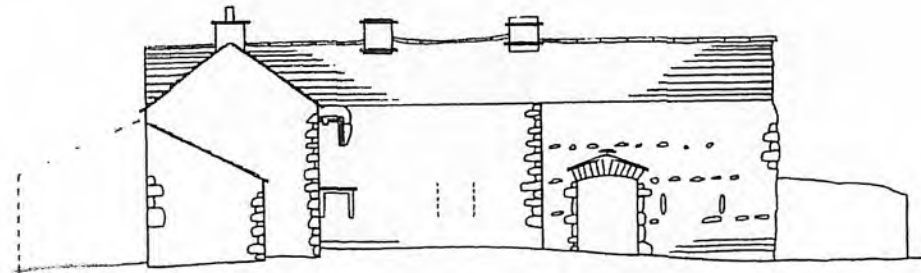
North-west elevation

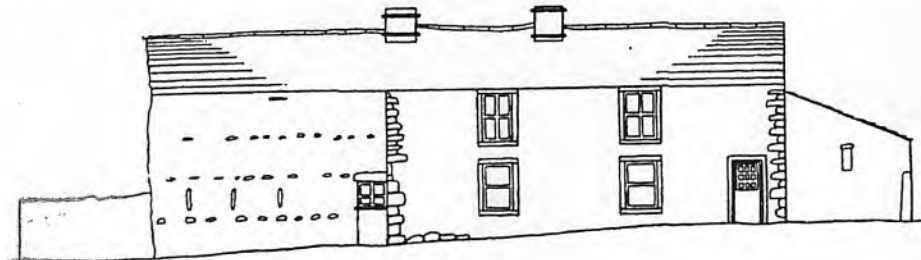
South-east elevation

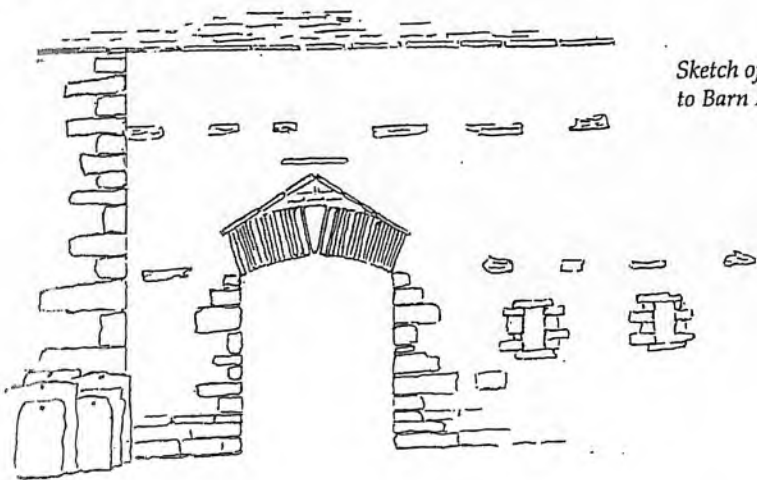
Sketch of doorway to Barn A

The three-bay barn (A) with its threshing floor, crop storage and stable was added to the south-west gable perhaps around 1700. Evidence for this date comes from the banded king-post timbers, typical of others in the Settle area of this type and date.

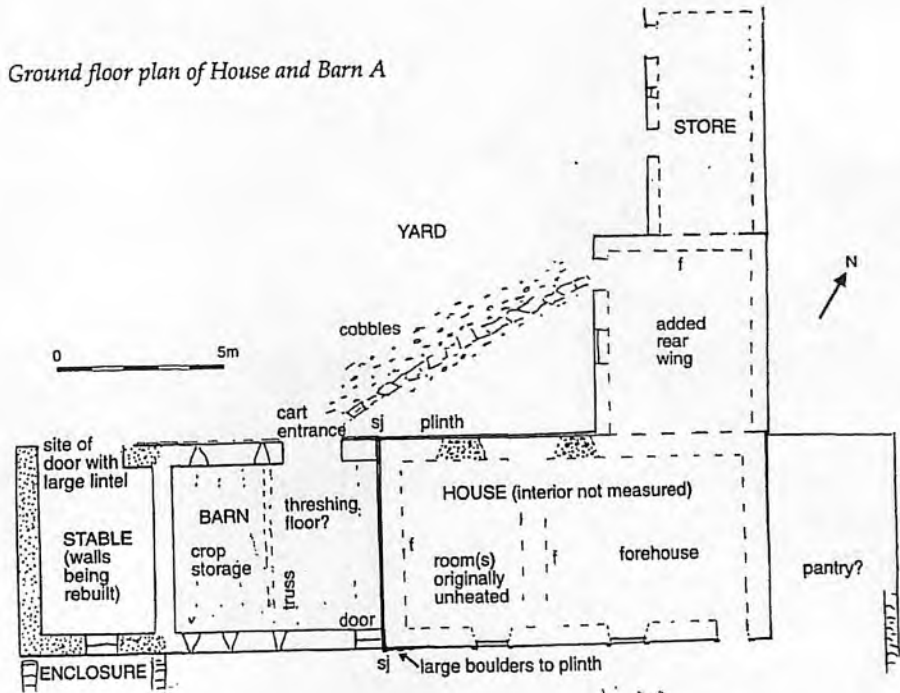
Ground floor plan of House and Barn A

The farmhouse (Report 1497) is a two-cell two-storey direct entry house with a central chimney stack. One cell may have been unheated and divided into a low end dairy and parlour, which became a heated parlour when the rear wing was added. The north elevation has blocked mullioned windows on both floors, indicating a fully two-storeyed house of 17th century date. The rear wing was added in the early 19th century when the south elevation was refronted with large rectangular windows with broad tooled surrounds.

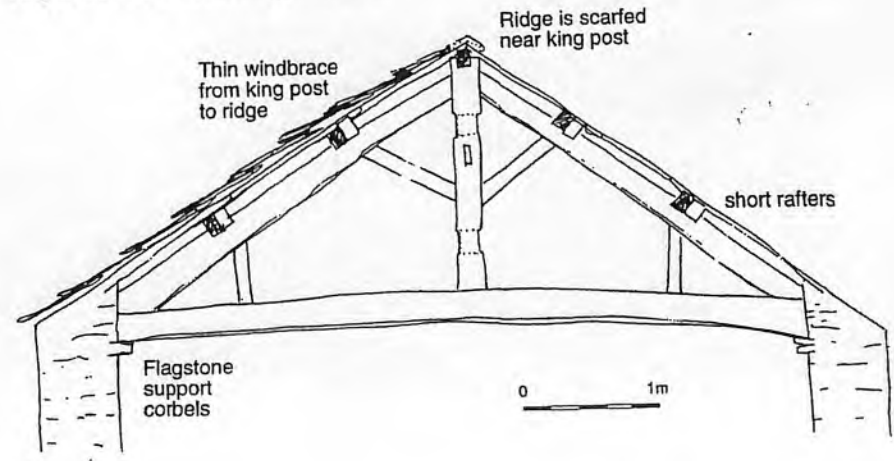
Roof truss in Barn A looking south-west

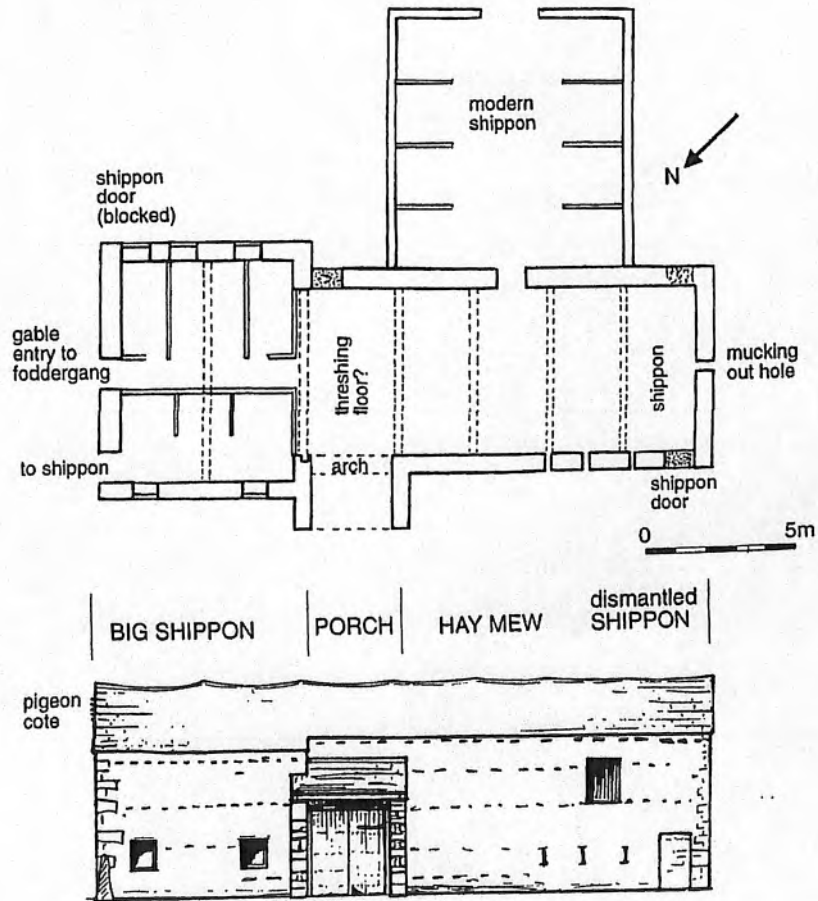
Figure 4: The imposing gable-entry barn at Low Birkwith (Barn B).

Evidence of a smaller shippon, now dismantled, is seen on the right, with the larger gable-entry shippon on the left. The arrangement of partitions and stalls in the big shippon has been altered. (Drawings by Alison Armstrong and Tony Tolhurst)

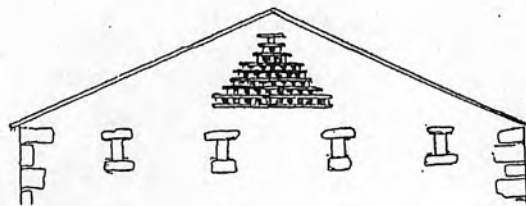
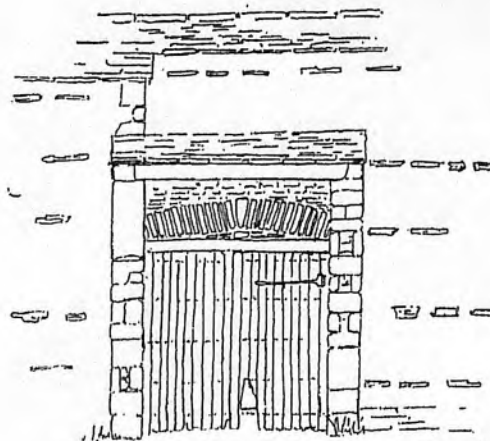
Sketch of columbarium,
north-east gable of Barn B

Sketch of doorway to Barn B

- in main low Birkwith farm roof
- ten ventilation holes
- walls: limestone rubble with
see 7 v 3555 aperture & gables (pick-dressed)
from rd 1995 state for full detail
Plapstone
- it has a very rare columbarium
in the E gable apex containing
47 entry holes

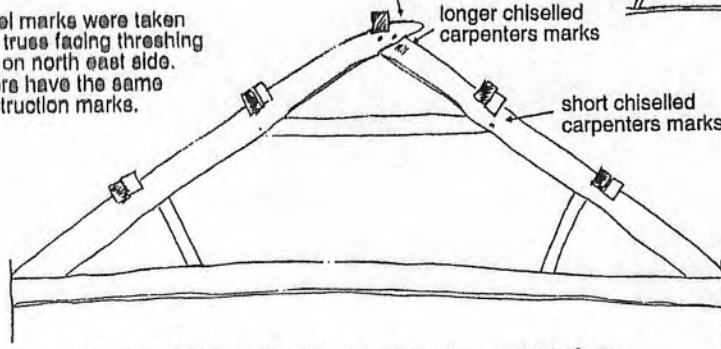
Chisel marks were taken
from truss facing threshing
floor on north east side.
Others have the same
construction marks.

Roof truss of Barn B - five out of the six are of this form.

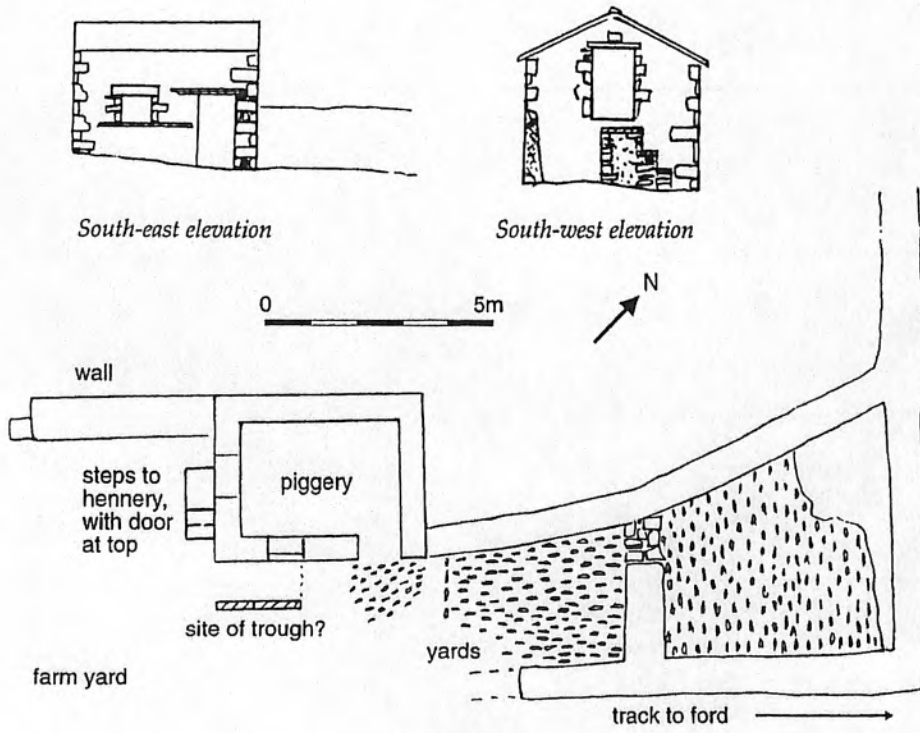
Low Birkwith - Hennery-Piggery E (Report 1499)

West of the farmhouse across the yard is the hennery-piggery (E) (Report 1499), a small square stone building housing hens above and pigs below. It is built of local rubble with a Ribblesdale flagstone roof. The sawn timber joists, roof timbers and floorboards, together with the quoin and lintel details, suggest a 19th century date. In plan form, the building is a typical example of its kind, similar to one recorded at Kettlewell.

- within Low Birkwith farm group
- Leuven piggery
- walls: limestone rubble
- roof: flagstone
- condition: fair but it is due to be renovated under a HLS grant
- surveyed with permission

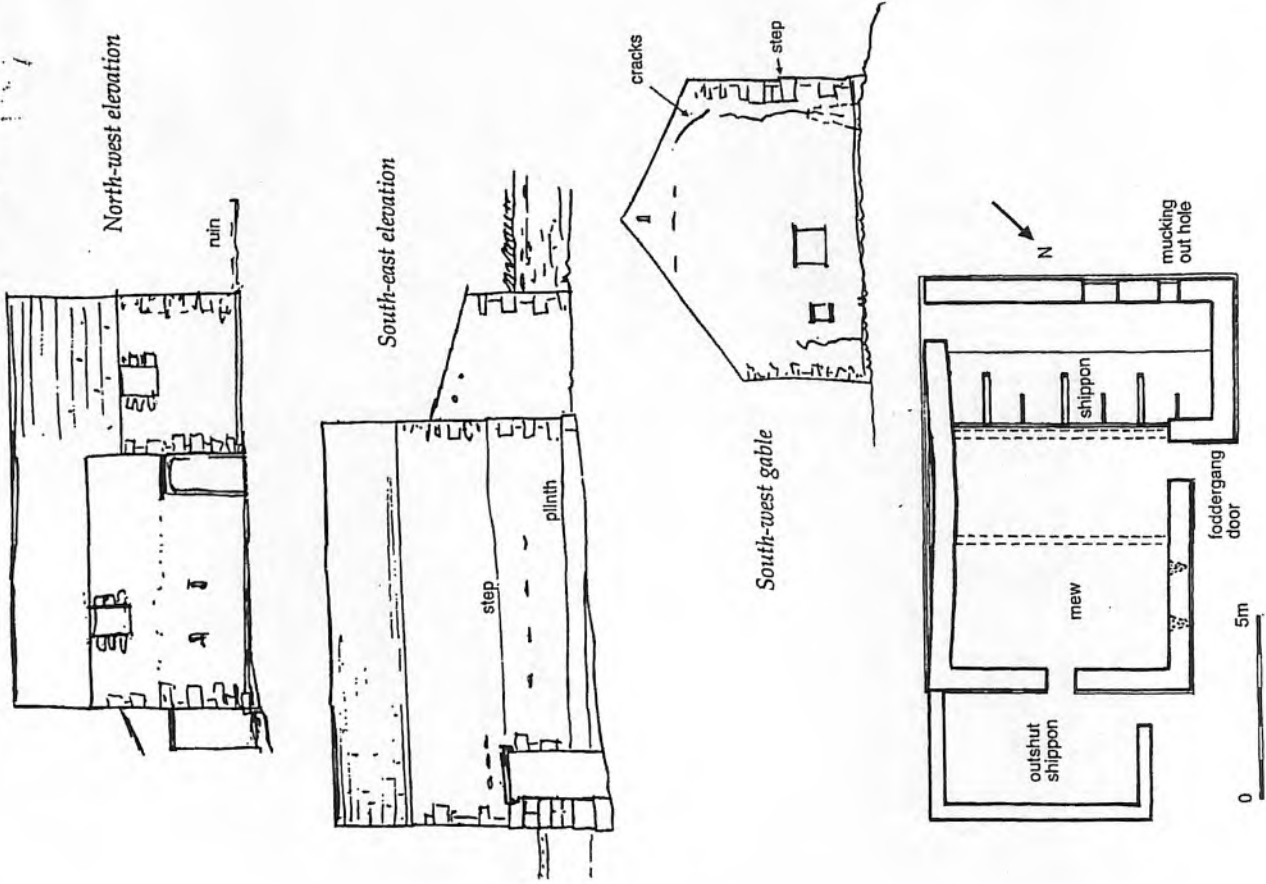
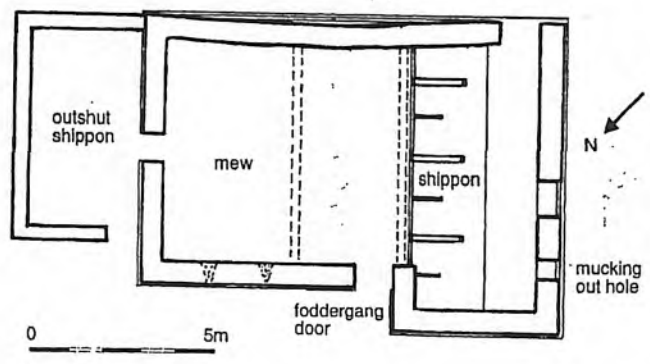
Figure 3: The L-shaped plan of Barn C at Low Birkwith

The barn comprises a shippon for 7 cows with hay storage and an outshut shippon or byre at the east end. On the south-east elevation there is a pronounced step in the wall at about 2.5m height with a change in walling pattern allied to gable end cracking at the same height, which suggests that the barn was originally lower, but with a steeper (possibly cruck built) thatched roof. The present roof, of sawn bolted king-post trusses with trenched purlins, is of mid-19th century date, while the plan form of a two-door field barn to a reversed L-shape is common in Ribblesdale.

The barn was apparently rebuilt in the mid to late 19th century to the local L-shape, re-using some earlier timbers and with boskins of softwood and Horton slate. The outshut shippon was added perhaps as late as 1900.

Boskins are of 'slate' framed in timber with a further single slab, shown on the plan, dividing each stall. The outshut shippon was probably added when the barn was found to have surplus hay storage capacity. (Drawing by Tony Tolhurst)

- on the edge of Low Birchwith farm
- walls: covered limestone + sandstone, mixed rubble
- roof: o/slat - slate
baru - flagstone
- slate bostling survive within the slippan
- use: nil
- condition: poor but it is due to be renovated under a HLS grant
- surveyed with permission

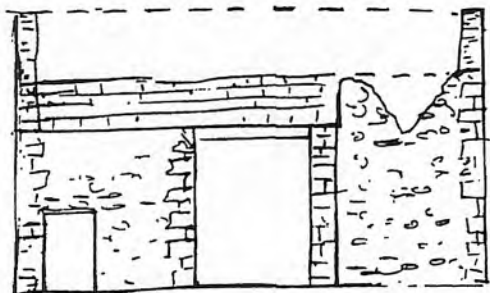
Sketch of south-east elevation

^{p. 10.} Finally, 360m west-south-west of the farmhouse lies the final building of this group to be recorded (D) (Report 1501). The barn is ruinous, and the roof has partly collapsed along with part of the north-west wall; this has allowed a close examination of the fallen roof timbers. The building is of coursed rubble with a stone slate roof and is built to the Ribblesdale L-plan, with a shippon at the toe end of the L, a hay mew at the other end and a porch in the angle. The roof had two principal rafter trusses, assembled from re-used cruck timbers, while at the shippon end the collapsed boskins were of Horton slate with softwood framing. One unusual feature was a probably re-used late medieval door or window head in the shippon window.

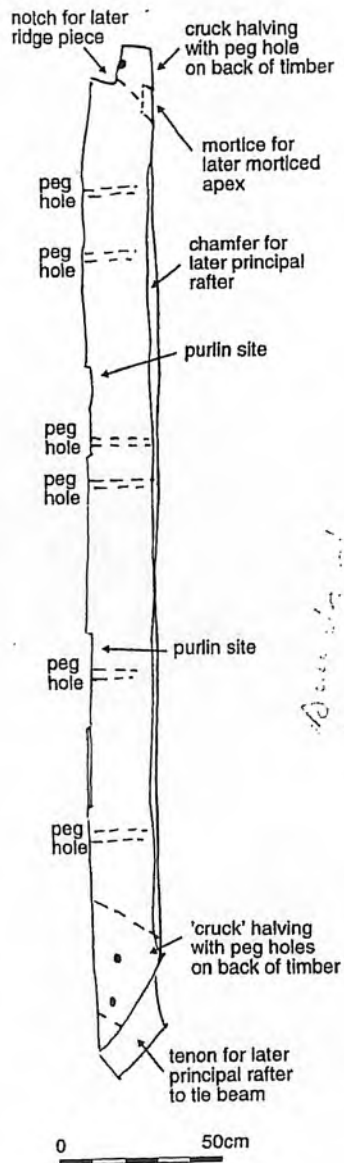
Reused timber with halvings found in Barn D. The timber has been recut and straightened.

Sketch reconstructions from timbers found in Barn D:
A: Reconstruction of cruck-like principal
B: Reconstruction of full cruck
Length between halvings is 2.56m

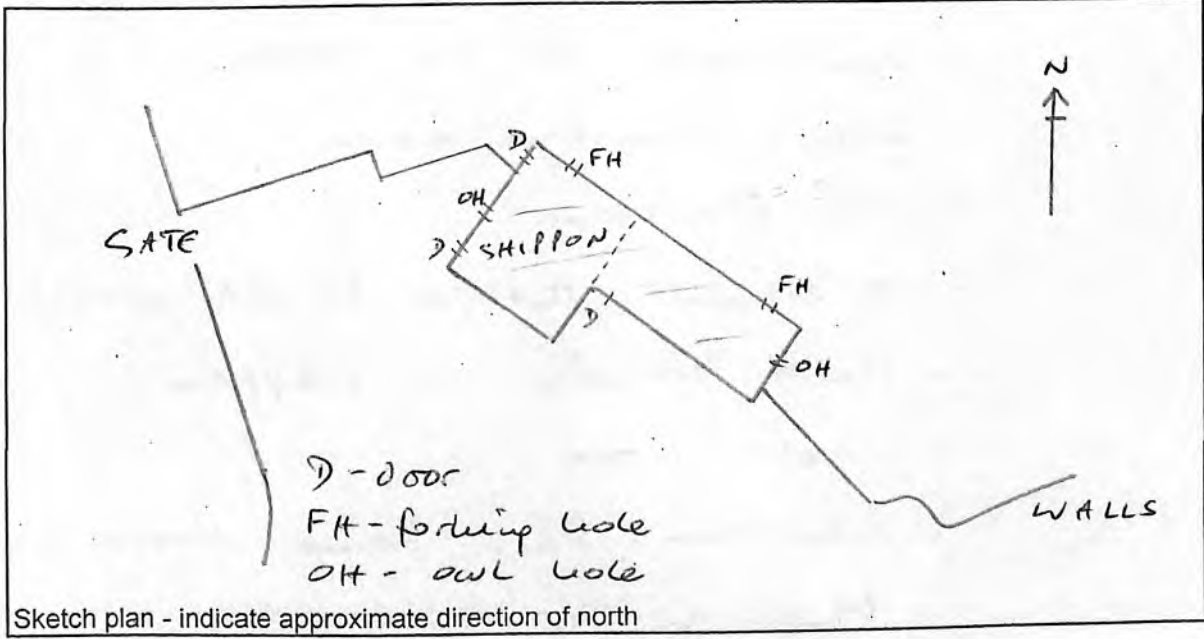
NGR (8 figs)	Building name (if known)
SD 7982 7684	STUBBING BALN

- isolated field edge position
- offset to SW elevation
- vent hole in NW gable
- walls: limestone rubble
- roof: flagstone
- prominent through to all walls
- slate boshing in skipper
- use: none
- condition: fair. Some loose roofing
flaps on SW side
- surveyed with permission

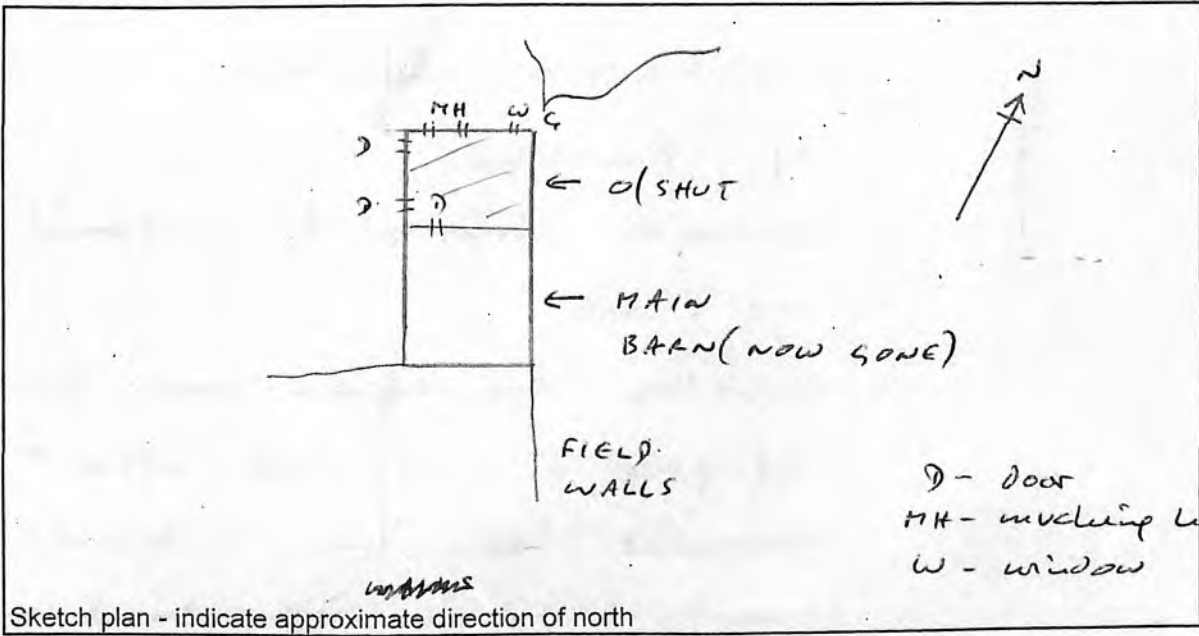
NGR (8 figs)	Building name (if known)
59 7963 7576 7959 7576	DALE HILE BARN

- isolated field edge position
- o/skut to W elevation
- walls: coursed limestone
- roof: flagstone
- concrete base in skipper
- use: nil
- condition: the main barn has collapsed & only the o/skut remains. The E wall stands to c. 2 m high, the S & W are mainly gone.
- surveyed with permission

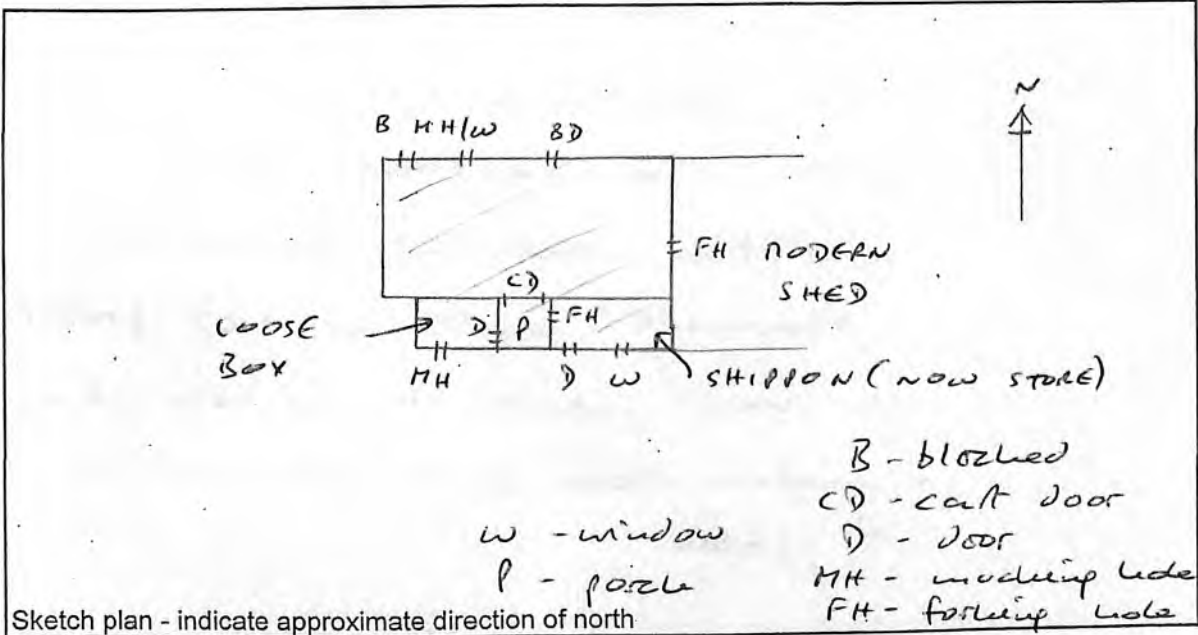
NGR (8 figs)	Building name (if known)
SD 8043 7555	SCALE FARM

- within farm group
- walls: random rubble
- roof: flagstone
- use: Lambing / stock shed
- condition: excellent. Recently renovated under a HLS grant
- 4 vent holes to N elevation
- modern stock shed attached to E gable
- Surveyed with permission

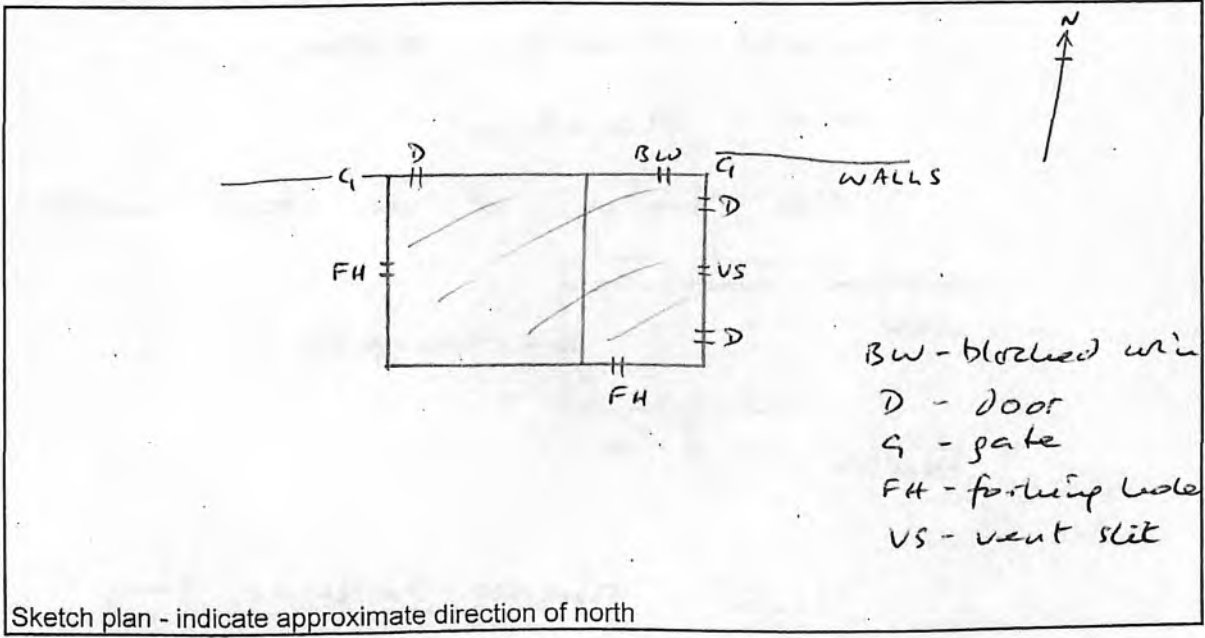
NGR (8 figs)	Building name (if known)
SD 8052 7482	LOW BARN

- isolated field edge position
- walls: random rubble
- roof: flagstone
- the barn is on two levels:

- slate + timber basking in the shippan
- use: informal sheep shelter in shippan. None in mewstead
- condition: sound, maybe the mewstead floor is rotten
- surveyed with permission

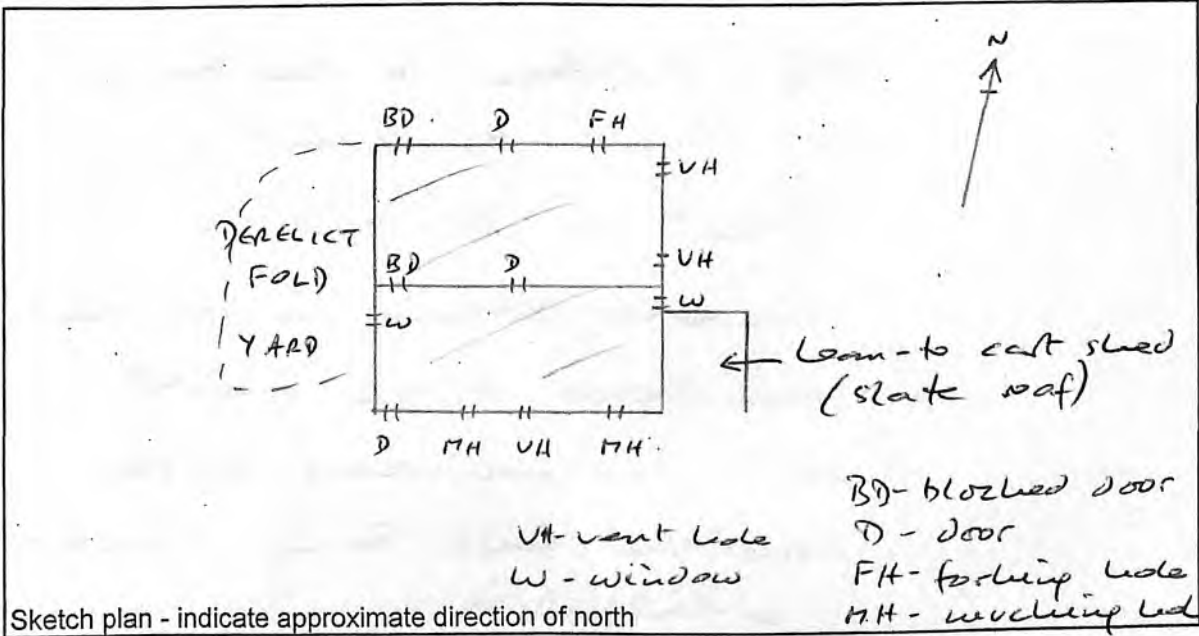
NGR (8 figs)	Building name (if known)
SD 8067515 58	FAR BARN

- isolated field edge position
- walls: limestone rubble
- roof: flagstone to the baru;
slate to o/slunt
- o/slunt is not tied in
- concrete base in o/s slipping
- semi-dressed quoins & lintel
- use: informal sheep shelter
- condition: fair. Some structural
weaknesses
- surveyed with permission

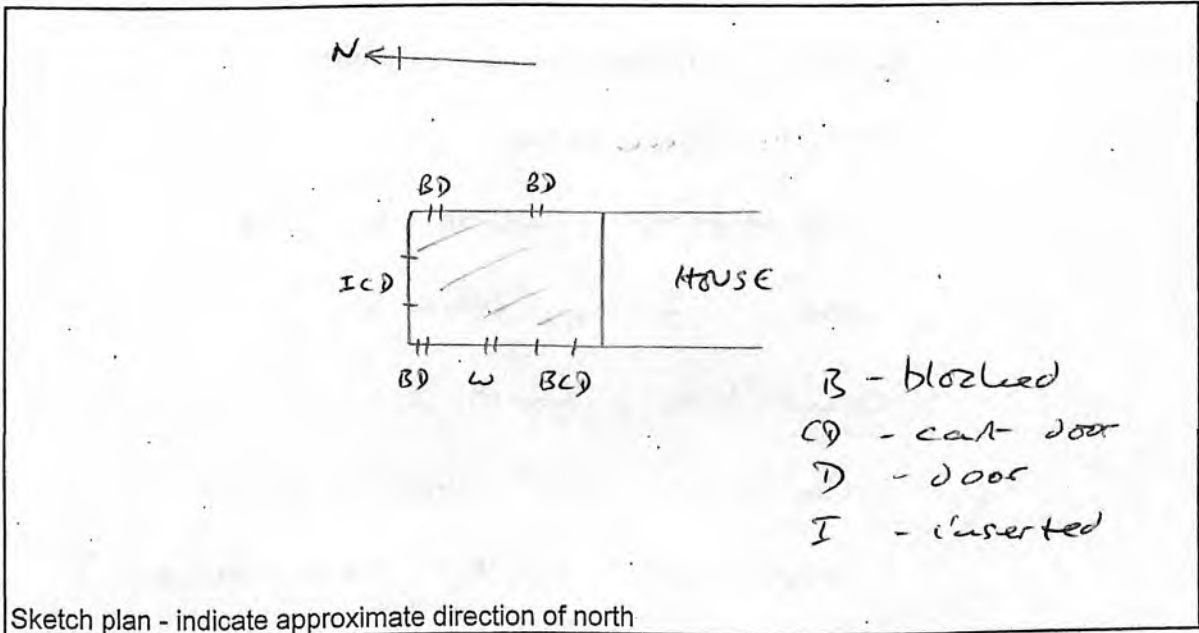
NGR (8 figs)	Building name (if known)
SD 8073 7479	TOP FARM (LAITHE)

- within farm group
- walls: limestone rubble
- roof: flagstone
- chamfered jambs to FH
- use: farm store
- condition: good
- interior not accessed
- surveyed with permission

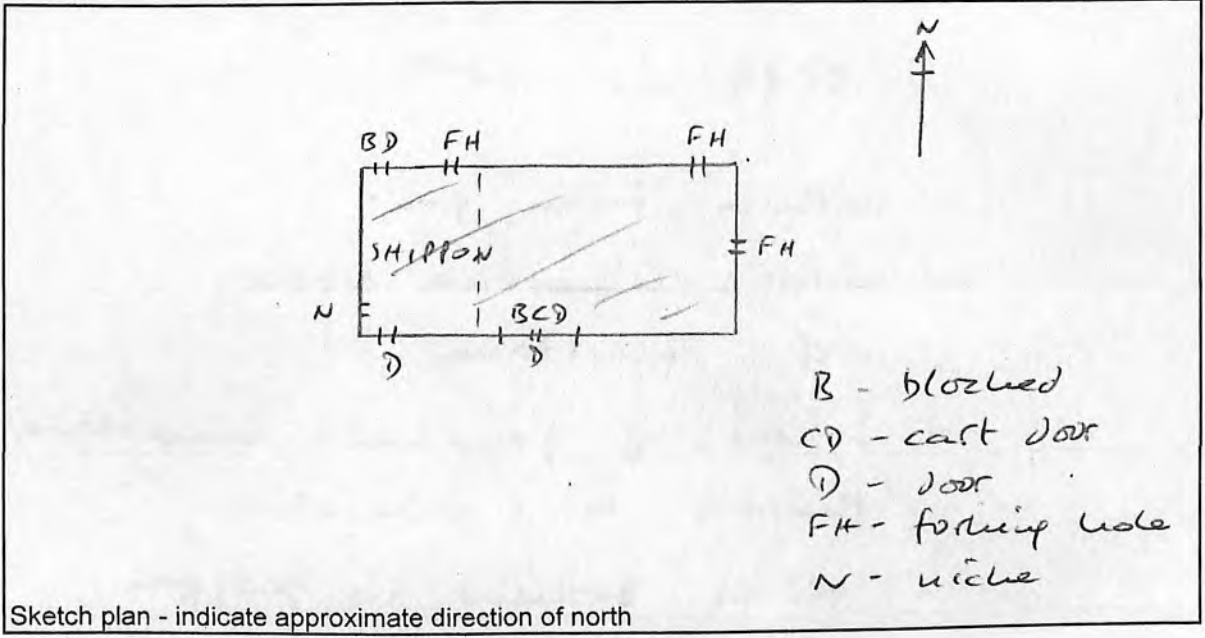
NGR (8 figs)	Building name (if known)
SD 8072 7478	TOLL FARM

- within farm group
- walls: limestone rubble
- roof: flagstone
- 3 rows of prominent limestone
throughout to S elevation
- slate boshier in skipper
- slate drip course over voussoirs
to blocked cat door to S elevation
- use: none
- condition: fair. Slight damage
to SW top corner
- surveyed with permission

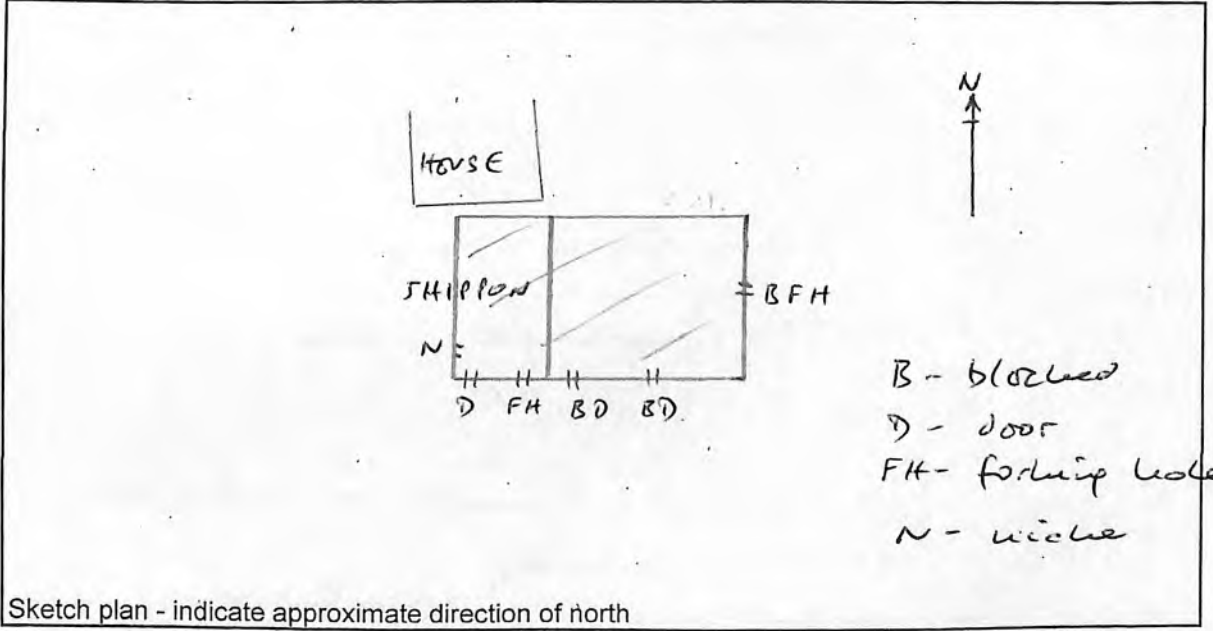
NGR (8 figs)	Building name (if known)
SD 8074 7479	TOP FARM

- within farm group
- walls: limestone rubble
- roof: slate
- prominent limestone through set randomly
- the main section of the barn is not accessible
- use: none obvious
- condition: walls fair; roof poor
- limestone voussoir over E blocked door
- surveyed with permission

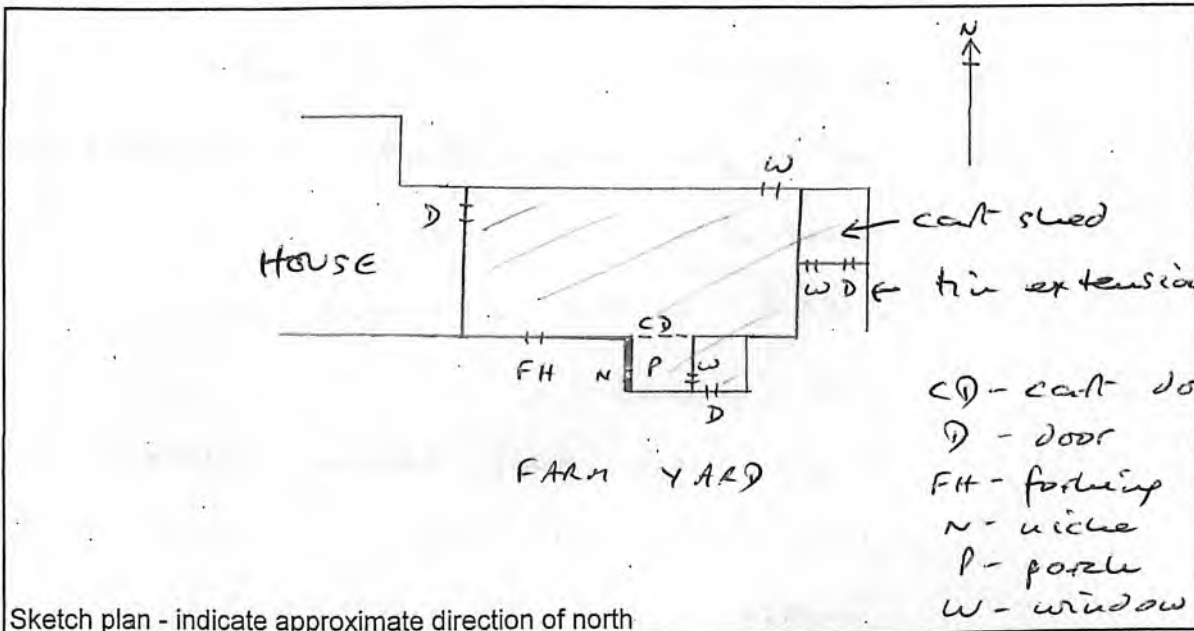
NGR (8 figs)	Building name (if known)
SD 8052 7732	OLD INS

- within old lap farm group
- former (17th c) Laithe house/barn
- walls: coursed limestone
- roof: flagstone; slate to cart shed
- rused timbers to cart door porch
lintel with voussoir above
- use: nil
- condition: poor. Some structural
failure at the W end of the
house
- the derelict house has 17th c
mullioned windows
- surveyed with permission
