YDNPA traditional farm buildings census record sheet

NGR (8 figs)	Building name (if known)
SD 7812 7788	ARRIVANS BARN LODGE HALL

Horton TFB survey 7 2-19

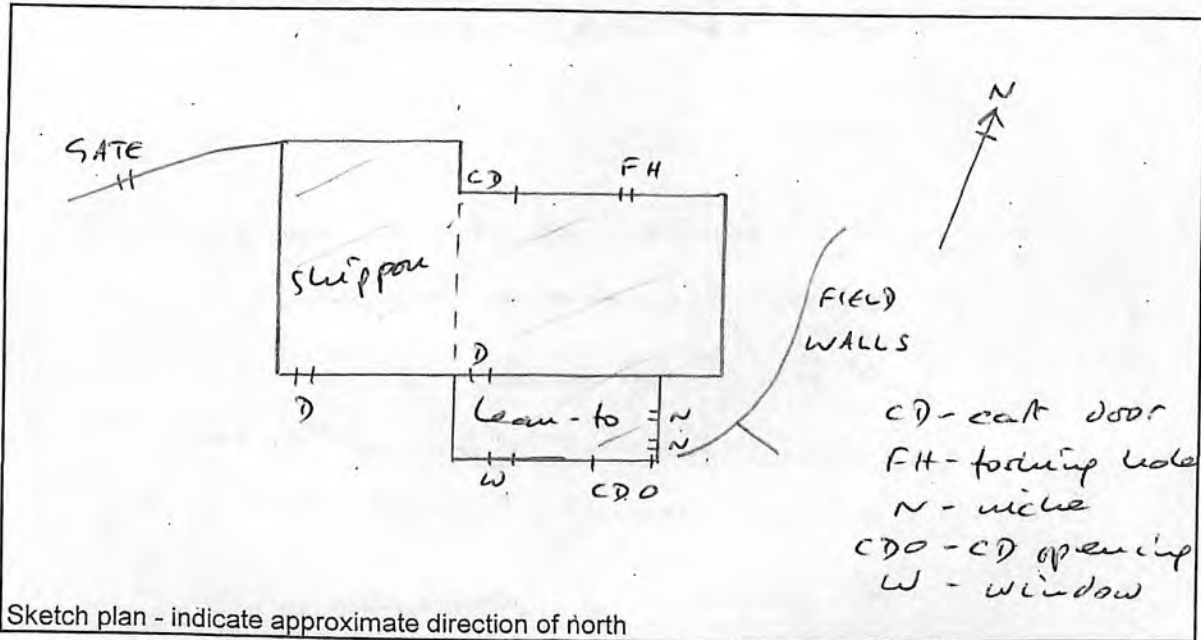
Building ID
HR 183 183

1 tie beam
4 queen posts

- isolated position in field
- elevated on southern side
- SPAB no. —
- on fringe of farm group
- walls: limestone rubble
- roof: flagstone
- lean-to cast shed attached to S elevation, but not tied in. Tin roof
- E gable is rendered
- vent holes: 3 rows of 3 in E gable, 9 in the N elevation, 2 in the S elevation
- use: cast shed & store
- condition: walls sound but the roof is sagging at the W end
- surveyed with permission
- slate boshing in chimney
- the NE corner is built on a substantial plinth

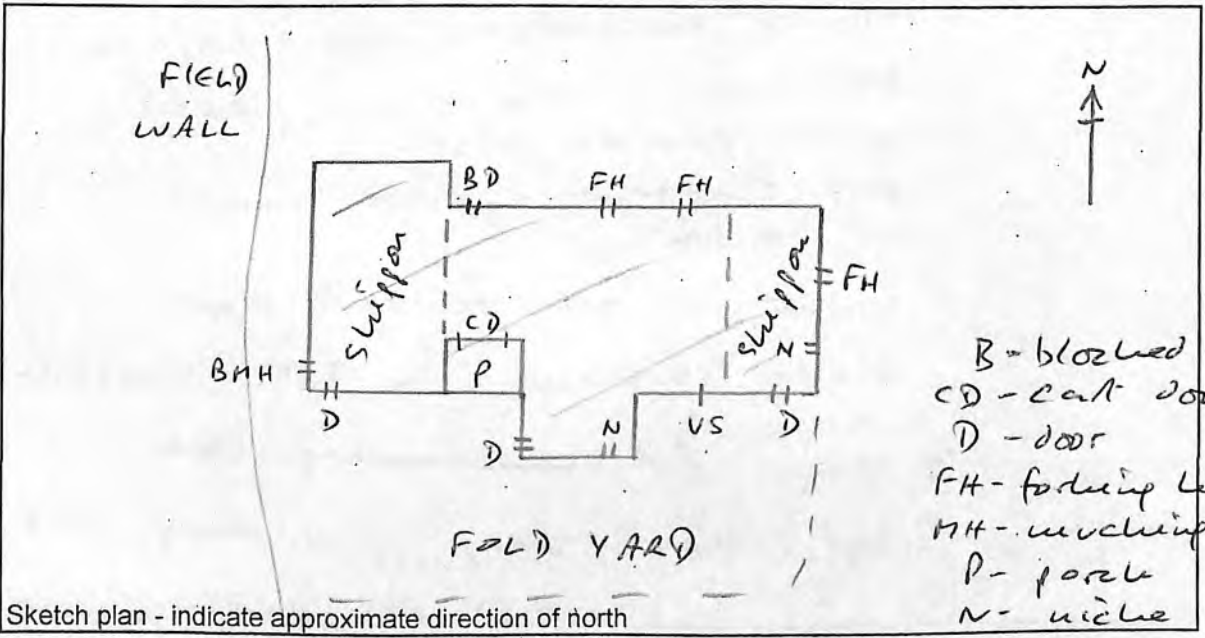
NGR (8 figs)	Building name (if known)
SD 8159 7117	STANABER BARN

- isolated ~~random~~ field edge position
- fold yard to south of barn, descent
- walls: random rubble
- roof: flagstone + slate, mixed
- east entrance
- timber lintel to east door
- slate basking in both slippans
- use: old machinery store
- condition: very poor. Half the roof has gone + upper masonry between the 2 FHS on the N elevation
- surveyed with permission

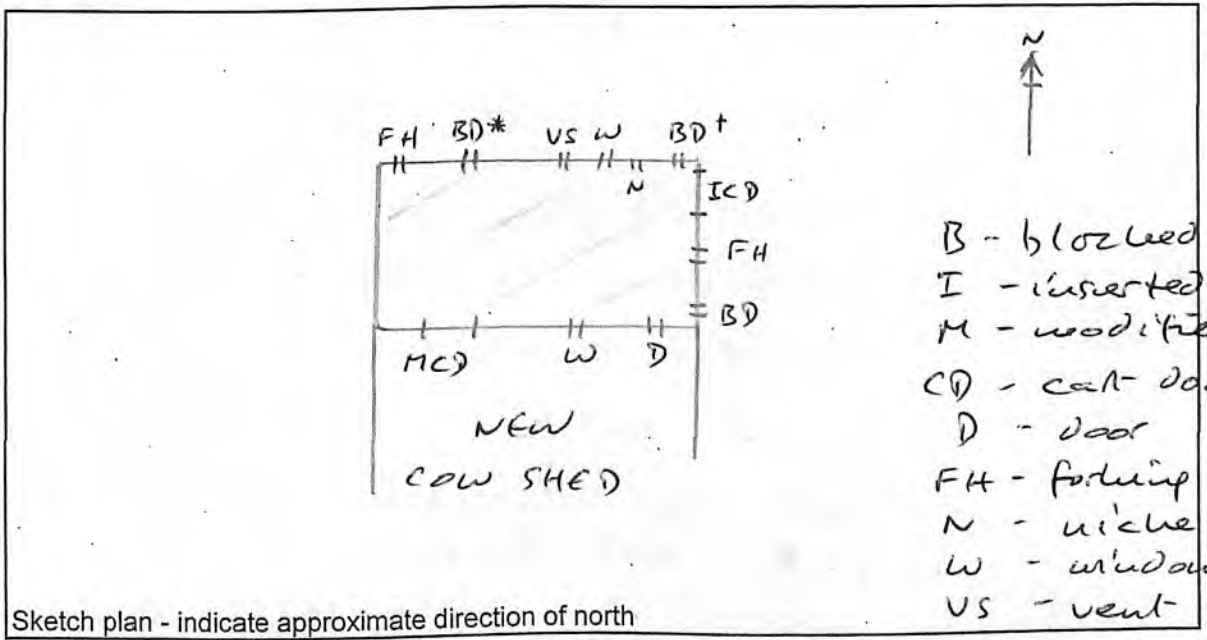
NGR (8 figs)	Building name (if known)
SD 8201 7110	NEWLAND BARN

- The cast door on the S elevation has been modified leaving the voussoir arch of the original in situ

- within farm group, just south of Newland House
- walls: random rubble with prominent throughstones
- modern concrete cow shed built on to S elevation
- cast door inserted into E gable, with RSJ lintel
- roof: corrugated asbestos sheeting
- 3 vent holes on S elevation
- semi-dressed sandstone quoins
- blocked door (BD⁺) does not show on the exterior wall
- blocked door (BD*) has a dressed and chamfered lintel + slate rain hood
- ~~condition~~^{use}: cow byre + hay store
- condition: excellent
- surveyed with permission
- forking hole on the E gable has a chamfered lintel recycled from another building!

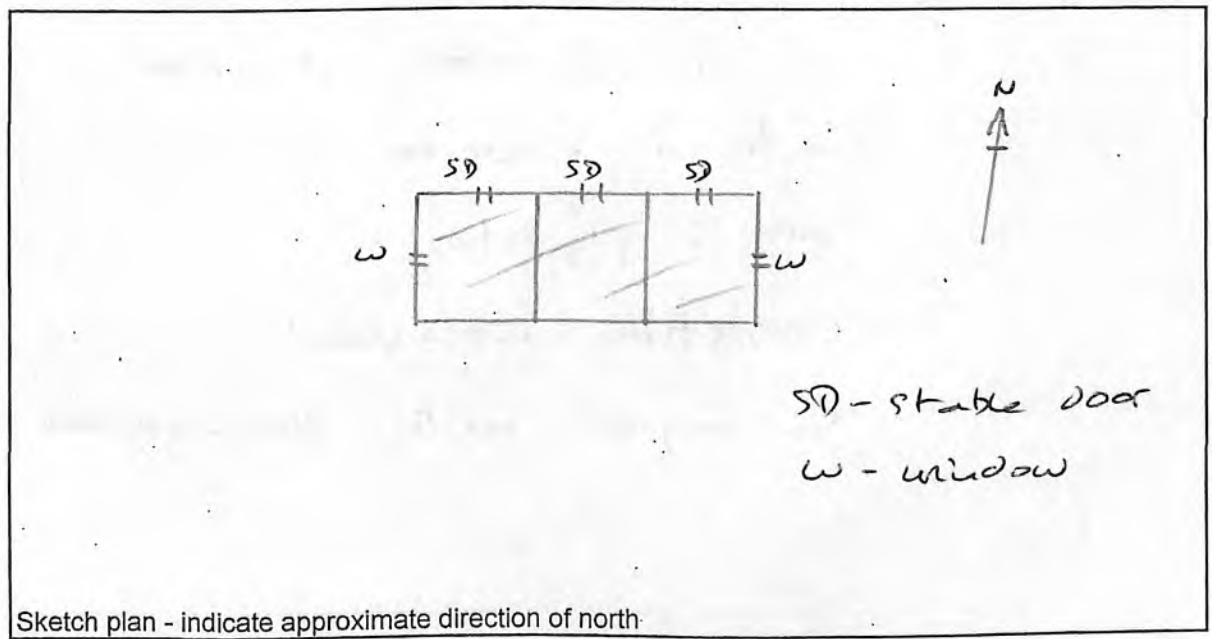
NGR (8 figs)	Building name (if known)
SD 82048 71193	NEWLAND HOUSE

- walls: random rubble

- roof: flagstone

- a stable block divided into 3 discrete cells

- use: pig sty

- condition: excellent

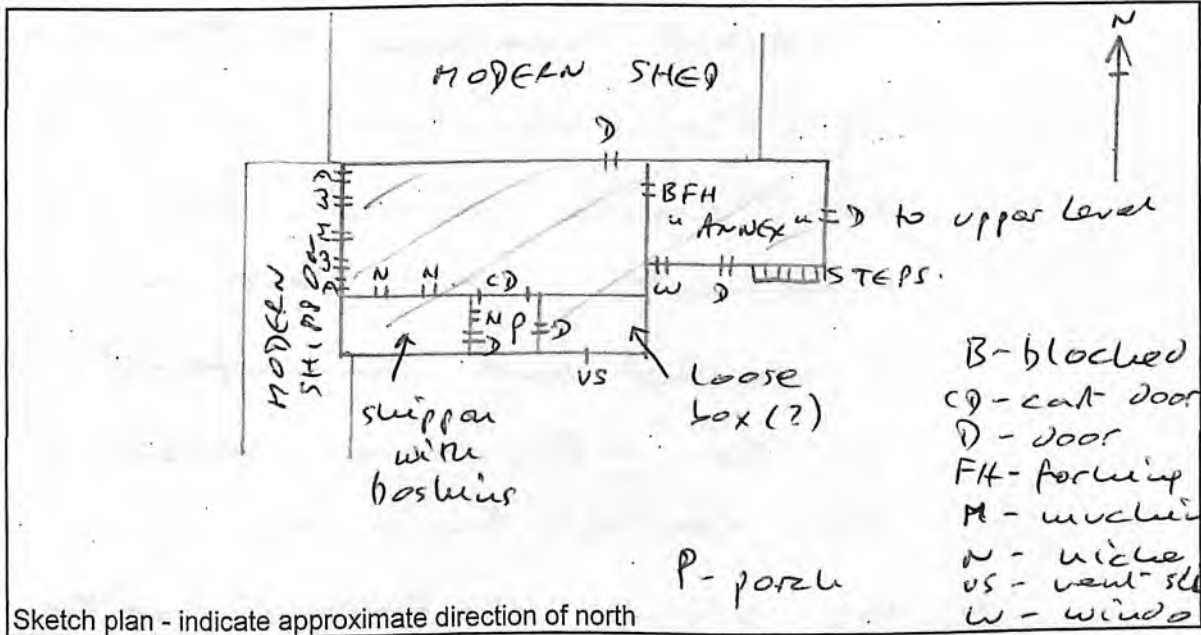
NGR (8 figs)	Building name (if known)
SD 82073 71217	NEWLAND HOUSE

- owl hole in w gable apex

- within farm group
- walls: mainly limestone rubble, with coursed limestone to the "annex"
- roof: flagstone; "annex" - flaps + slates
- the "annex" is not tied in and represents a later add-on. It has 2 dressed and chamfered quoins on the NE corner recycled from an earlier building
- the o/slot is tied in, with a catslide roof
- against the S elevation of the "annex" is a flight of stone steps, not leading to an upper door
- re-used timber lintel behind sandstone voussoirs to the cat door
- use: garaging for a historic tractor collection
- condition: good (apart from the cracked CD lintel - due for repair)
- surveyed with permission
- above the niche in the porch is a doorway.

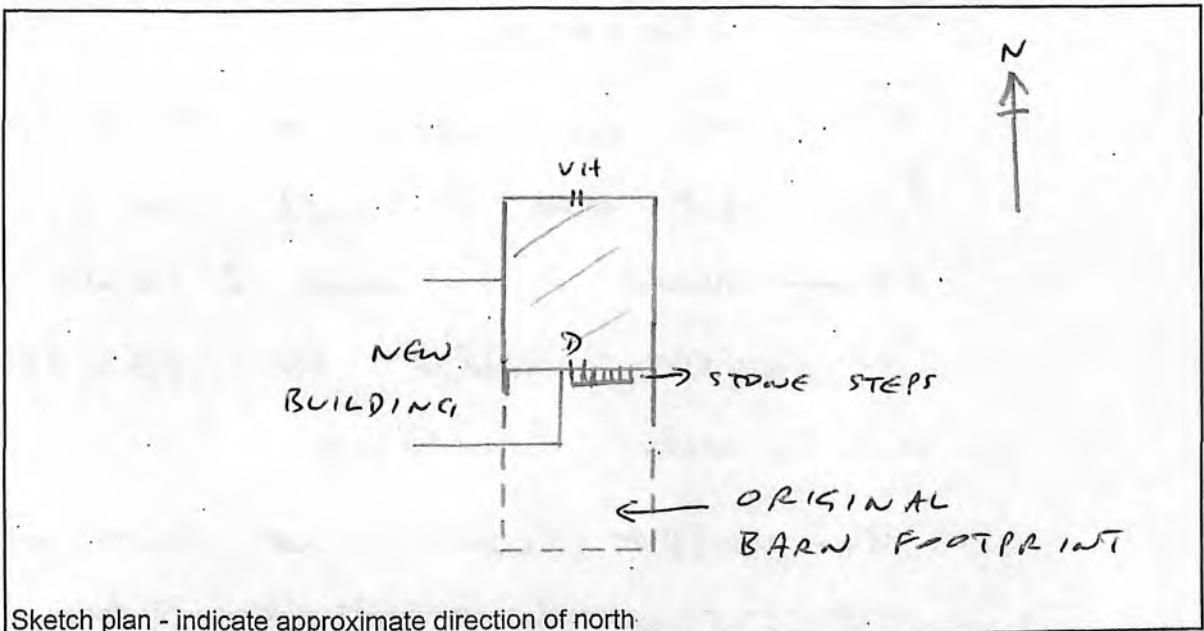
NGR (8 figs)	Building name (if known)
SD 82046 71223	NEWLAND HOUSE

- walls: limestone rubble
- ^{roof}: flagstone
- it was originally c. twice as long but the S half was demolished & a new S gable (v. poorly) built to create a smaller building.
- the upper level door has a voussair arch, not in situ.
- use: general store
- condition: fair
- surveyed with permission

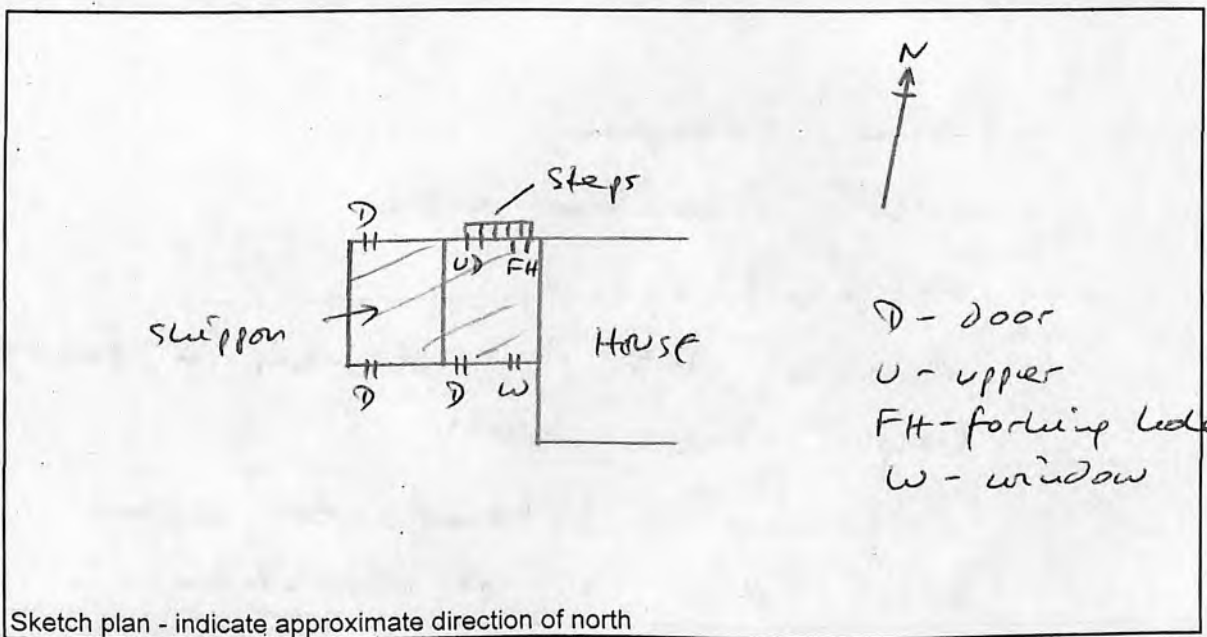
NGR (8 figs)	Building name (if known)
SD 81469 71446	DAY BECK FARM

- farm complex
- walls: limestone rubble
- roof: flagstone
- divided into 2 cells by a full-height stone wall
- outside ^{stone} steps lead to upper level door on N elevation
- use: coal & general store; former shippon
- condition: good
- surveyed with permission

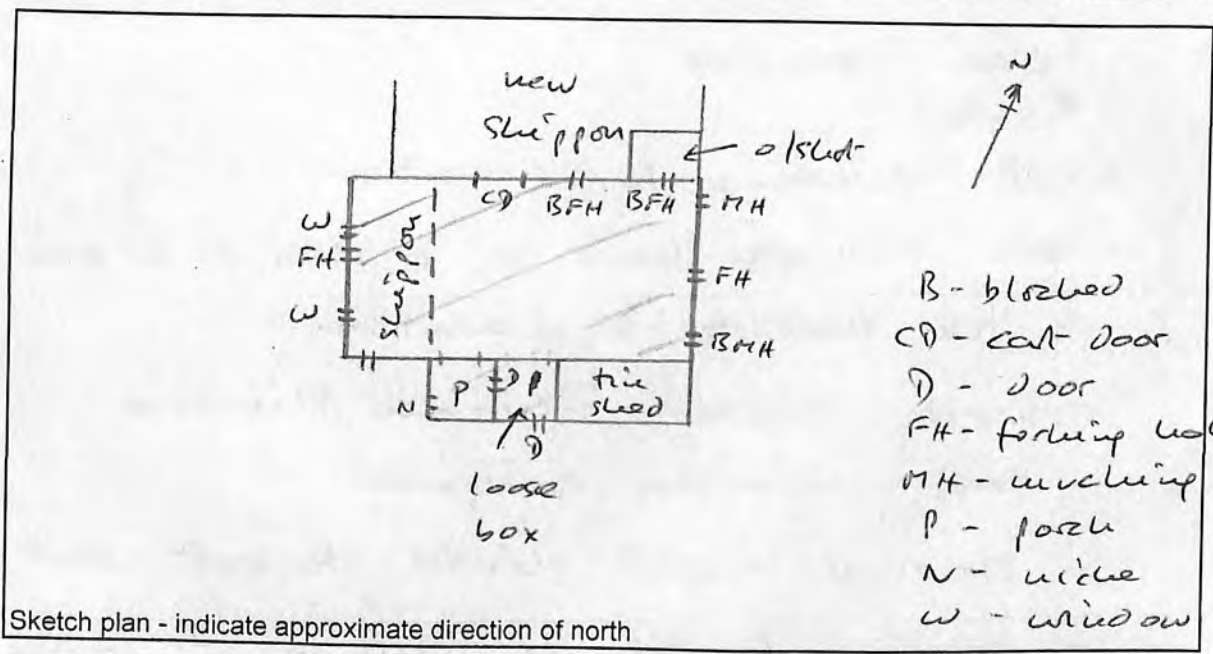
NGR (8 figs)	Building name (if known)
SD 8148 7182 4	DRY BECK FARM

- farm complex
- 5 bays
- east entrance to S elevation
- new skipper built on c. 1974 to N elevation,
+ his shed to SE elevation
- walls: coursed Silurian flagstone
- roof: asbestos, corrugated
- reused timber lintel to east door
- timber lintel to BMH on E gable
- upper doorway in W wall of porch
- use: lambing shed
- condition: sound
- surveyed with permission
- the oldest it held in

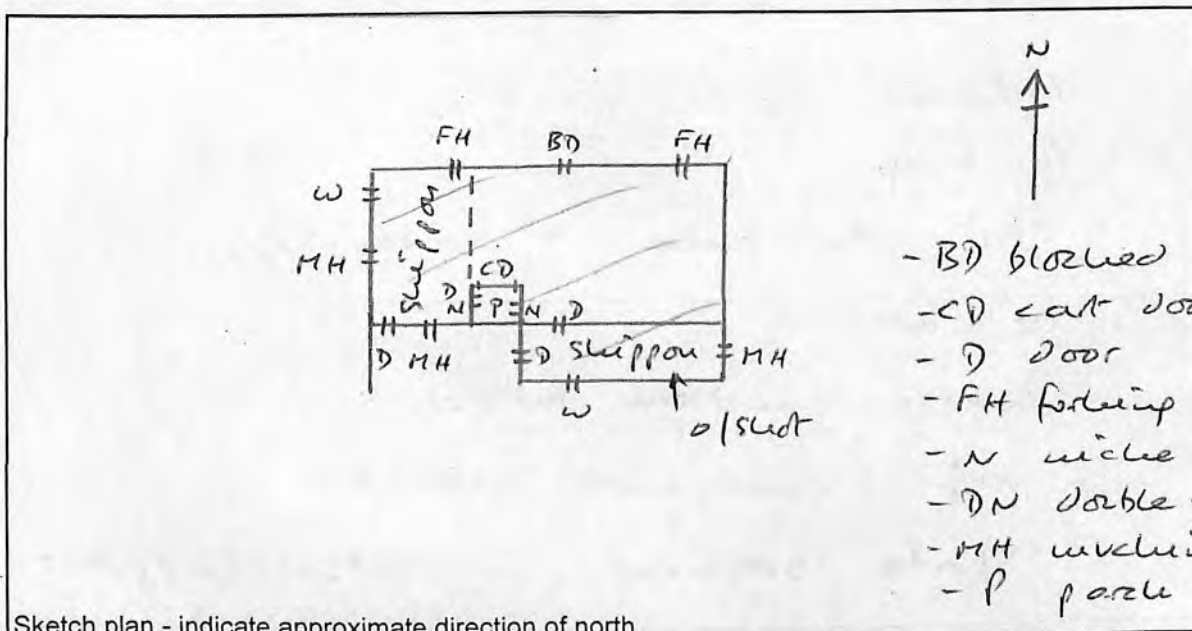
NGR (8 figs) **Building name (if known)**
 SD8129 7132 **MORLEY BARN**

- isolated field position
- 4 bays
- cart entrance to south side
- tie beams
- walls: random rubble
- roof: corrugated asbestos
- slate boshing in both gables
- the o/slot is not tied in
- 5 rows of slate through on the E & W gables, 4 on the N elevation
- use: none apparent. A 'dead' car is parked within
- condition: sound
- surveyed with permission

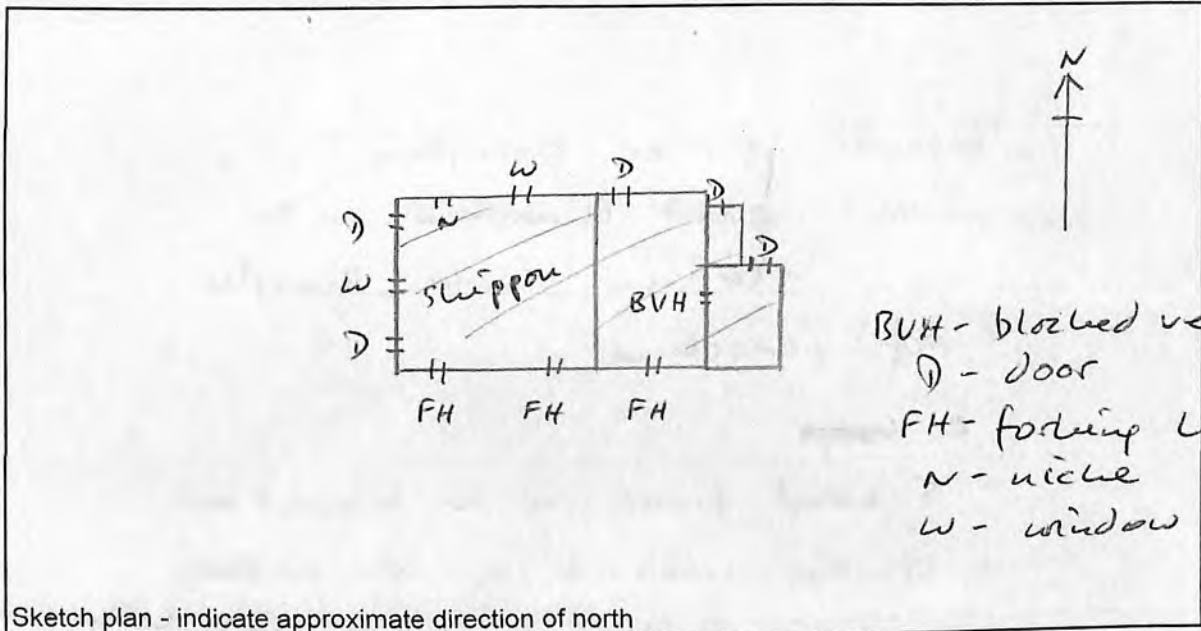
NGR (8 figs)	Building name (if known)
SD82008 71452	DUB COTE

- former farm complex
- walls: coursed limestone with
Silurian slate quoils
- roof: flagstone
- 3 ~~4~~
- 5 vent holes in N elevation
- stable lean-to on E gable
with attached lean-to shed, both
with flagstone roofs.
- peck-dressed sandstone quoils to
SW & NW corners.
- undressed sandstone lintel to N door
- well-preserved timber boshing in skipper
- half-height stone wall separator
the skipper from the rest of the barn.
- use: none
- condition: walls good, some holes in
the roof :- fair overall
- surveyed with permission

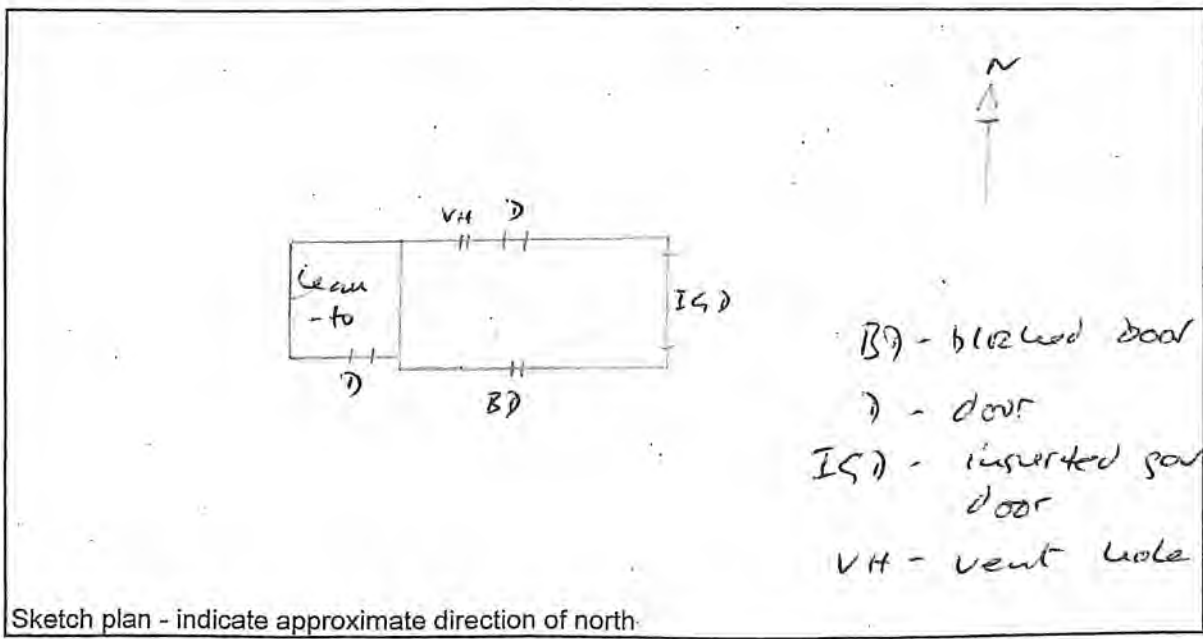
NGR (8 figs)	Building name (if known)
SD 80553 73647	AT SOUTH VIEW, NEW HOUSES

- SPAB no. —
- in former farm group
- Walls: random rubble
- roof: flagstone
- originally a pigpen, converted to a garage, & now used as a store & for milking goats
- Lean-to is not held in
- condition: excellent
- surveyed with permission

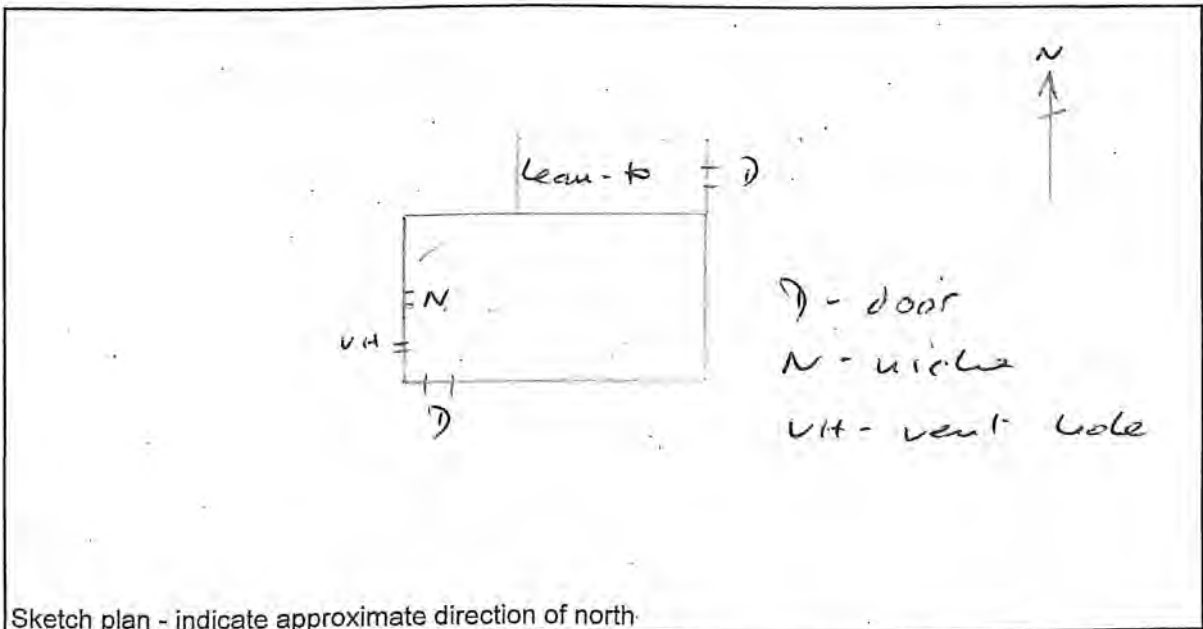
NEW HOUSES

- in former farm shop
- mixed limestone & sandstone coursing to walls
- flagstone roof
- prominent trough to gable + S elevation
- lean-to is not tied in
- use: coal store
- condition: fair. The N half of the roof is sagging badly
- surveyed with permission
- re-used timber in the truss

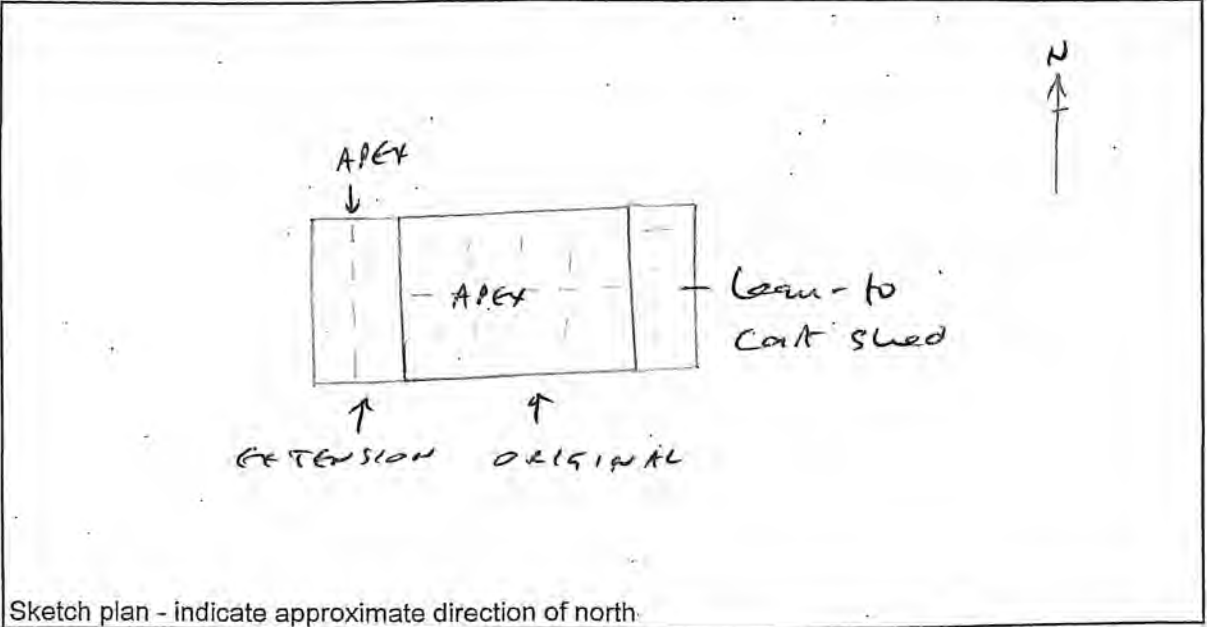
NGR (8 figs)	Building name (if known)
SD 79954 72615	BEECROFT HALL

- farm house (disused) within farm group
- the bulk of it is an 18th/19th century rebuild with added west wing, on a 17th century earlier form with mullioned windows, narrower than this house
- The E gable is built on a substantial plinth, now within a semi-dilapidated cart shed
- use: nil
- condition: the roof is stable but it has been empty for decades and is looking in a sorry state
- surveyed with permission

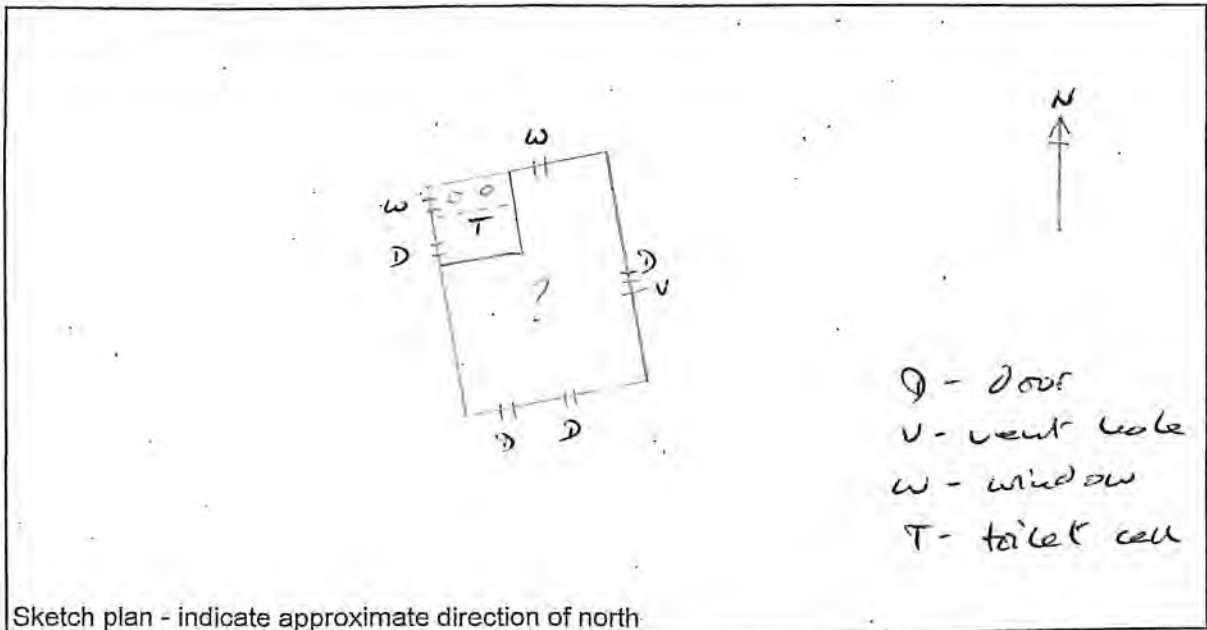
NGR (8 figs)	Building name (if known)
SD 79948 72626	BEECROFT HALL

- SPAB no. —
- within farm group
- walls: limestone rubble except on E elevation (random rubble)
- roof: slate
- it is composed of several cells (poss. 4) but only 1 could be accessed. This was a two-seater long-dop toilet, with wooden seat intact
- use: nil
- condition: the roof is failing ∴ poor
- surveyed with permission

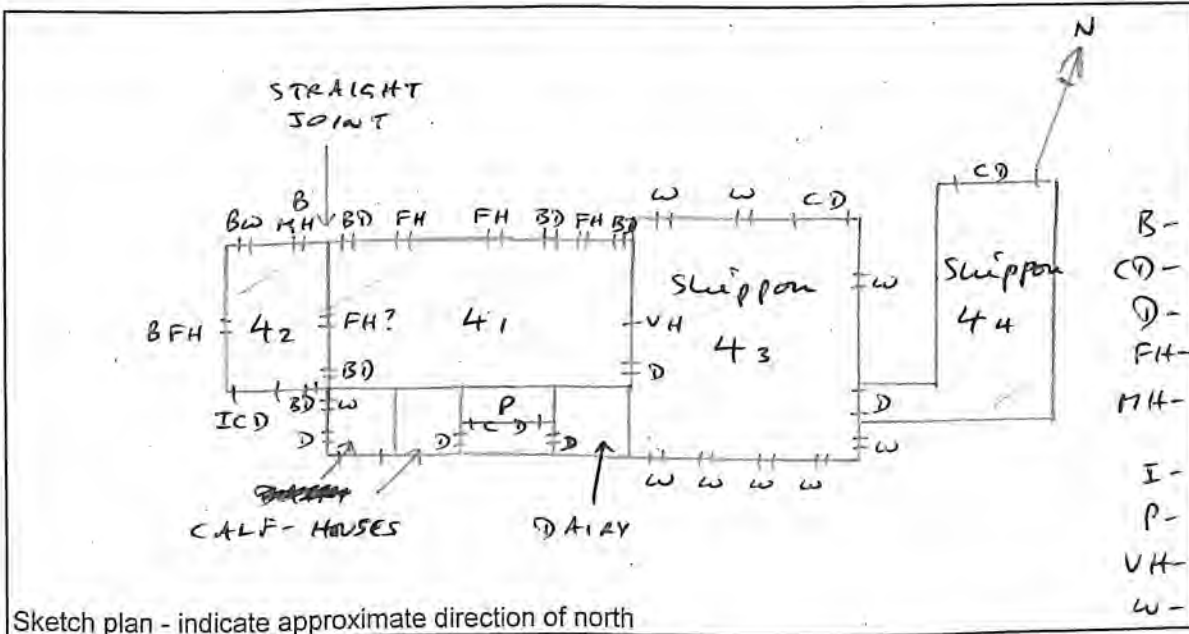
NGR (8 figs)	Building name (if known)
SD 799877263	BEECROFT HALL

- When the barn was extended, it was re-roofed as one unit
- use: machinery store (B₁), cattle sheds (B₃ & B₄)
- Condition: sand
- Surveyed with permission

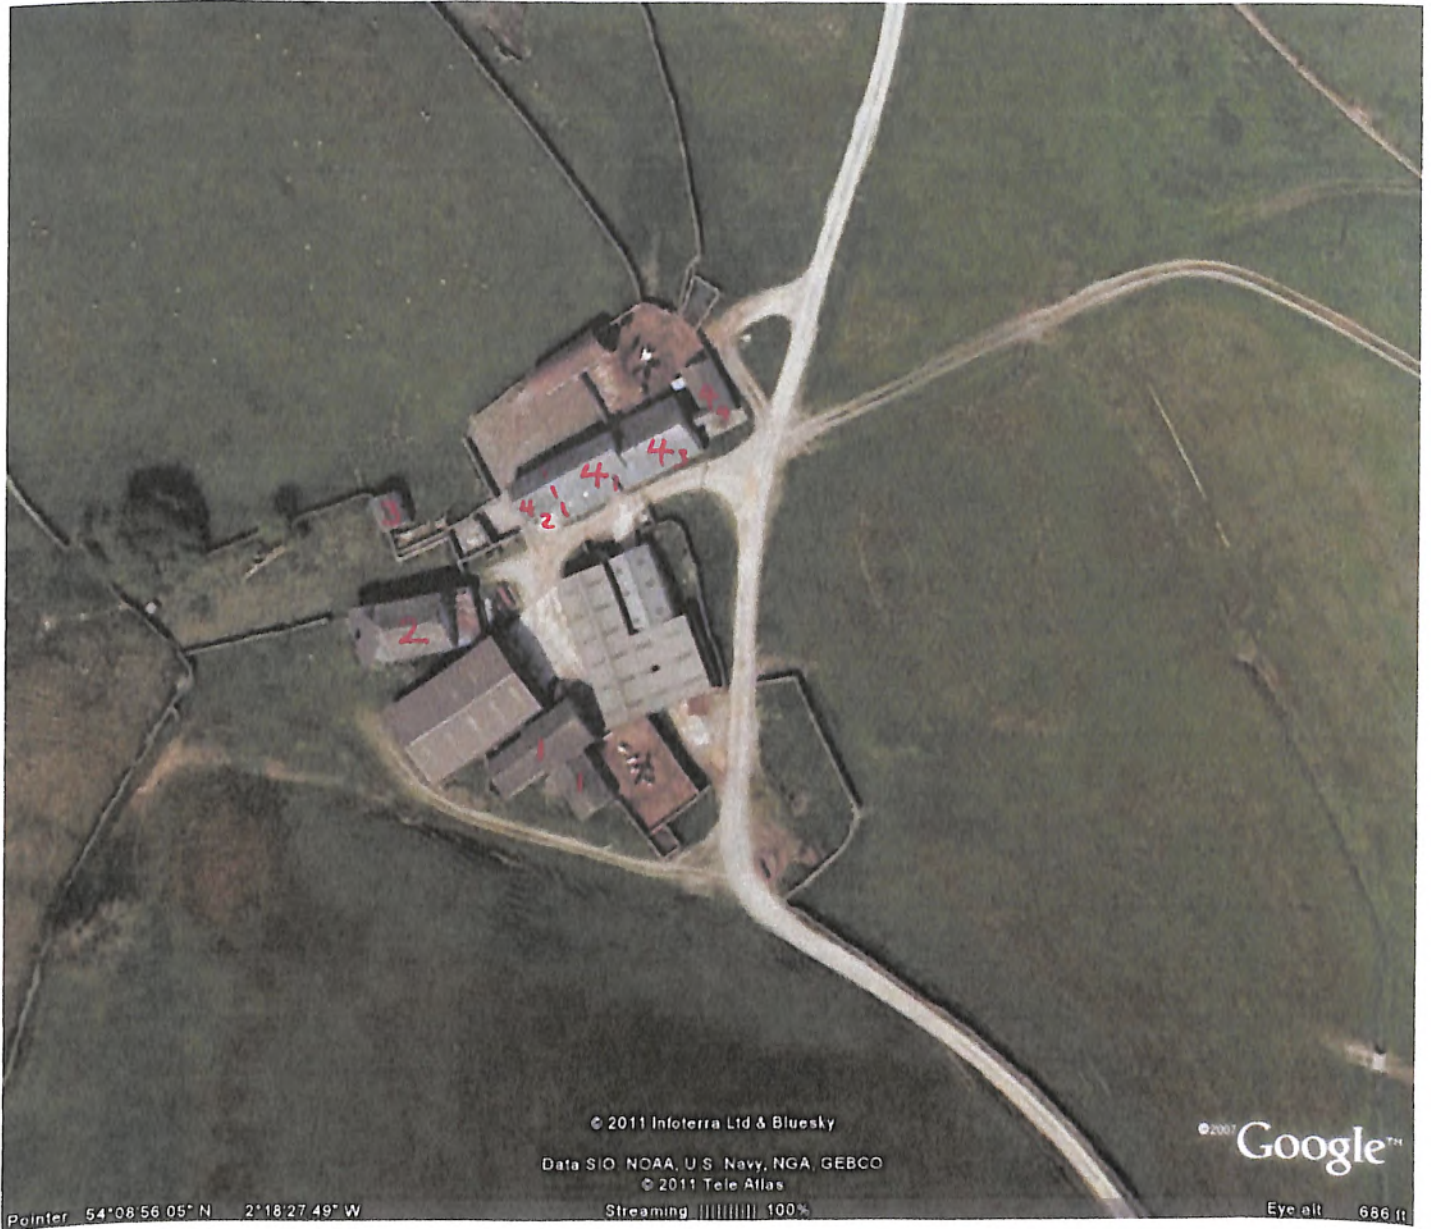
017/417 BEECROFT HALL

1 - TFB HR 200

2 - 2001

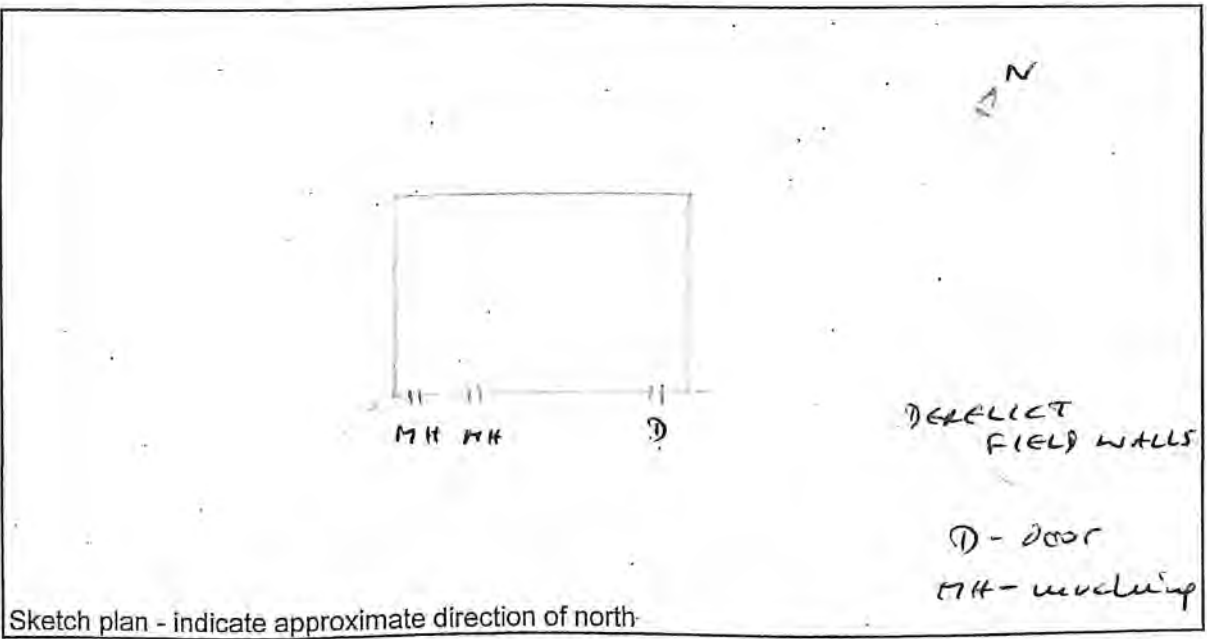
NGR (8 figs)	Building name (if known)
SD 8018 7177	(MOUSATON PLANTATION)

- SPA 3 no. —
- Isolated field edge position
- walls: limestone rubble
- roof: flagstone
- 6 rows of masonry in the east gable, 4 on south elevation
- not accessed. W gable & N elevation not seen
- condition: sound. slight damage to roof
- use: ?
- 'surveyed' with binoculars

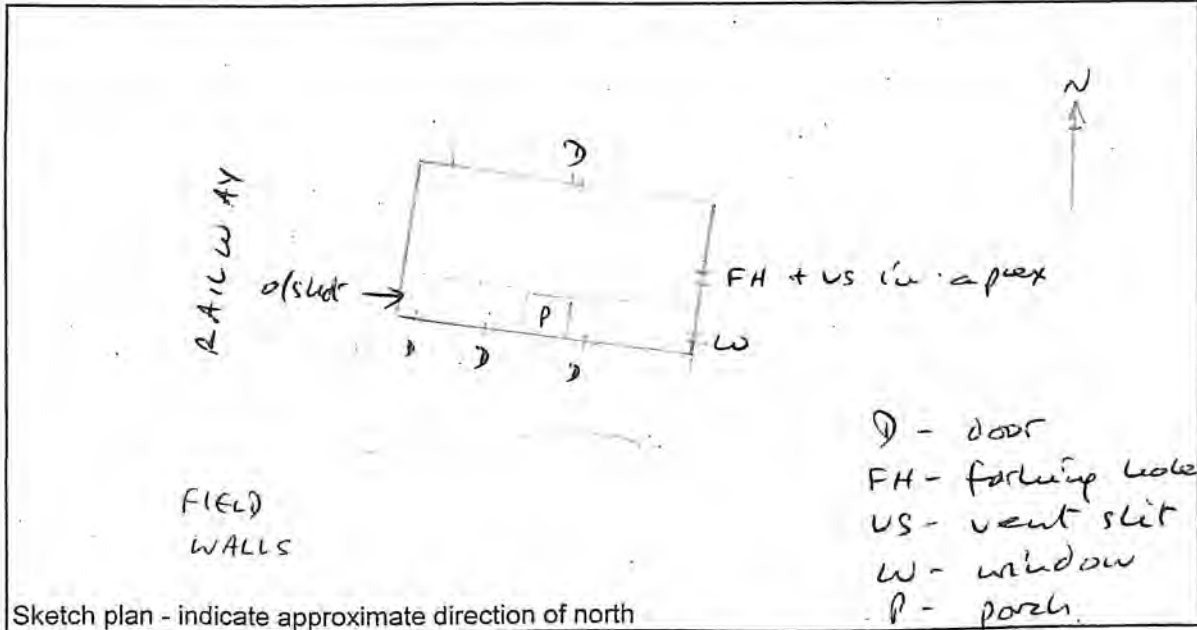
NGR (8 figs)	Building name (if known)
SD 8046 7155	SARTH HOUSE BARN

- isolated field edge position
- walls: random rubble
- roof: slate. Porch has a tile roof
- not accessed - W gable +
S elevation not visible from road
- condition: sound, though the S roof
is "wavy"
- use: ?
- 'surveyed' from road

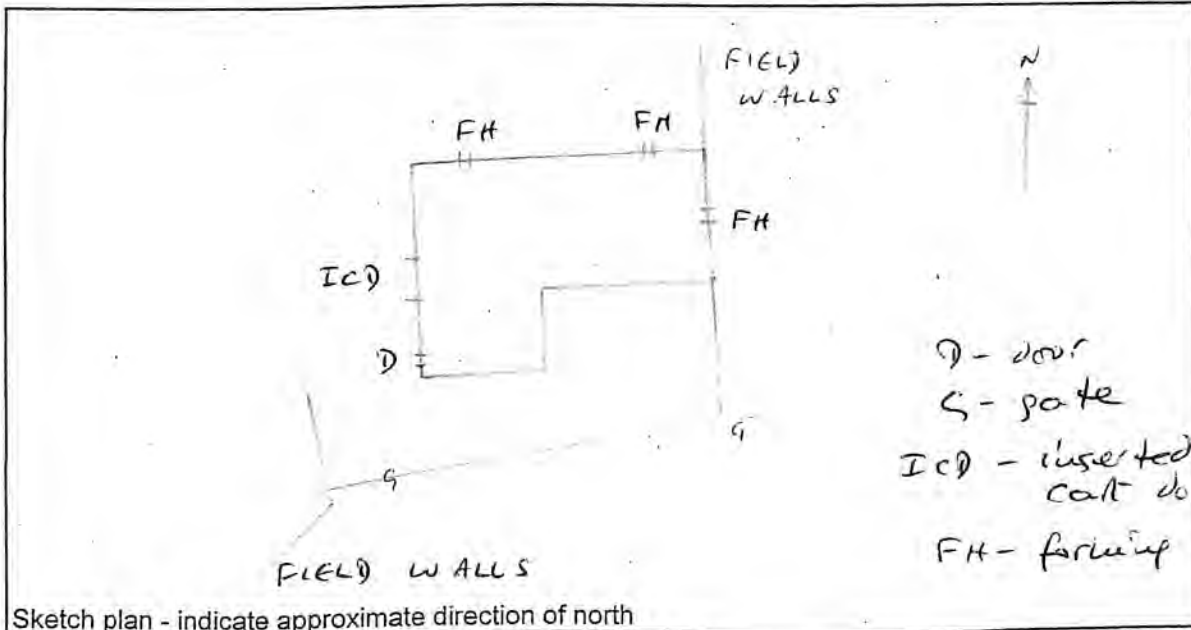
NGR (8 figs)	Building name (if known)
SD8097 7158	CROOKS BARN

- field edge position
- walls: limestone rubble
- roof: flagstone to barn,
asbestos to o/sud
- condition: sound
- use: none apparent
- 'surveyed' from PROW
