# YDNPA traditional farm buildings census record sheet

Building ID
HR
208

NGR (8 figs)	Building name (if known)
SD 8095 7217	HOLME FARM BARN

Parish	Site visit date	Recorded by
HARTON IN RIDALE	14-7-11	D. JOHNSON

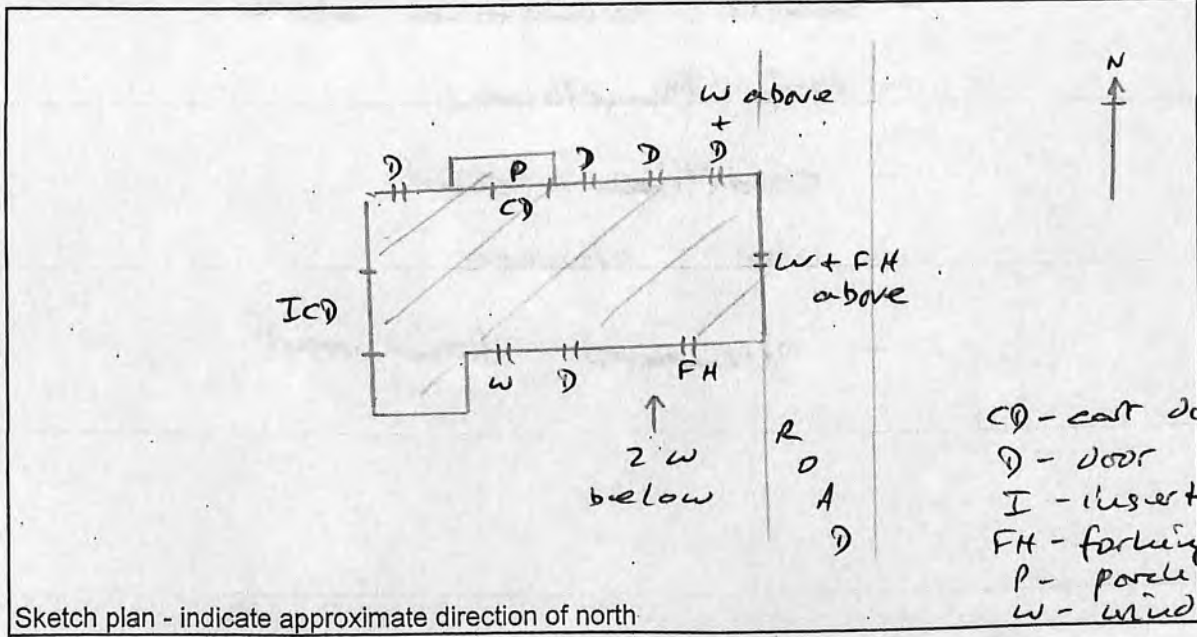
Length 17.50m  
 Width 6.80m

common rafters & tie beam

- within farm group
- walls: limestone rubble
- roof: flagstone
- condition: sound
- use: storage
- 'surveyed' from road

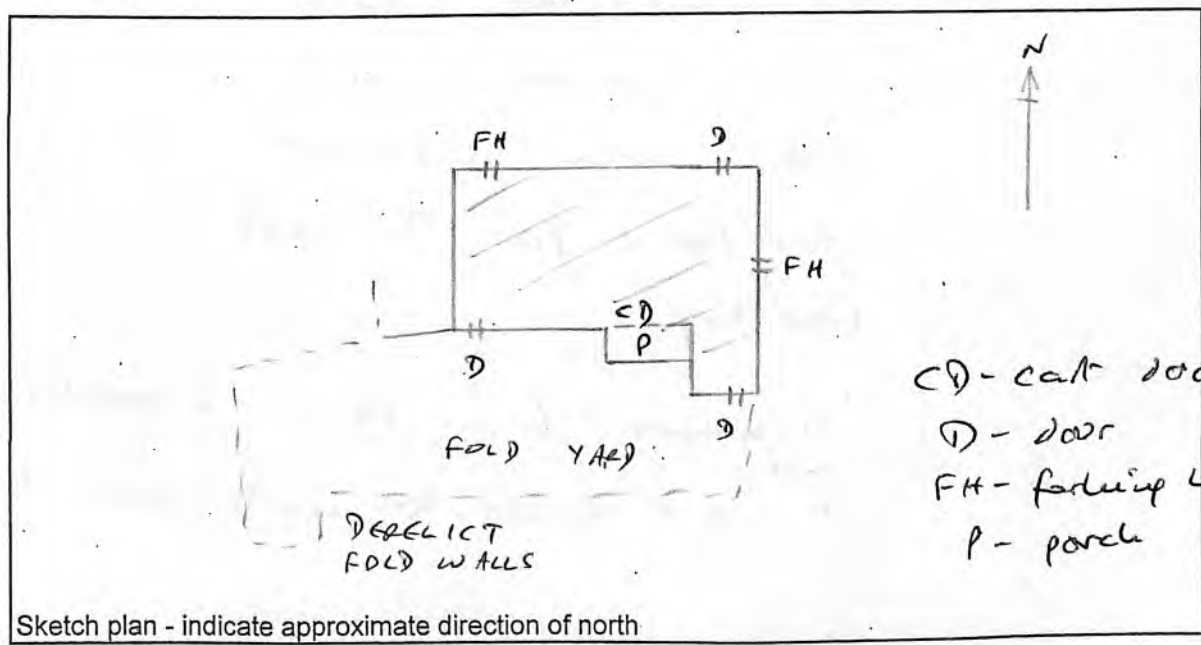
Building ID
HR
209

Length 10m  
 Width 8m

- isolated field edge position
- roof: corrugated asbestos
- walls: limestone rubble
- use: none apparent
- condition: poor. One roof ch  
failing
- 'surveyed' from PLDW & road-access  
refused
- 5 vent holes to north elevation

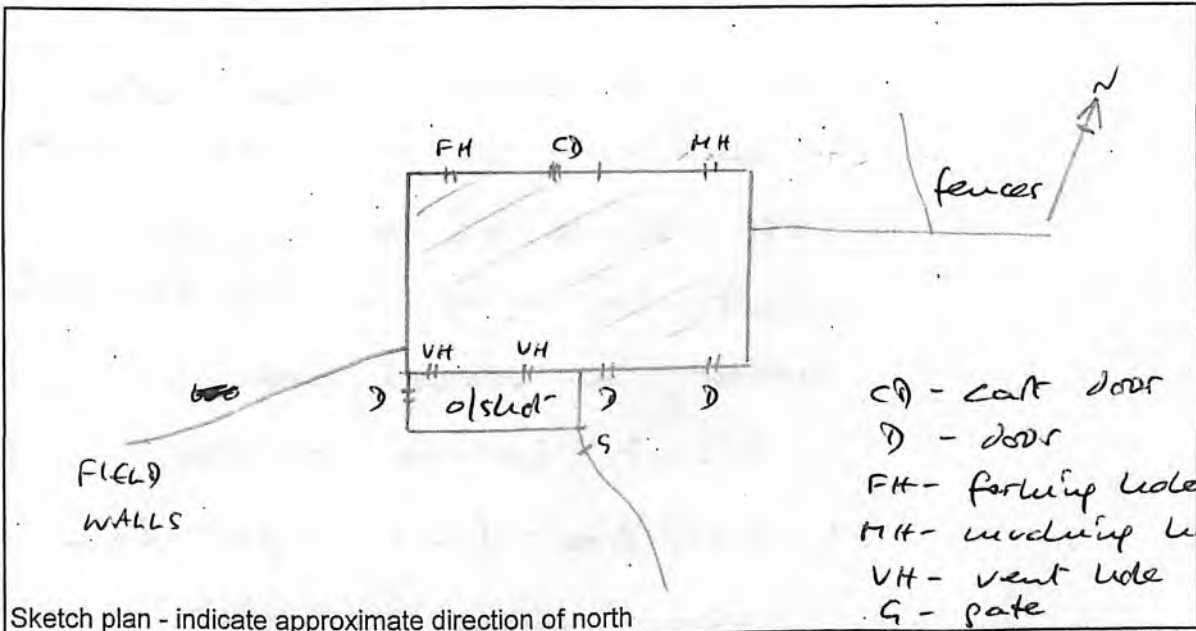
Building ID
HR
210

Length 10m  
Width ~~7.5m~~ 6.80m

- isolated position within field at junction of 4 fields - most walls now derelict.
- walls: limestone rubble with sandstone quoins, jambs & lintels
- roof: slate; tie to o/skdt
- east door has a timber lintel below a vousoir arch
- o/skdt largely ruinous
- condition: fair, apart from o/skdt
- use: none apparent
- 'surveyed' from PtOW
- 5 vent holes to W gable, 4 to east gable

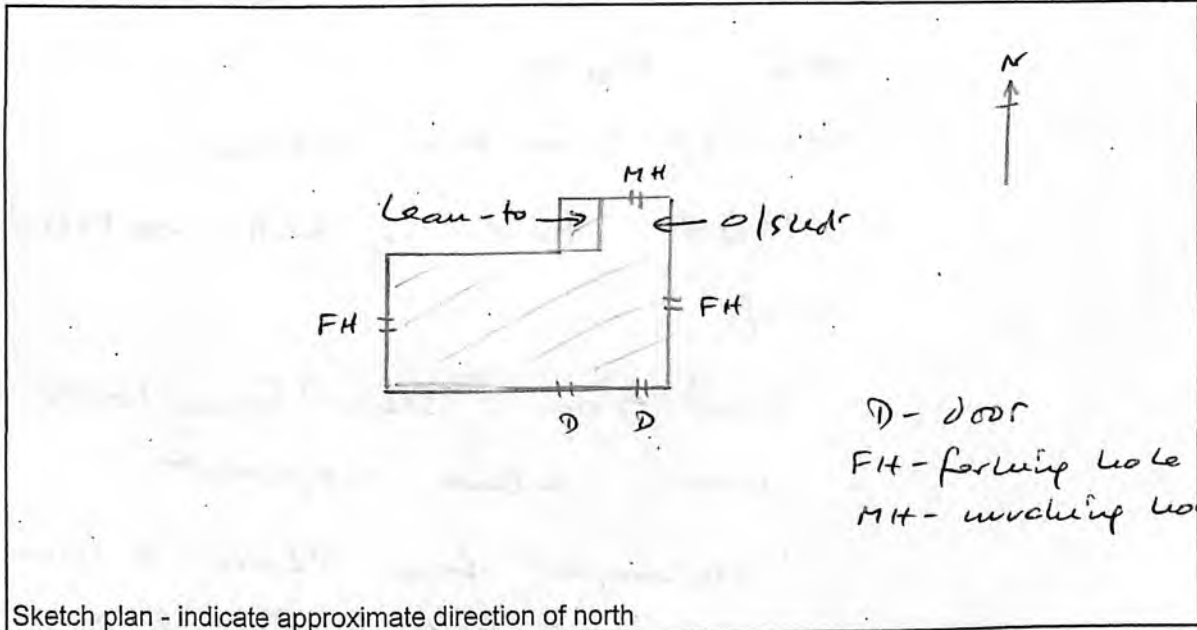
Building ID
HR
211

Length 10m  
Width 6.7m

- isolated position within field, ~~at~~  
~~from~~ ~~junction~~ ~~of~~ ~~the~~ ~~fields~~
- roof: slate
- walls: limestone rubble
- o/skirt tied in, with cat-slide  
roof
- condition: sound. Some loose slates.
- use: none apparent
- 'surveyed' from flow & from  
adjacent field with permission

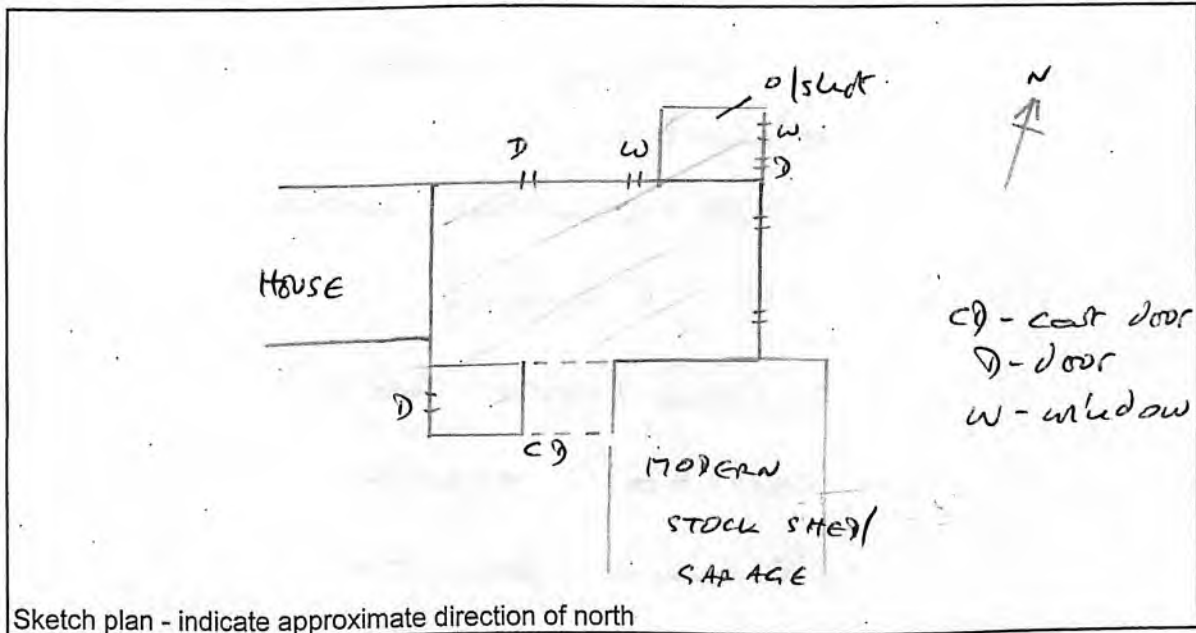
Building ID
HR
212

Length 12-30m  
Width ~~9-30m~~ 7-60m

- within former farm group
- 3 forming holes to rear elevation
- walls: random rubble
- roof: flagstone
- laid the horse barn
- condition: excellent
- 'surveyed' from road
- use: store

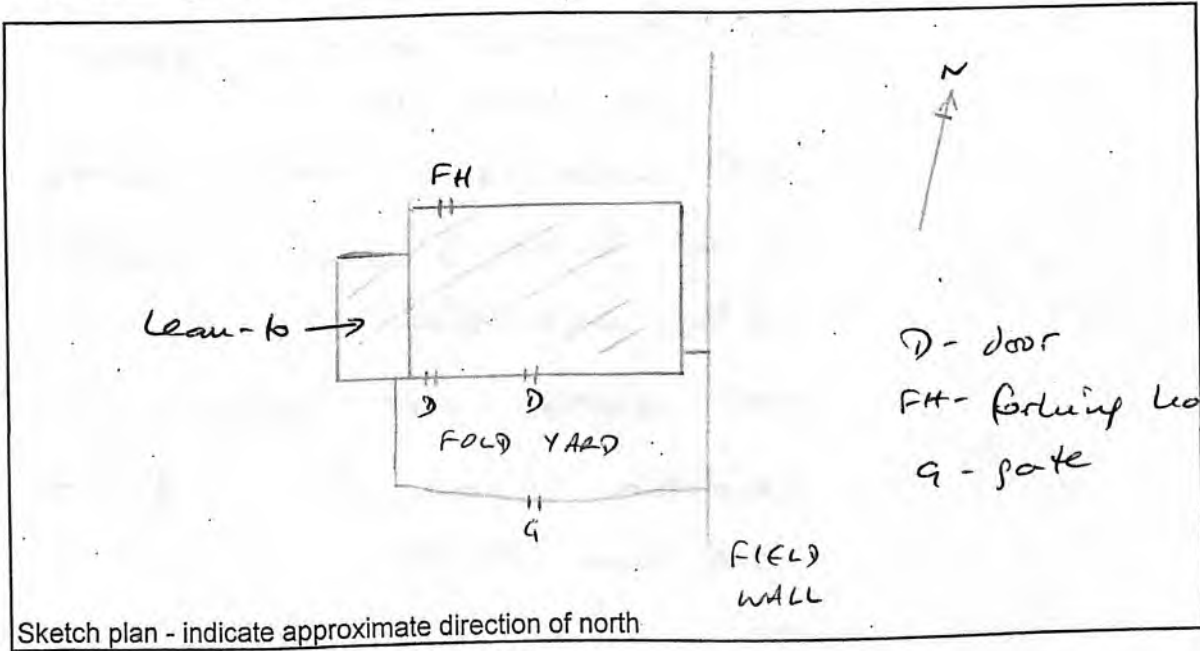
Building ID
HR
213

Length ~~7.30m~~ 7.90m  
 Width ~~7.30m~~ 7.50m

- isolated field edge position
- walls: random rubble
- roof: flagstone to bary, slate on lean-to
- owl hole + 2 vent holes on W gable; 5 vent holes in north elevation
- east gable not seen
- condition: poor much of the roof has fallen
- 'surveyed' from road
- use: none apparent

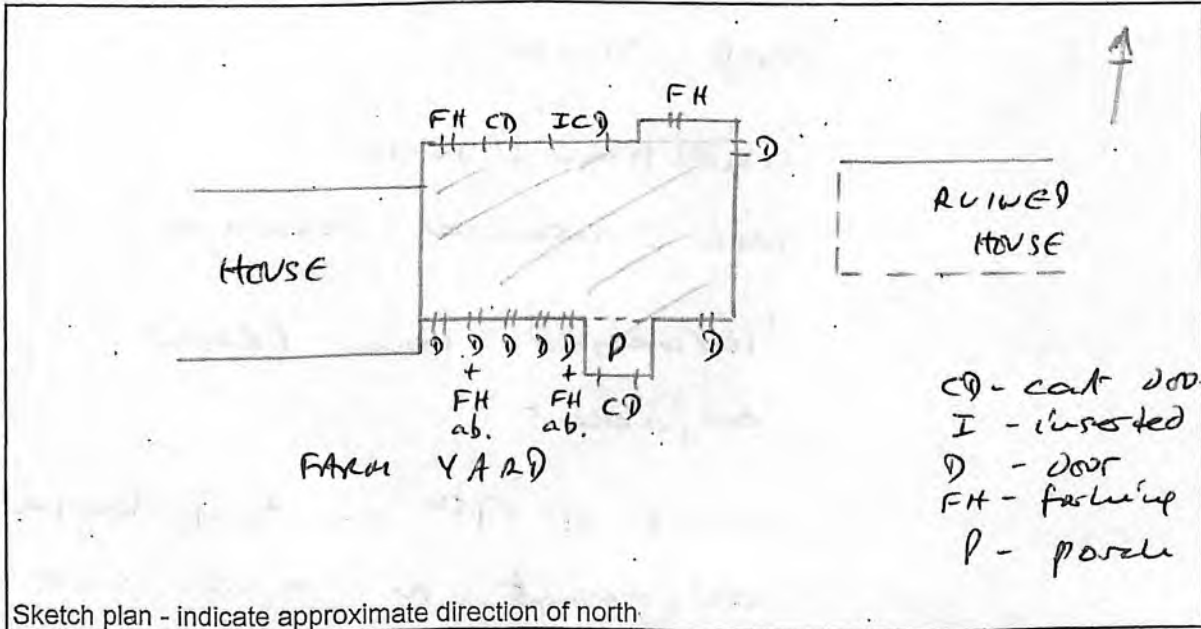
Building ID
HR
214

Length 19m  
 Width 8-20m

- SPA3 no. —
- within farm group
- walls: limestone rubble with slate through
- roof: slate
- condition: sound
- use: general storage
- 'surveyed' from PROW adjacent
- mine of 17th century lease adjacent on east side
