Low Birkwith farm  
(Name of buildings)

Building type: farm complex consisting of farmhouse with attached barn A, detached barn B,henenery-piggery,lower field barn C,higher field barn D.(see attached maps)

### THE BUILDINGS AT LOW BIRKWITH

Low Birkwith farmhouse with barn A

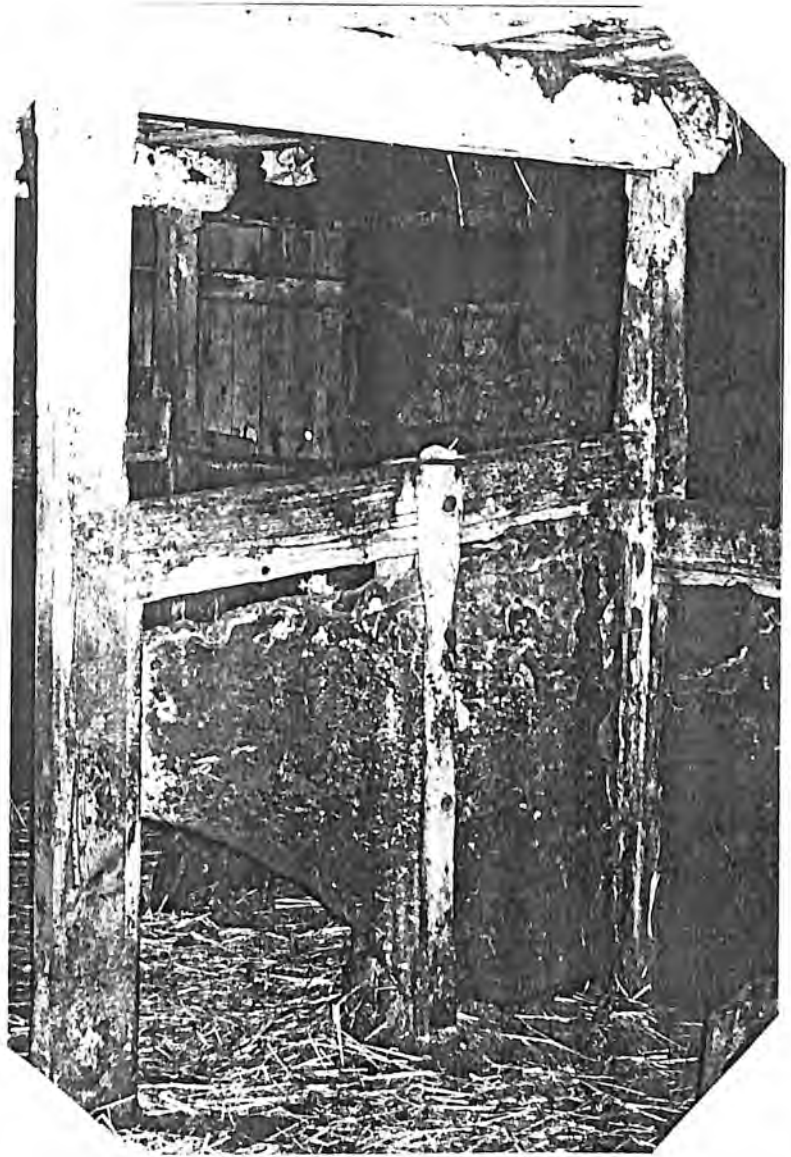
photo ⑥

The skellbuse, deviding the foddergang from the shippon at the end of the barn, and the boskins (stall partitions) are well made of softwood posts and rails infilled with large local 'slates'. The timbers have chamfered edges and the double stalls (booses) are further devided by small vertical 'slate' slabs. The tethering posts with sliding rings are still present. Grooved settle stones form the edge of the groop (walkway/channel) which drains to the door. One timber in the shippon is reused and is of oak with two chamfered sides. It has two mortices in what would have been the underside (for studding) and a row of notches for floor joists in the side. Over the boskins is a hay loft.

Boskin with slate infill  
& tethering post
