NORTH YORKSHIRE:

Keeper's Cottage,
Brackenbottom,
Horton-in-Ribblesdale

Recorded by Sallie Bassham and Arnold Pacey, 15-16 September, 1997

Keeper's Cottage is an 18th-century house, 2 rooms wide and 2 rooms from front to back, with a central entrance, and can be described as follows:

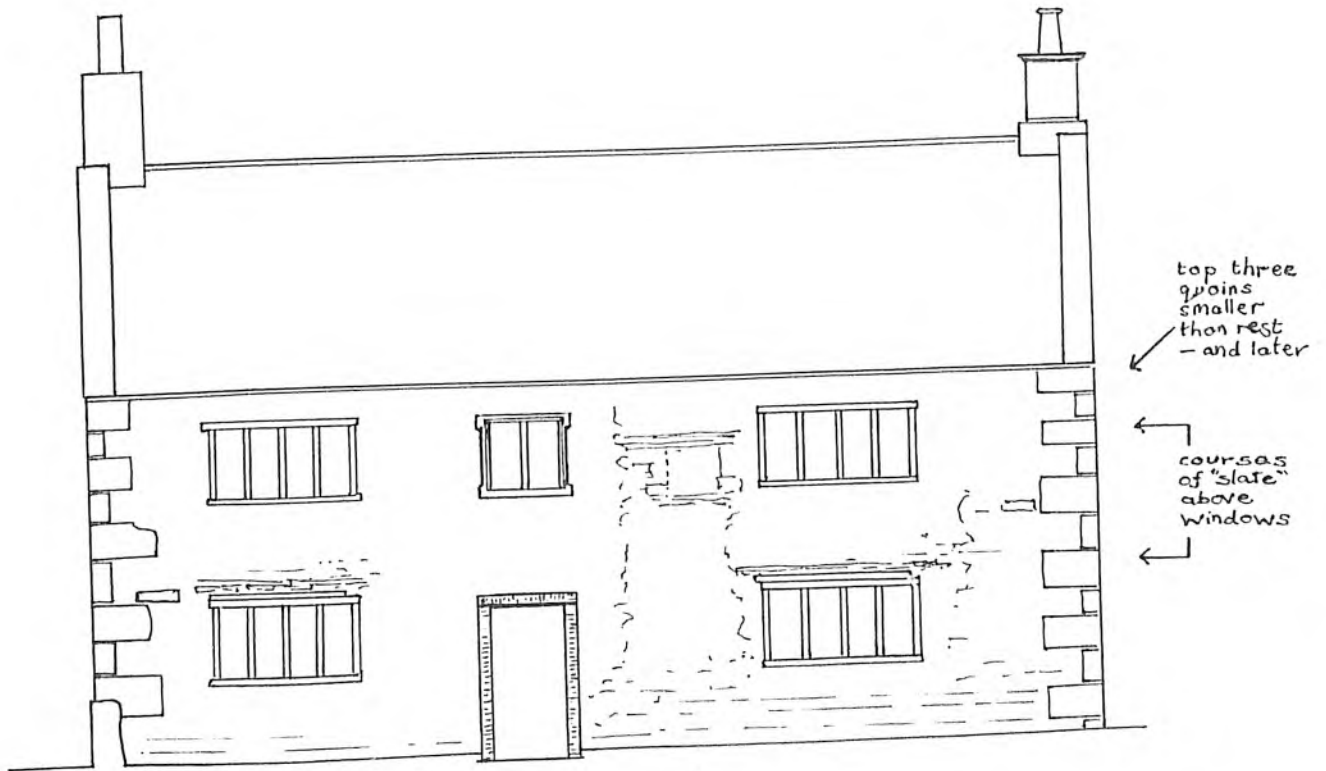
west elevation

↑
centre window
more carefully
made than
the rest;
door jambs
have broad
tooling

↑
area of
early walling
with blocked
window;
note courses
of "slate"
above and below
window.

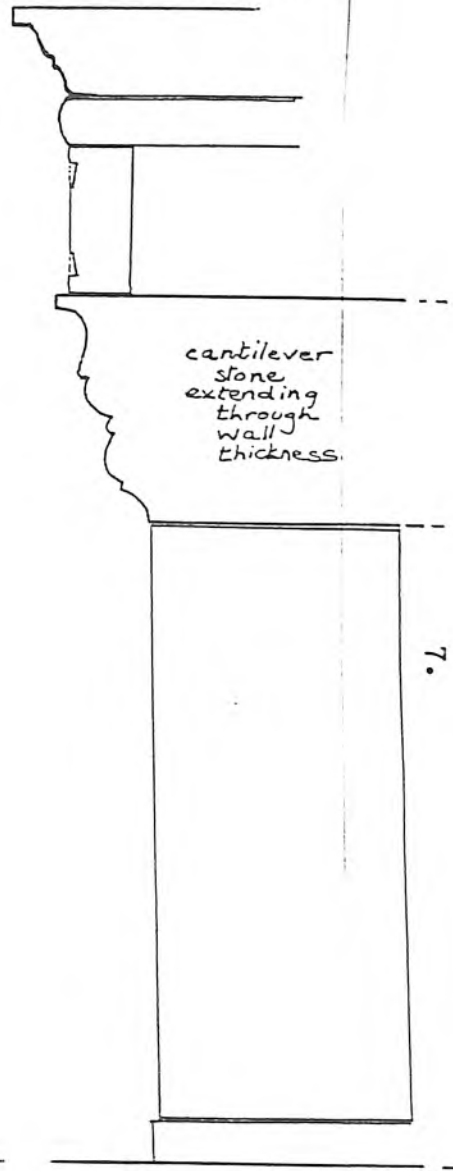
STONE FIREPLACE IN PARLOUR

PROFILE

- Limestone (Carboniferous) is the chief walling material.
- Sandstone (probably Silurian) is used for lining the flues (where limestone would decompose), and shows on the wall surface around the flues. A fine-grained sandstone is used in the parlour fireplace.
- Gritstone is used for some lintels and dressings.
- Flagstone or "slate" (Silurian rock from the Austwick Flags or Horton Flags) is the roofing material, and courses of "slate" appear in the walls above and below windows, and indicate the position of a blocked window.
