# THE EXPLOITATION OF THE HORTON FLAGS—CONSIDERED AS AN EXAMPLE OF INDUSTRIAL ARCHAEOLOGY

W. R. MITCHELL

## ABSTRACT

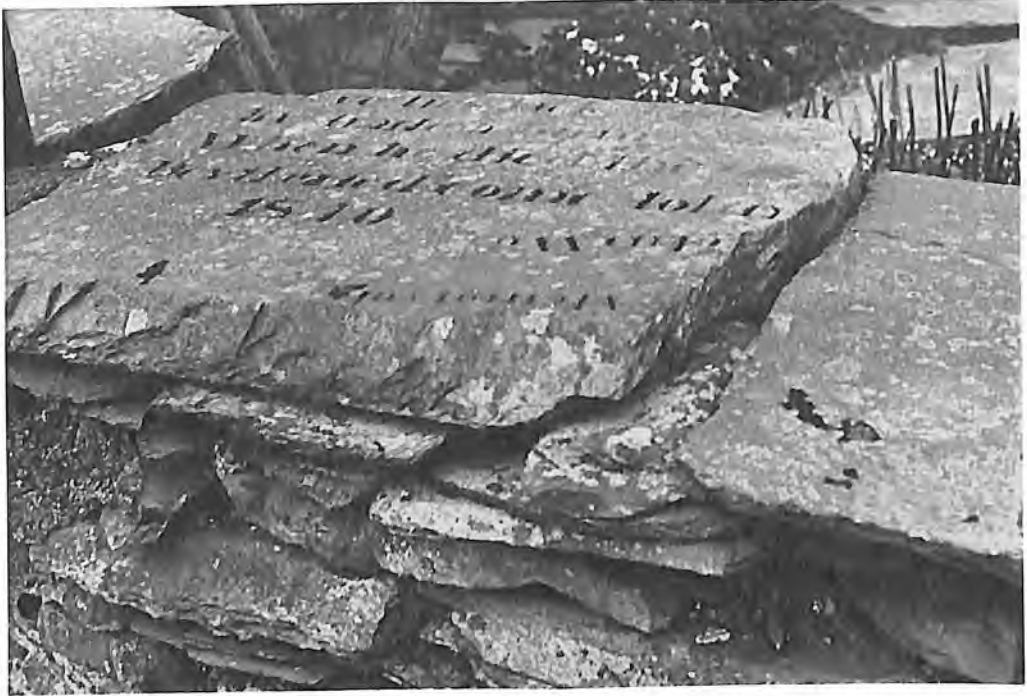
FIG. 3.

This wall composed of Horton Flags can be seen at Studfold. The inscribed stone appears to be the work of an apprentice to the trade of quarryman who was trying out a variety of chisels.

By the 1760s, the Flag had become a favourite material for tombstones. Lettering was a skilled job. There is a stone on a garden wall at Studfold on which someone appears to have practiced the craft. In the churchyard at Horton, memorial stones have a moderate amount of decoration, finely finished. A flower-like emblem is popular—and doubtless very difficult to cut. Decorations were incised on the upper edges of some memorials. Old tombstones in the churchyard at Settle (the church was opened in 1838) are of Horton Flag. An immense piece, used as a memorial, is affixed to the inside of the porch at Giggleswick.

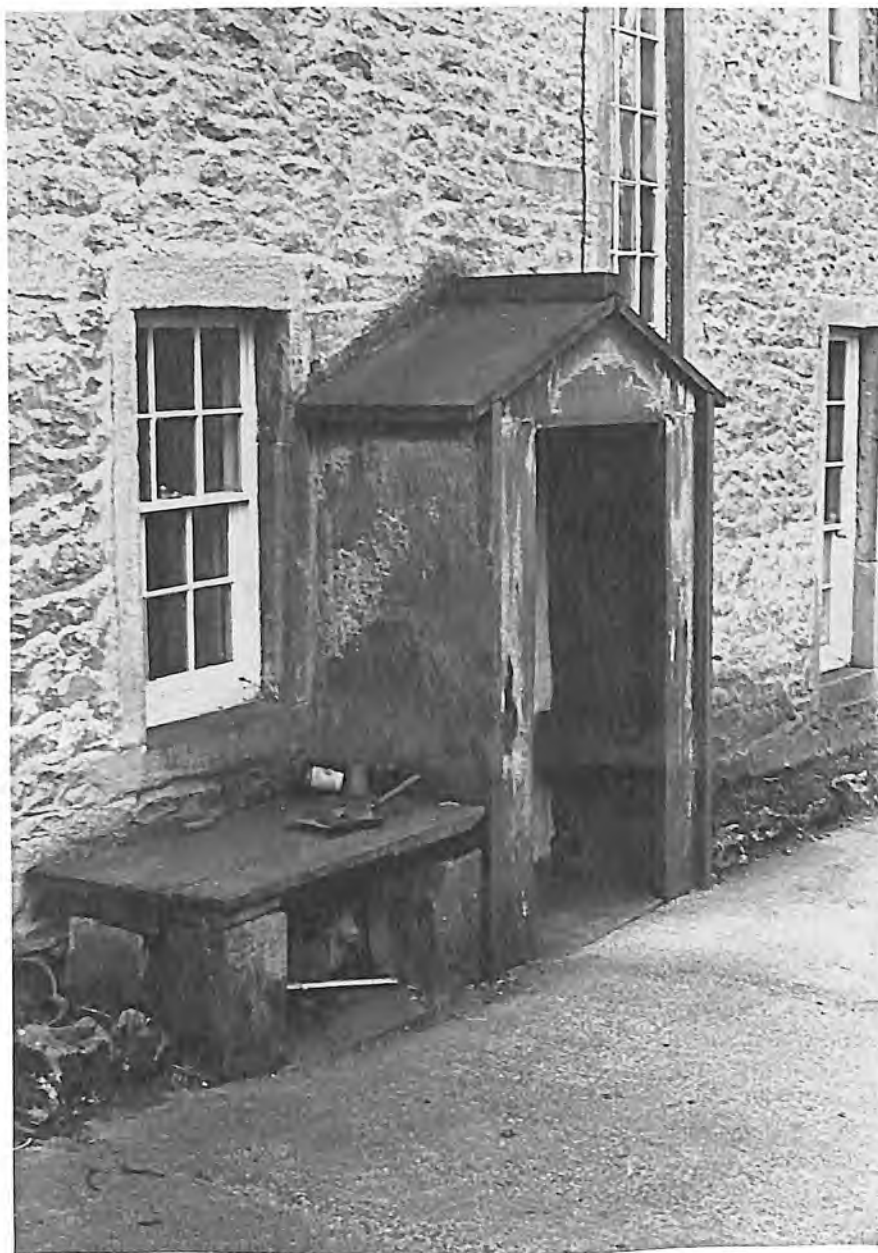
FIG. 5.  
A porch of high quality workmanship. The use of Flag extends to ledges within the porch. The farm is near Settle, in North Ribblesdale.

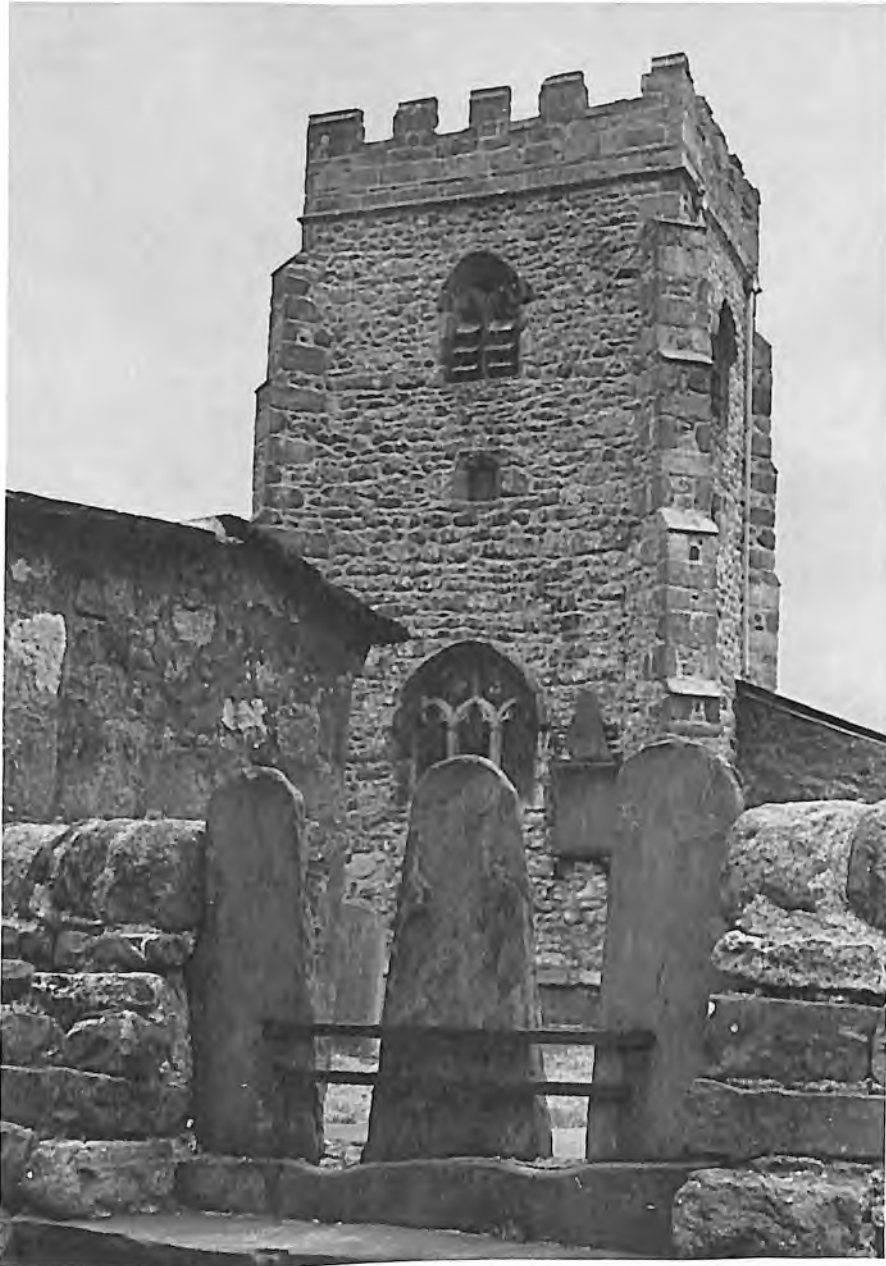
FIG. 6.

Horton-in-Ribblesdale Church. Flags have been used to roof the lychgate and for the stile.

*Horton-in-Ribblesdale Church and Yard* (GR 810722) See Figs. 6 and 12. Look for monuments in (and on the outer walls) of the church. Within, on a window ledge, are brasses that originally adorned memorials outside. The churchyard paths are of Flag; and so are the bases of the foot-scrappers just outside the porch. Gravestones of Flag include some that have been given simple decoration. The lych gates are roofed with immense pieces of Flag bolted together.

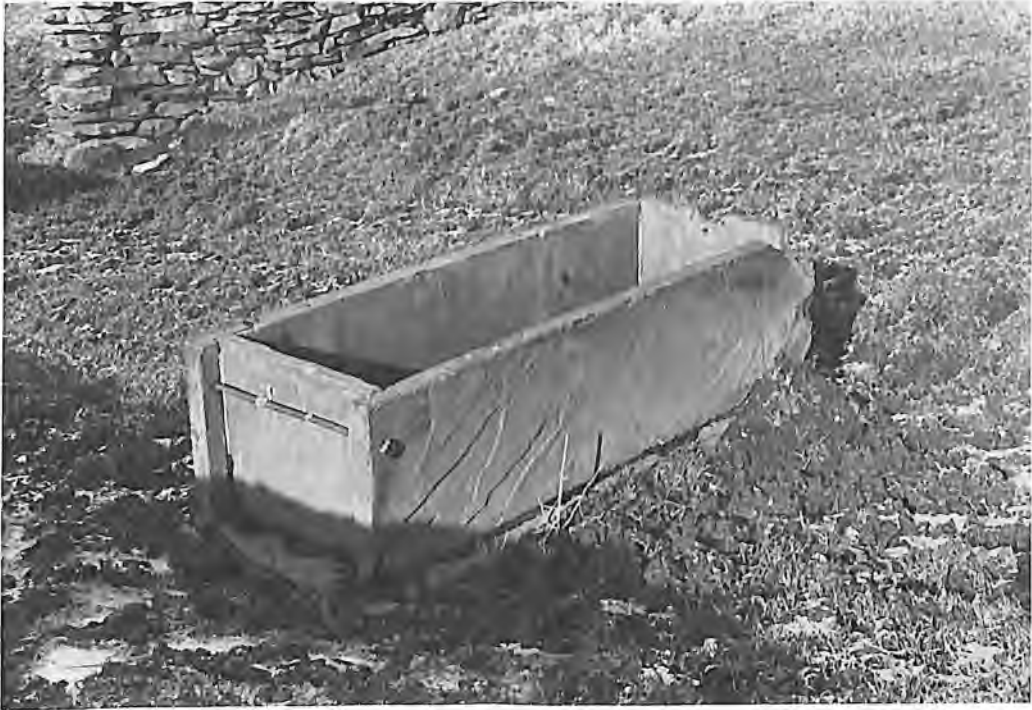
FIG. 8.

A field trough made of Horton Flags. Such a trough was a common feature on farms in North Ribblesdale. Joints were sealed with white or red lead!

*Troughs.* To this day, farm animals in many fields in highland Craven rely entirely on a local rather than a piped supply of water. Troughs are much smaller versions of the cisterns, being similar in style and construction and invariably standing beside them. Some troughs were fitted into a gap in a drystone wall, providing water for stock in two

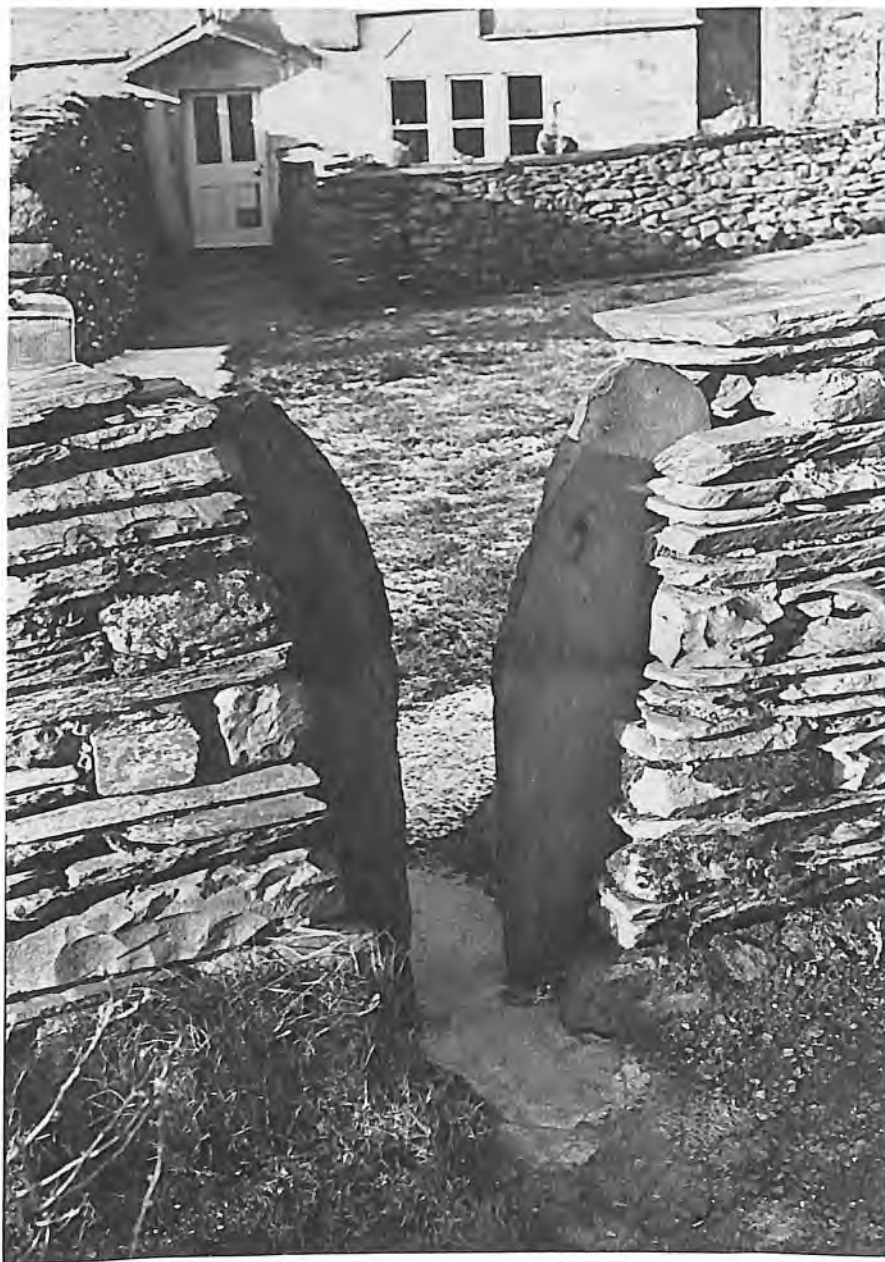
FIG. 10.

A stile at Sherwood Farm, near Helwith Bridge. This stile and the wall are composed of Horton Flags, pieces of which provide a canopy at the farmhouse door behind.

*Walls.* Around Helwith Bridge, the drystone walls (Fig. 10) are composed almost entirely of pieces of Flag; elsewhere it was used as "throughs" or as gate-stoops. Flag for walling was being sold in 1923 at "a shilling a cart load". If two courses of "throughs" were incorporated in a wall, the top "through" would be 45.5 cm or 61 cm, and the bottom about 80 cm. Gate-stoops varied in size and thickness; also in pattern, but generally they were shaped to the walls, to create a neat appearance (Fig. 11). A typical stoop was 109 cm by 48 cm by 5.08 cm. One form of stoop has three holes, into which the ends of bars of wood were slipped to provide a stockproof barrier at the entrance to a field.

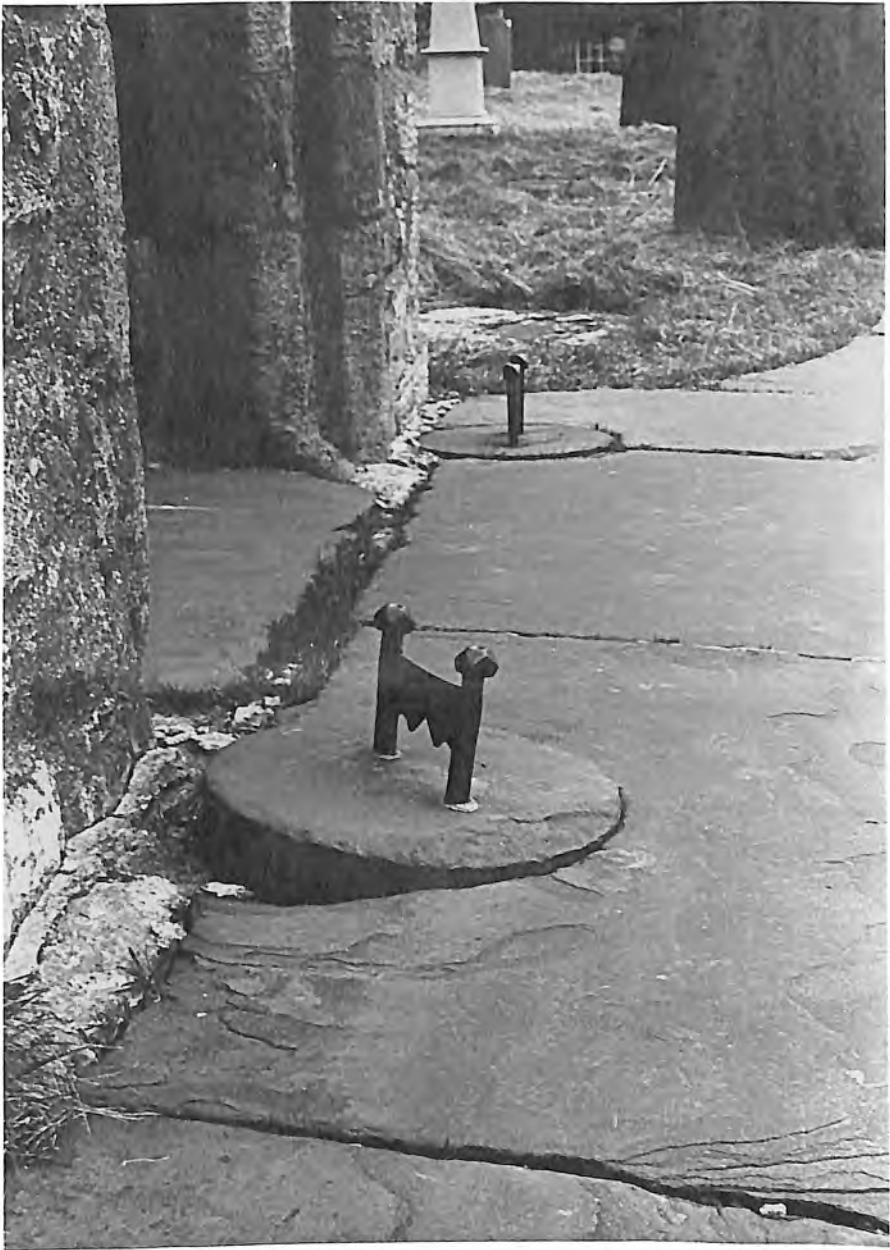
FIG. 12.  
Horton-in-Ribblesdale Church. The path and circular base of the foot scrapers are composed of Flag.

*Foot-scrapers.* Many of these remain, some of them being dated, (invariably from the latter part of the 19th century). An example outside the porch of Horton-in-Ribblesdale church has a diameter of 45 cm, and a thickness of 8.2 cm (Fig. 12). There is a possibility that the circular pieces of Flag on which scrapers stand were from holes cut out from pieces intended as covers for brewer's vats; some enterprising quarryman, and the local blacksmith, created an object that was useful and decorative.
