Alison Armstrong Collection – Cataloguing Sheet

Title	Langcliffe Wallet																																																																																									
Storage location	Ingleborough Community Centre, Alison Armstrong Collection, Box 1																																																																																									
About this record

VERNACULAR BUILDING SURVEY:

Building name: No 1, New Street, Langcliffe

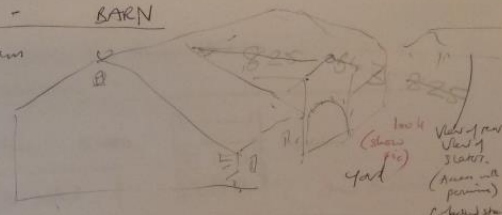
MAMZ - BARN
frage barn

View of rear
View of
3/4 view
(Anon with
pencil)
C-bend steel
("steep" angle
to steel.)

Old at top (24) but attached to old 19' c. Pitch is
1/2" drop.
