WEA TRIP: 11 June Guide:
 9.30 Bretton Hall PETER THORNBORROW

12.30 Gunthwaite
 GUNTHWAITE HALL BARN : SE 238 066

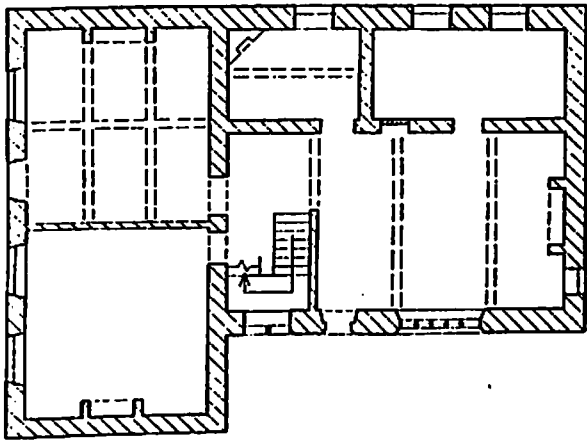
BARN AT NETHEREND FARM, DENBY

The building at Nether End Farm, now used as a mistal, is a simple rectangular structure of four bays with four cruck trusses. One gable, as so often happens, has no truss. Whether this was due to the fact that one gable truss decayed or whether another bay was added when the stone wall was built it is impossible to determine. The cruck trusses themselves have extended tie-beams carrying the wall-plates and two collar-beams, the upper collar being notched in a manner similar to the one at Dean Head. Three holes underneath the collar-beam, provided to take the upright rods of the wattle walling as at Far Field Head, afford the only evidence of the nature of the early walling. The present stone walls were built in 1663, assuming that the date on the gable is the date when the change took place.

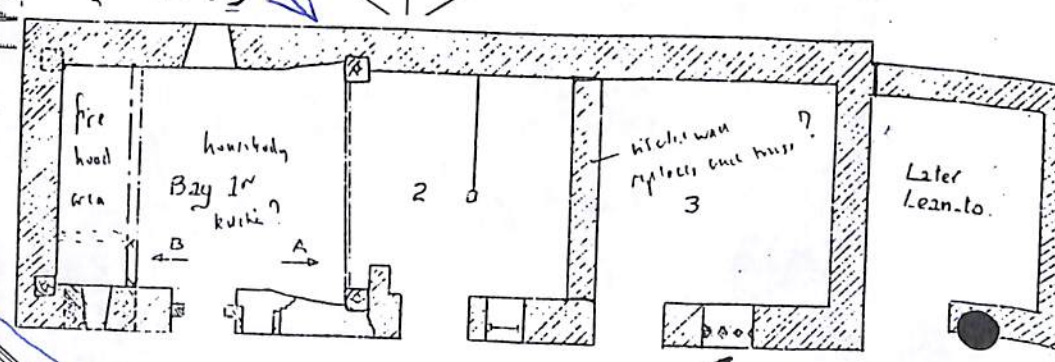
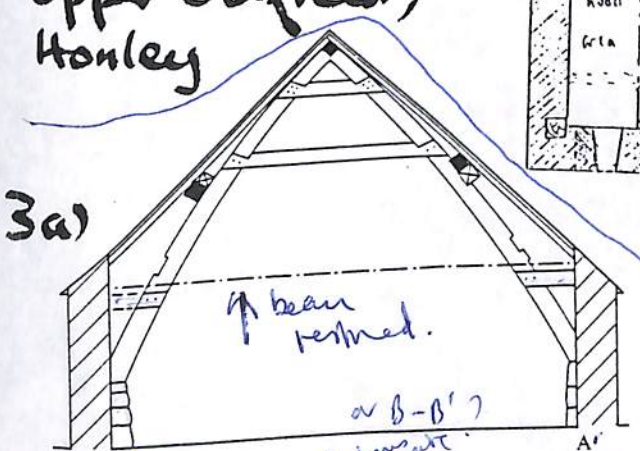
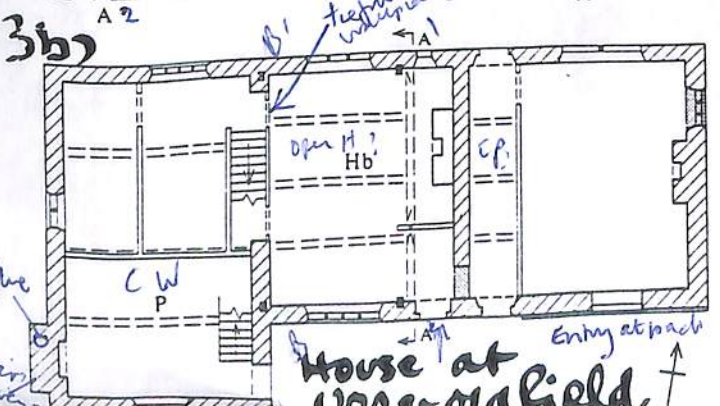
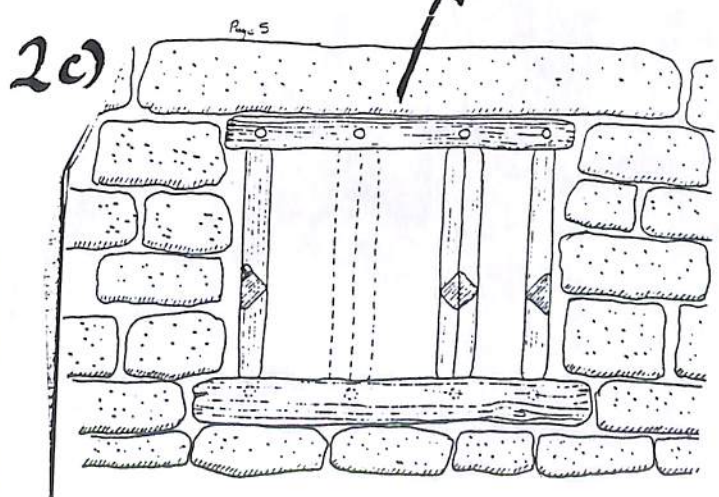
Inside elevation of Window in Bay 3
Scale 1 1/2" = 1'-0"
mullion sections superimposed
