## Conistone Keld History

## Evidence from the 2018 Restoration Project

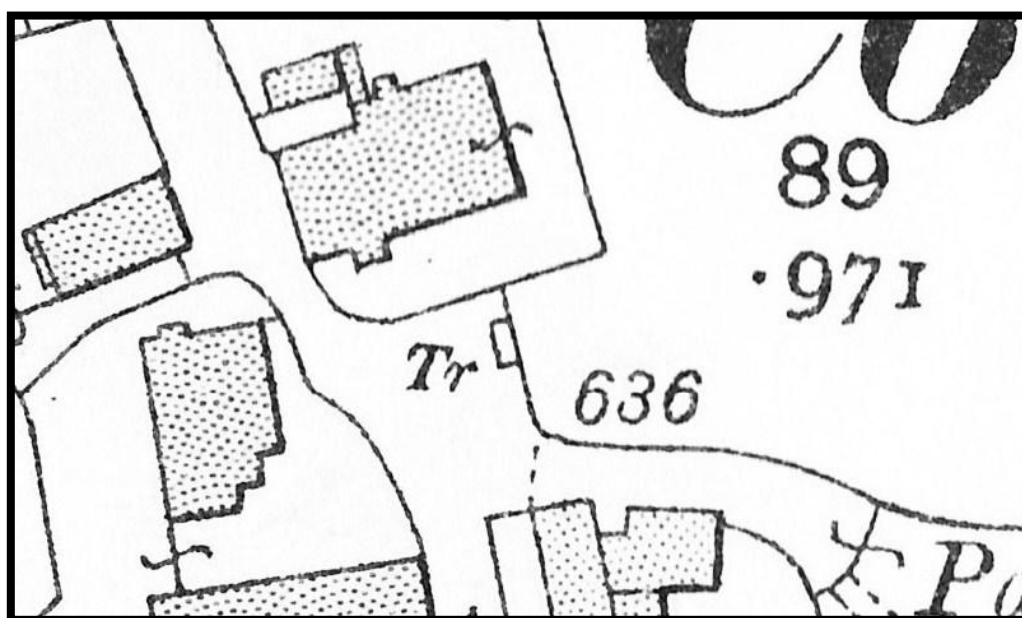
**Fig.1 The Keld Troughs (marked Tr)**

*This map is taken from an early 20<sup>th</sup> century O S Map. The building to the North of the Keld is Conistone Old Hall. The building to the East is Hemplands Farm. The area between the Keld and the road is open space belonging to the Village.*

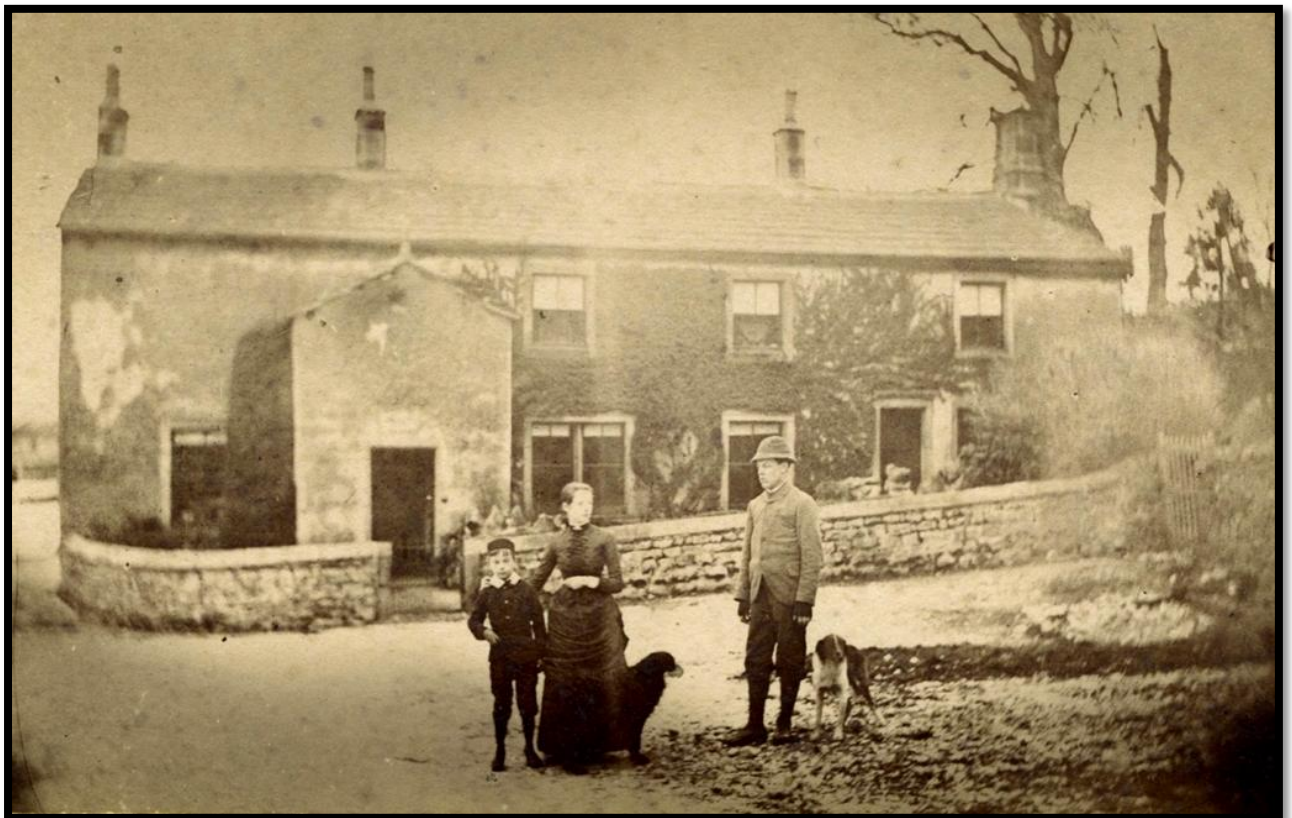
**Photo 1 Conistone Old Hall c 1895**

The oldest photo (**Photo 1**) dating from around 1895 shows three people posing for a photograph in front of Conistone Old Hall, along with dogs. Careful study of an enlargement (**Photo 3**) shows that digging has taken place across the Keld following an East –West axis. A pile of stones, probably to be used for cobbling, can be seen in front of the northern Trough (number 1). Trough number 1 has objects visible on the top, so the trough had no water in it, but is filled with solid material. This activity is seen as work to repair/renovate the Keld, as this would have to be done periodically to keep the Keld running and clear.

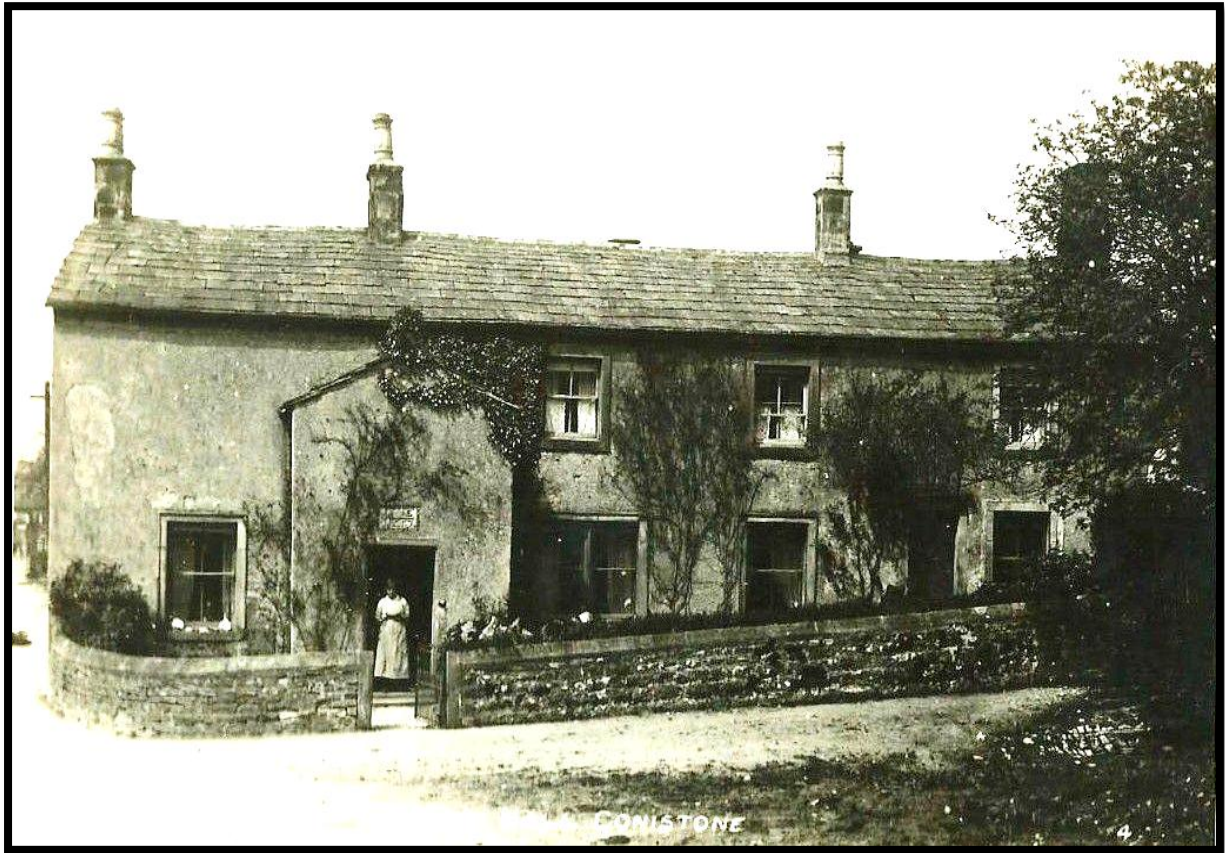
Photo 2 Conistone Old Hall c.1905

In **Photo 2**, the cobbles are in position, (see the enlargement in **Photo 4**) and can be recognised as the cobbles uncovered in the 2018 project. There seems to be a marked break of slope which leads to the Keld, and there is a level area in front of the Old Hall which probably gave access to the house and the field to the East (left) behind the Keld.

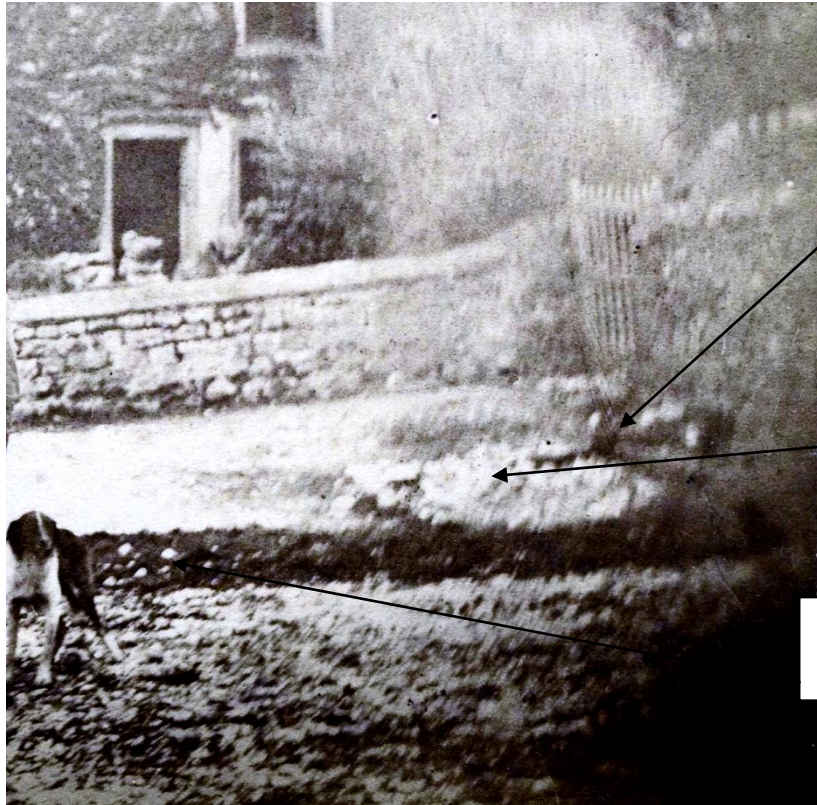
**Photo 3 1895 Photograph close-up**

Trough 1- objects on top

Pile of stones for cobbling surface?

Evidence of digging across the Keld

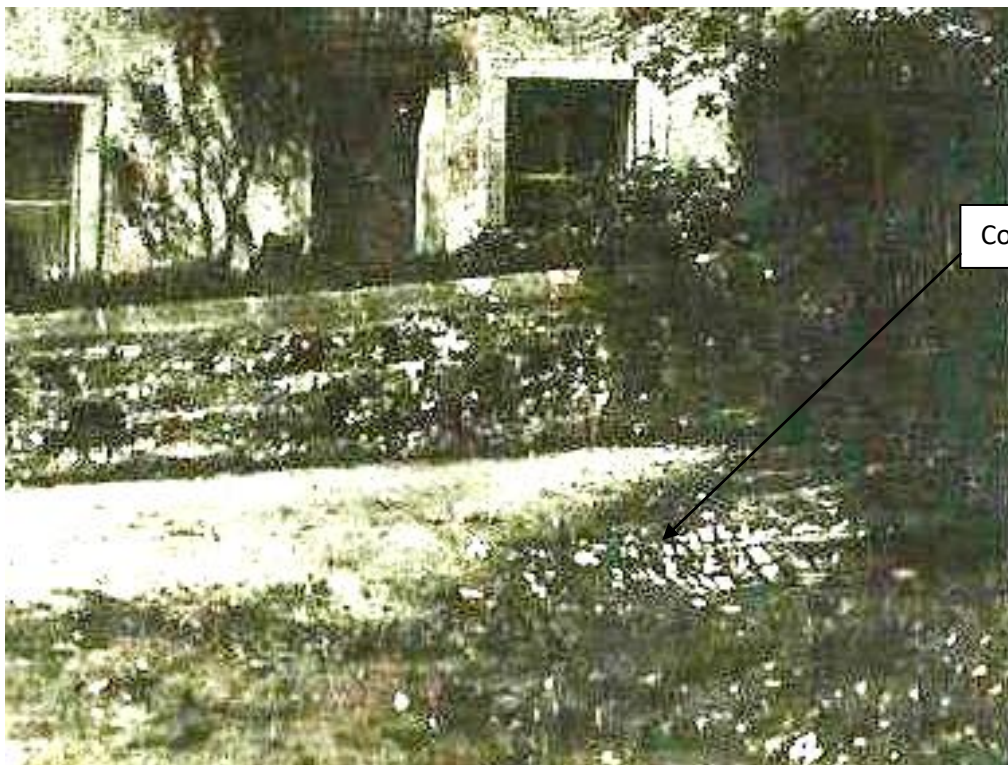
**Photo 4 1905 Photograph Close-up**

Cobbles in place

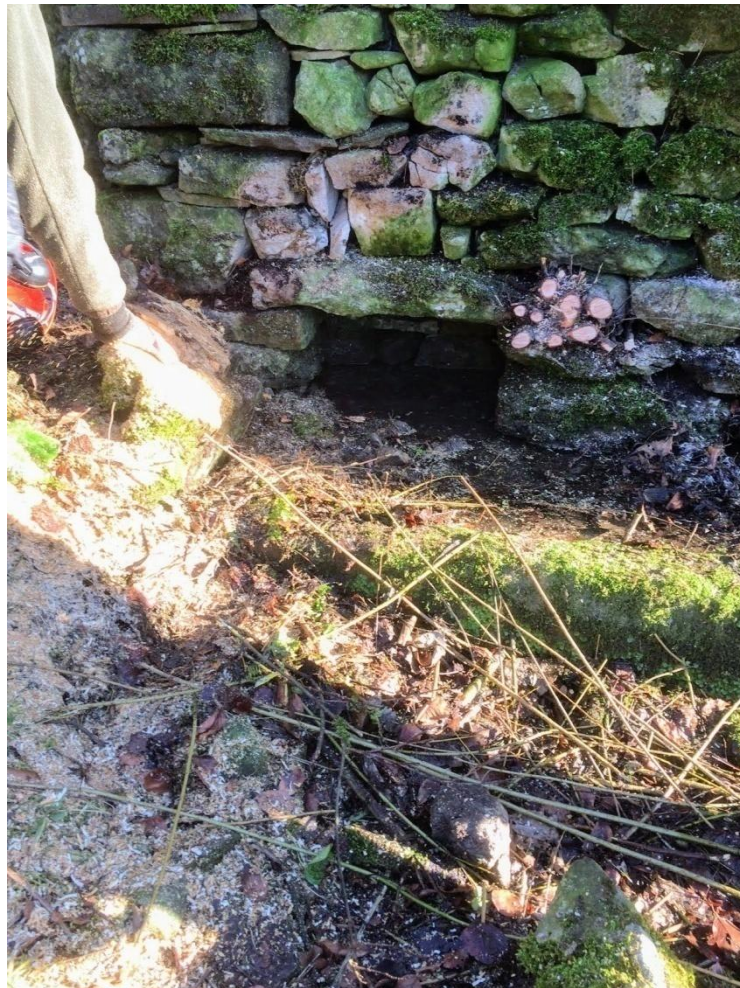
**Photo 5 Trough 1 before removal of sediment.**

*The spring source can be seen in the cavity in the drystone wall. There is no water in the trough. Note that no cobbling can be seen in the foreground due to debris and vegetation. This was revealed later.*

**Trough 1** was almost completely full of sediment when the vegetation was cleared away. This sediment was carefully removed using trowel and bucket. The sediment was removed until a clay layer was revealed at a depth of 49cm from the trough top. This clay layer marks the bottom of the trough, and spring water could be clearly seen rising from the north east corner, at the base of the drystone wall.

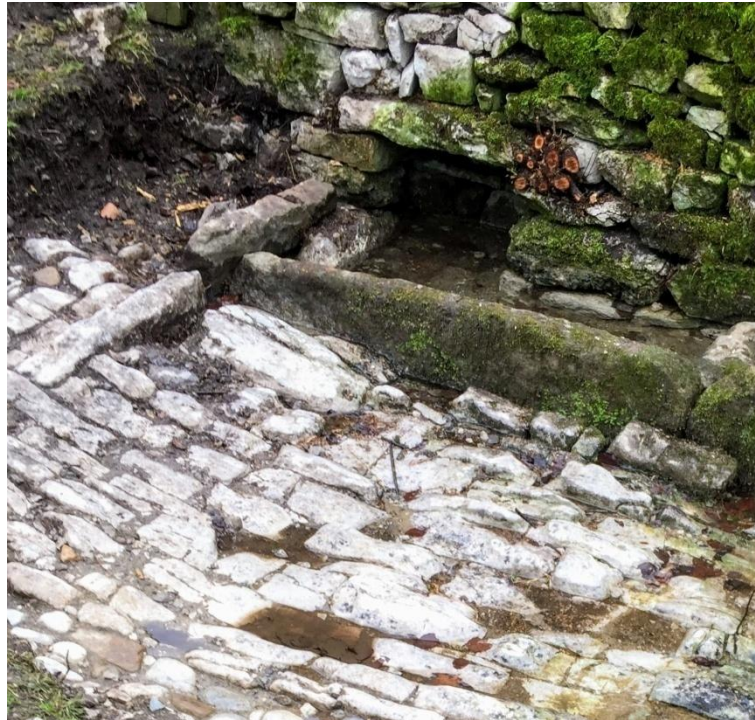
**Photo 6 Trough 1 after clearance.**

*Spring water can be seen rising from the recess at the back of the trough. The sediment which was removed revealed a quantity of shards of 19<sup>th</sup> century pottery. Animal bone fragments and some glass was also present. At the lowest level in the trough the oldest material was 19<sup>th</sup> century pottery. This evidence tells us that sedimentation/infill in the troughs must have started during the 1800's. There was a high proportion of broken earthenware plant pot material.*

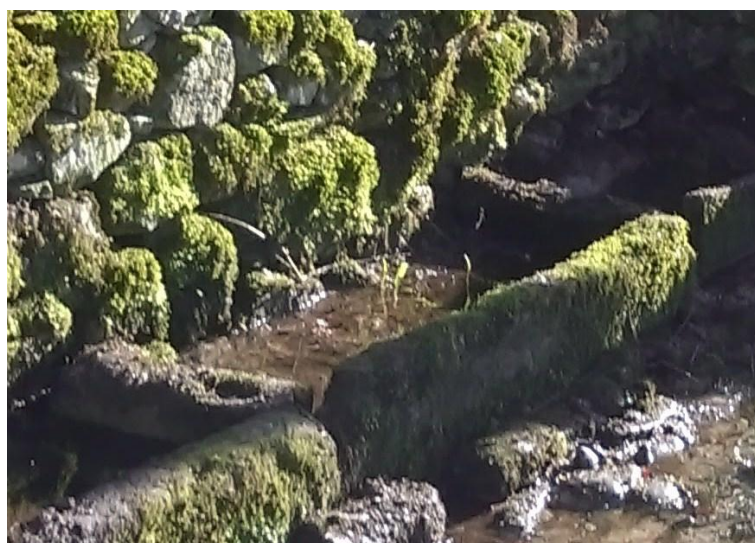
**Photo 7 Trough 2 during clearance**

**Trough 2** was almost full of sediment, but did have a shallow pool of surface water which emptied via a gap between trough 2 and 3

The archaeological material recovered was of the same period as trough 1. Again this indicates that sedimentation/ infill seems to have begun in the 1800's. The southern end of

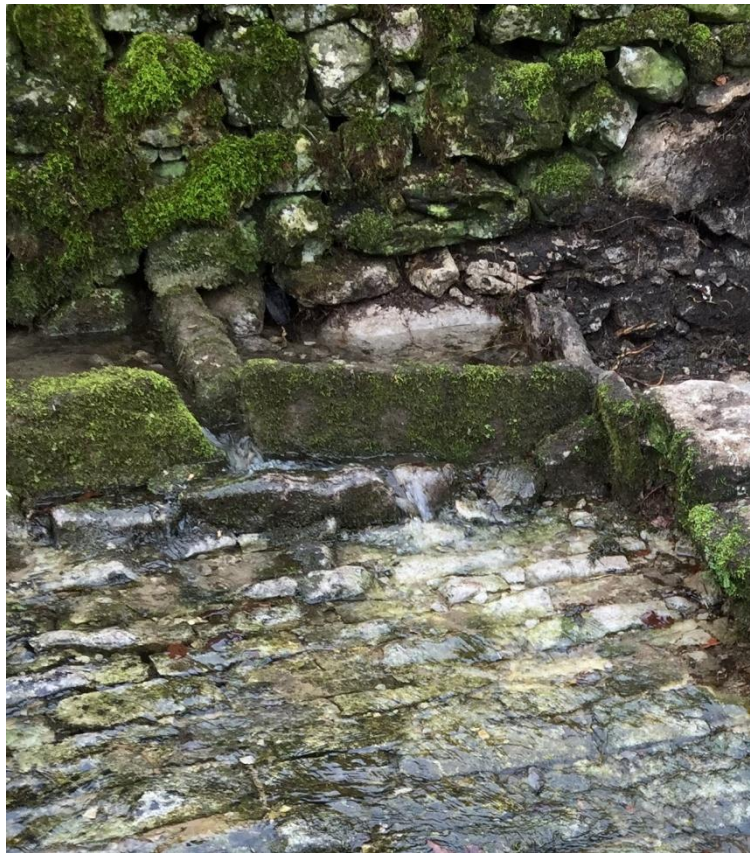
**Photo 8 Trough 3**

**Trough 3** is shorter than the other two troughs. Clearance revealed that the infill was of limestone stones of various sizes, with little evidence of sedimentation. This suggests that the trough was filled in deliberately at some period in the past. There was a small number of pottery fragments present (19<sup>th</sup> Century) . The sandstone section at the southern end of the trough is probably a broken piece of the original front sandstone slab. Wall collapse may have broken the front slab and the broken section moved to the side to form a shorter, truncated trough. The bottom of this trough was 38cm deep.

the long sandstone slab is damaged with a triangular piece broken off. This could have been done deliberately to aid flow of water out of the trough. (See Photo 8). The clay layer at the bottom of the trough was 44cm from the top.

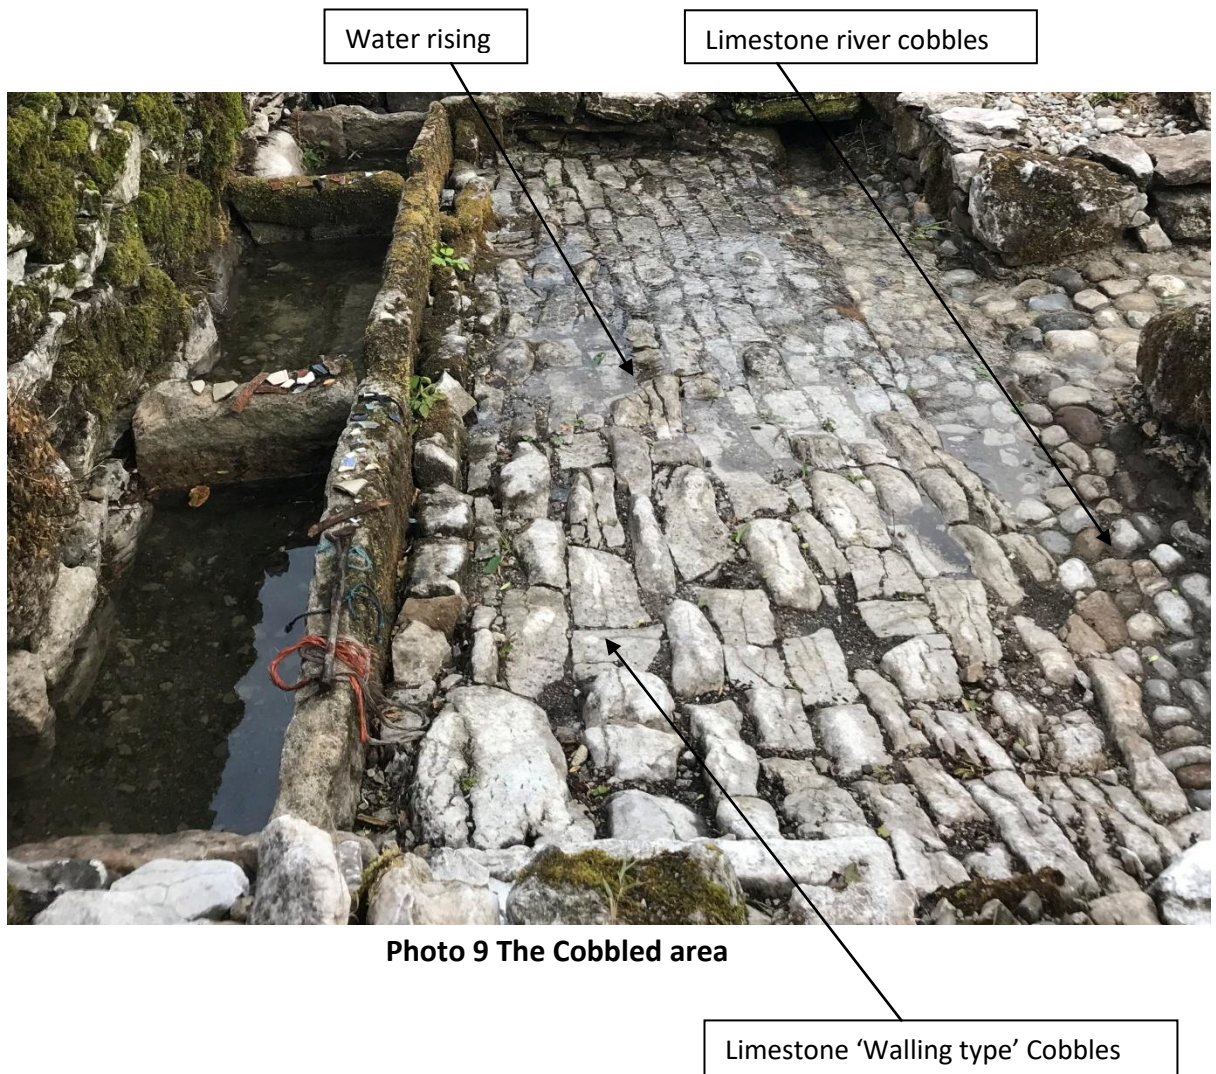
**The Cobbled Area** is the area immediately to the west of the troughs. The area was carefully cleared and the full extent of the cobbling was exposed. The cobbles nearest to the troughs are limestone similar in size to walling stones, but laid on edge. The cobbling around the periphery are limestone river cobbles. The cobbles must have been laid to keep mud/dirt from getting into the trough area when animals used them.

Water issues from an area where cobbling has been removed. Could this have been the result of the troughs being blocked and the water table has been tapped to access water more easily?

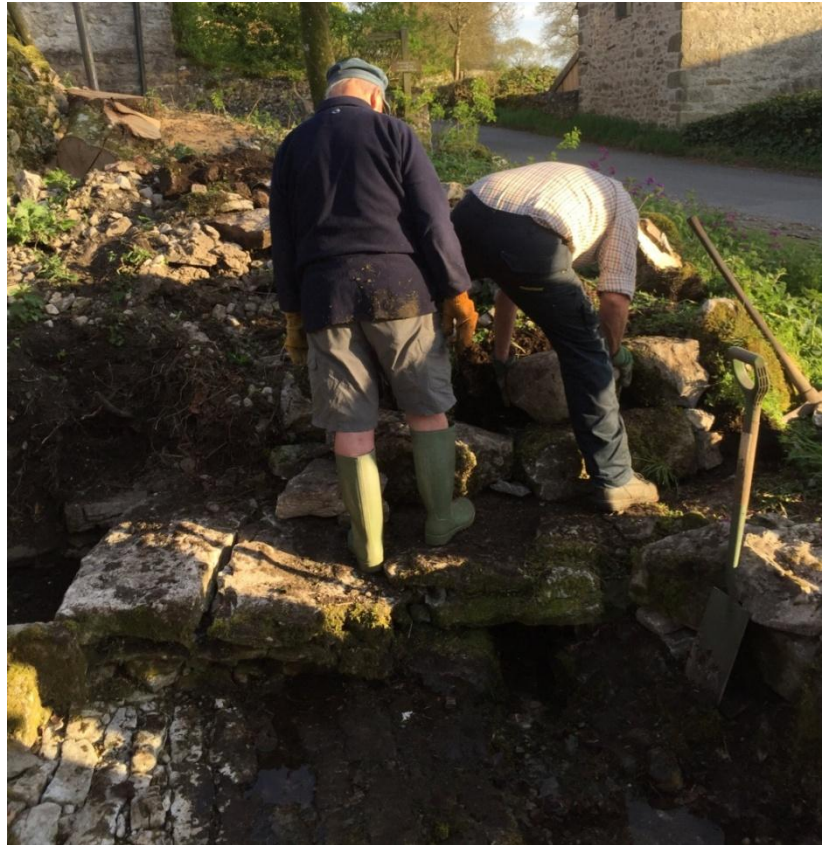
**Photo 10 The large limestone slabs to the south are uncovered.**

The large slabs cover a culvert which at one time took the Keld water under the road to Hemplands Farm.

The limestone slabs would have been used to prevent contamination of the water running through to Hemplands Farm. It would prevent debris from the adjoining areas from entering the flow. The slabs seem to be contemporary with the troughs when they were first constructed.

As clearance progressed, a culvert was revealed, covered by large limestone slabs. (Photo 10). This must have carried the water in a westerly direction to Hemplands Farm. Interestingly, there is another drainage culvert in the village, running from the lower village green in a westerly direction. The construction is identical to the one at the Keld, and could have been built at the same time. When trough 3 was filled in, the water could not exit the Keld through the culvert. The water was diverted away from Trough 2, across the cobbled area in a westerly direction and then on towards Hemplands Farm.

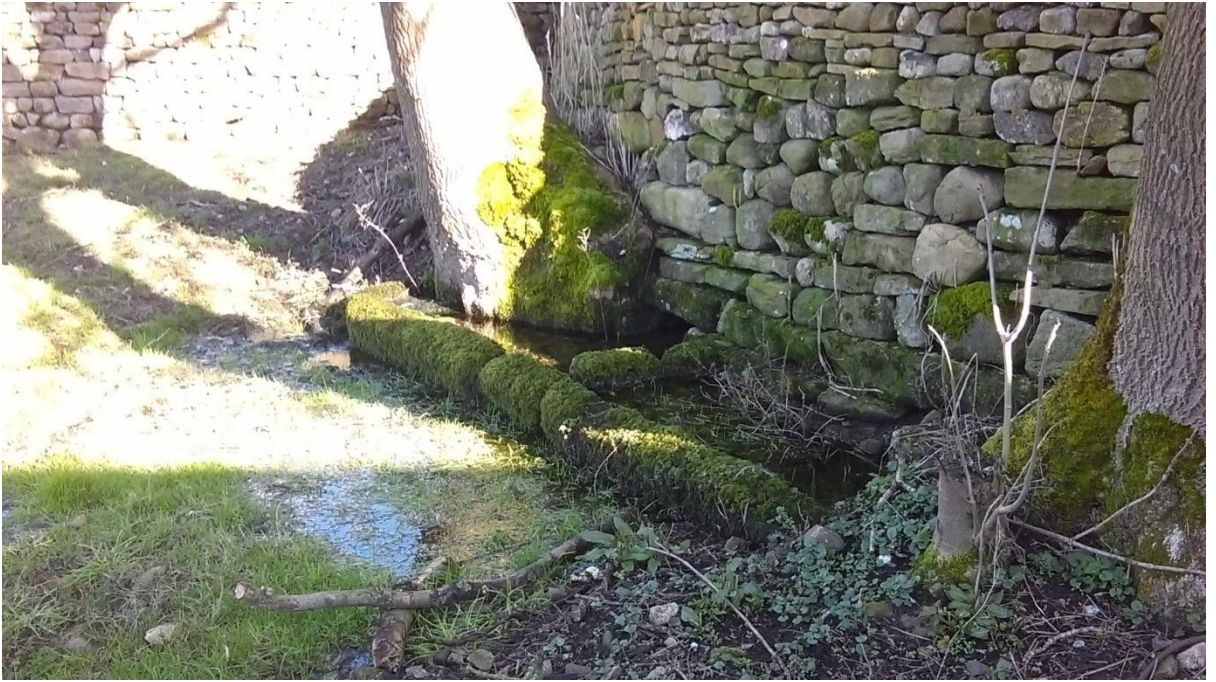
**Photo 11 Troughs at Hall Well, Appletreewick**

The construction techniques, using long sections of stone, traversed by shorter cross sections of stone, are to be found in other areas of the Yorkshire Dales. The troughs at Appletreewick are identical in construction. Could it be the case that the troughs at Conistone were constructed by the same builders? (see Photo 11)

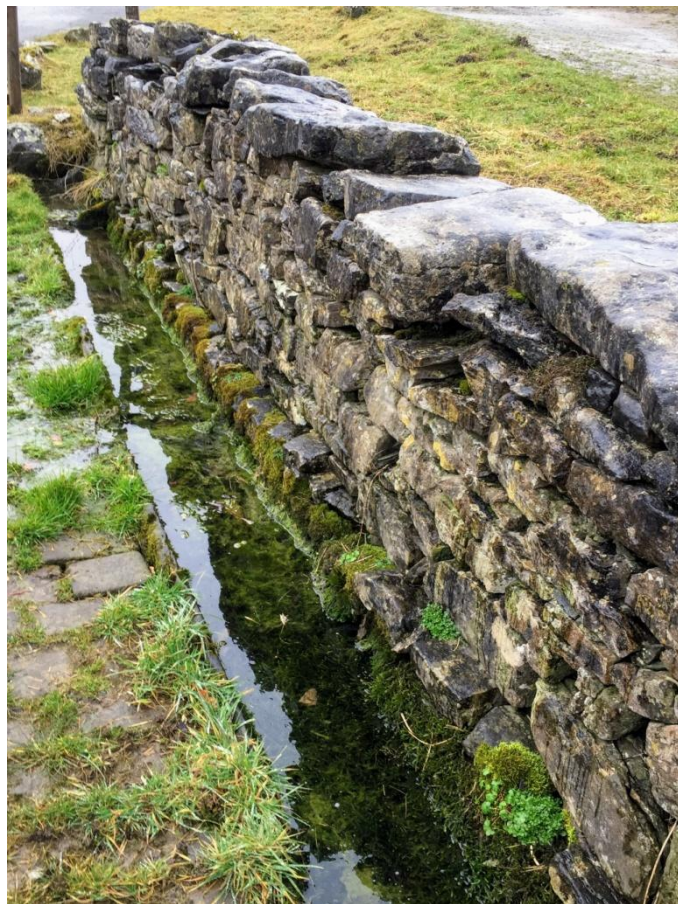
**Photo 12 Troughs at Feizor**

The trough at Feizor, North Yorkshire is shown in Photo 12. This trough is also built using the same techniques:-

Back Wall, Spring –fed troughs, long stone slabs traversed by shorter cross section stone slabs, with an outflow at one end of the troughs.
