Airton Friends Meeting House

A vernacular building survey

Alison C Armstrong

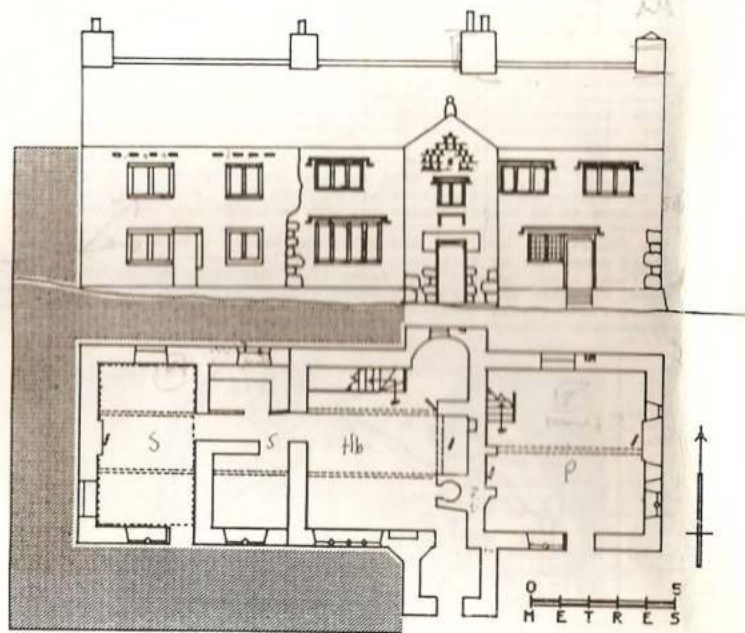
765 Hill Top Farm

Stone house dated 1617. Originally two cell lobby entry, one external door, shallow rectangular stair turret to N. Full height gabled porch added before house extended to W. in 18th Cent. providing new service rooms. Door to parlour blocked when oven relocated. E. end divided off to make cottage at this time. Very rare wall paintings in parlour and bedroom.

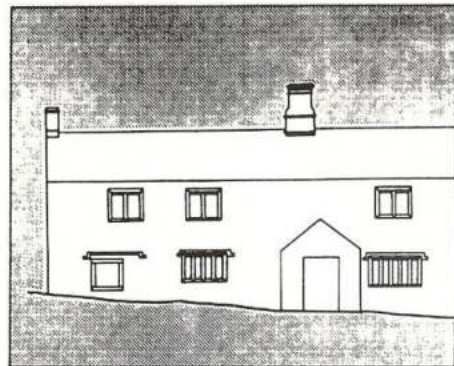
DARNBROOK House. 1664

17th Cent. stone house. Single pile, three cell with single storey porch, converted to double pile by 19th Cent. two cell addition to N. Lobby entry plan, door to E. cell blocked when firehood removed. Unusual internal doorhead inscribed 1B:1664:MB suggests later build has replaced stair turret or service wing. Four and five light windows with hollow moulded mullions and hood moulds.

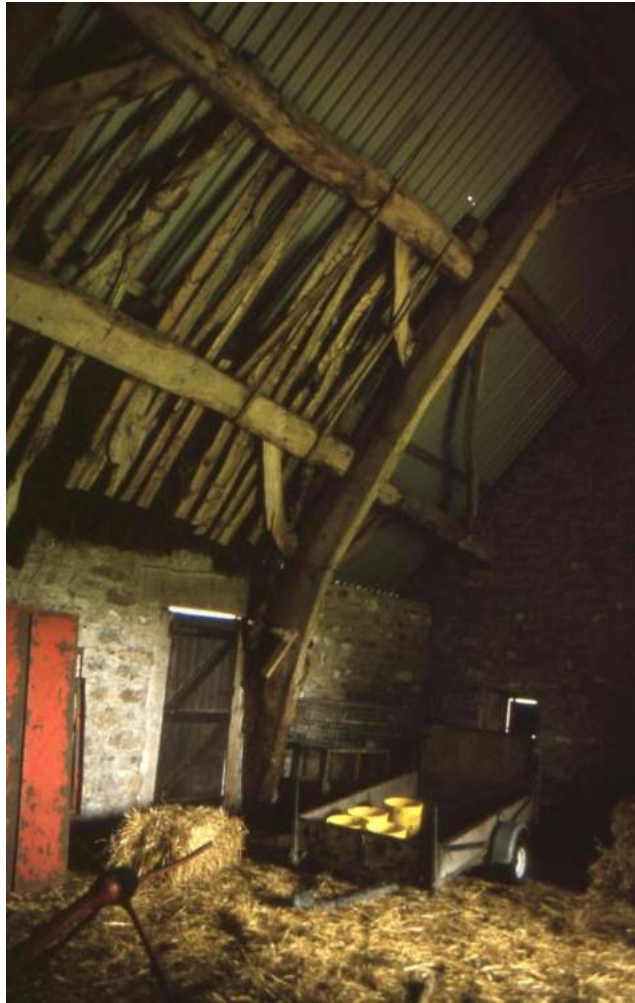
Cruck-framed barn in Barden.
Pre 1600

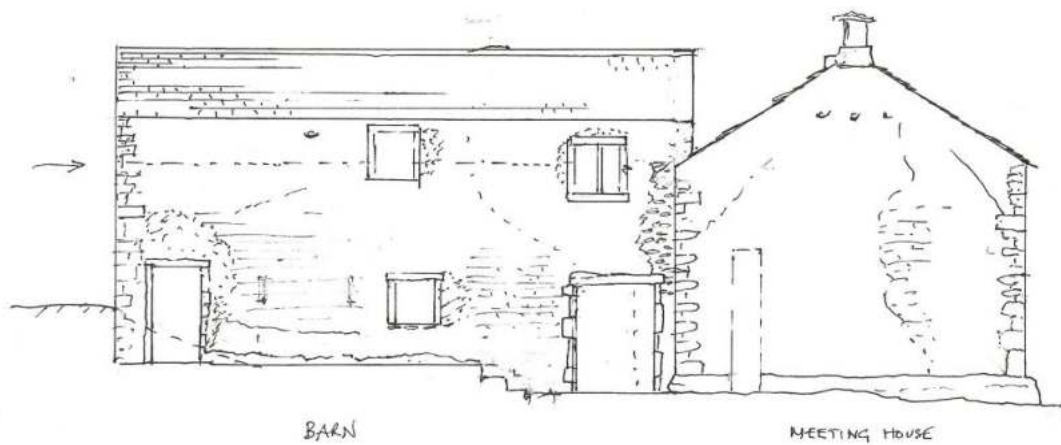
AIRTON MEETING HOUSE: EAST SIDE
0 1 2 3 m.

The east gable

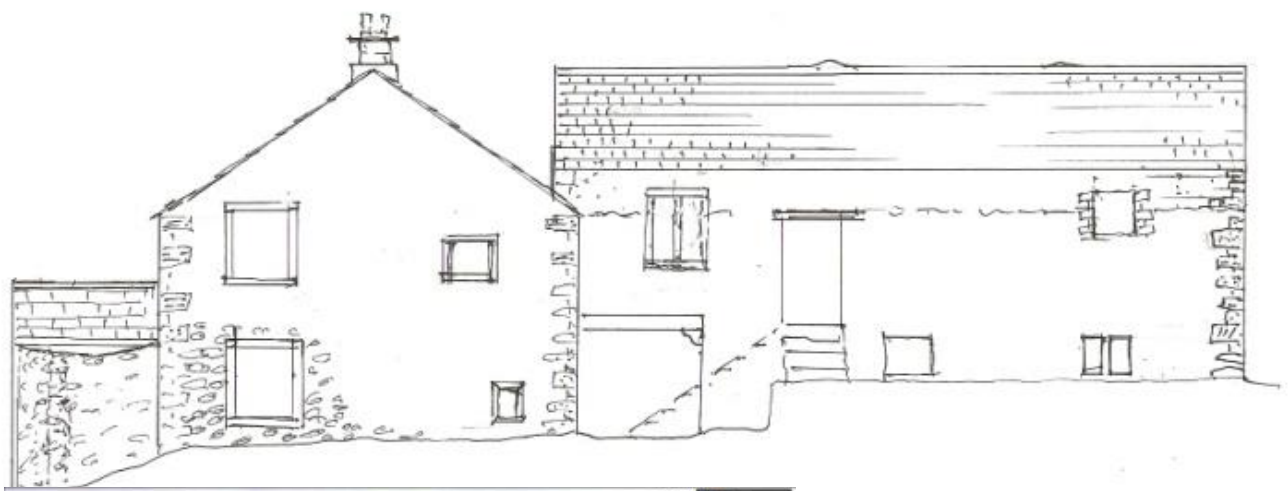
AIRTON MEETING HOUSE - West elevation

Nook cottage and the barn

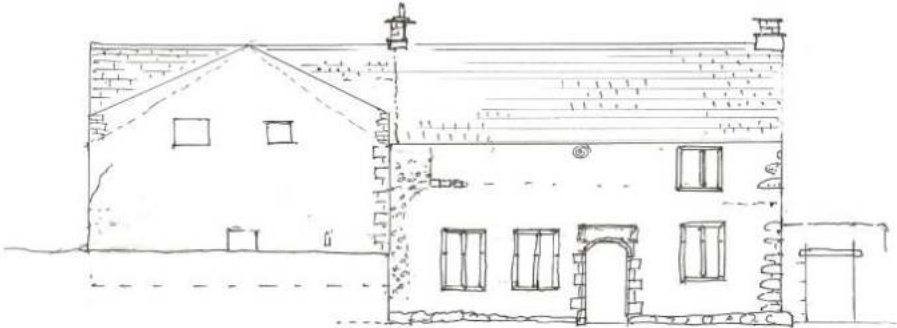
Fig. 1. AIRIDN MEETING HOUSE: SOUTH SIDE
0 1 2 3 4

The south side; showing barn gable and the Meeting House south front below it

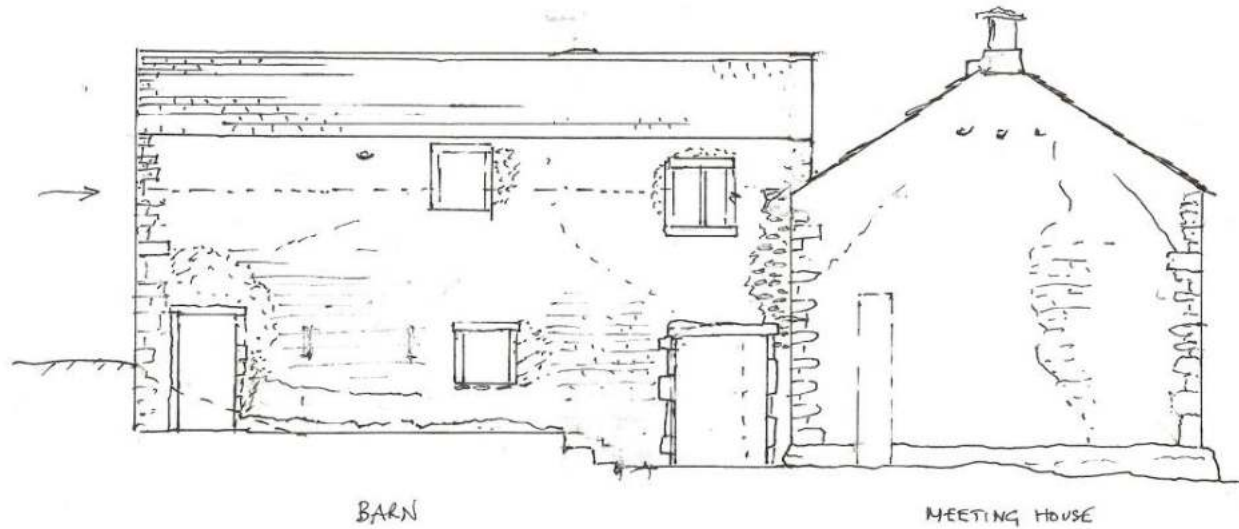
Fig. 3. AIRTON MEETING HOUSE: EAST SIDE
0 1 2 3 "

East elevation of the barn

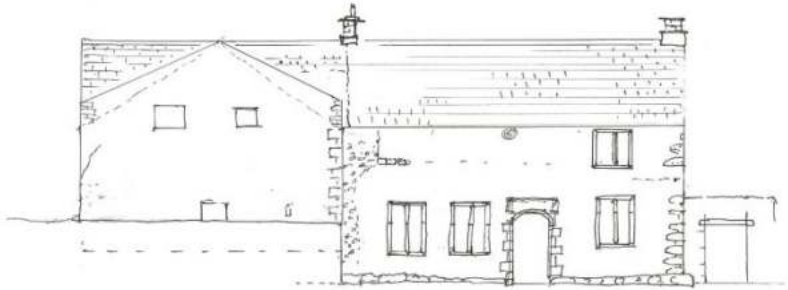
Fig. 1. AIRTON MEETING HOUSE: SOUTH SIDE
0 1 2 3 4

Detail of doors and windows and plinth

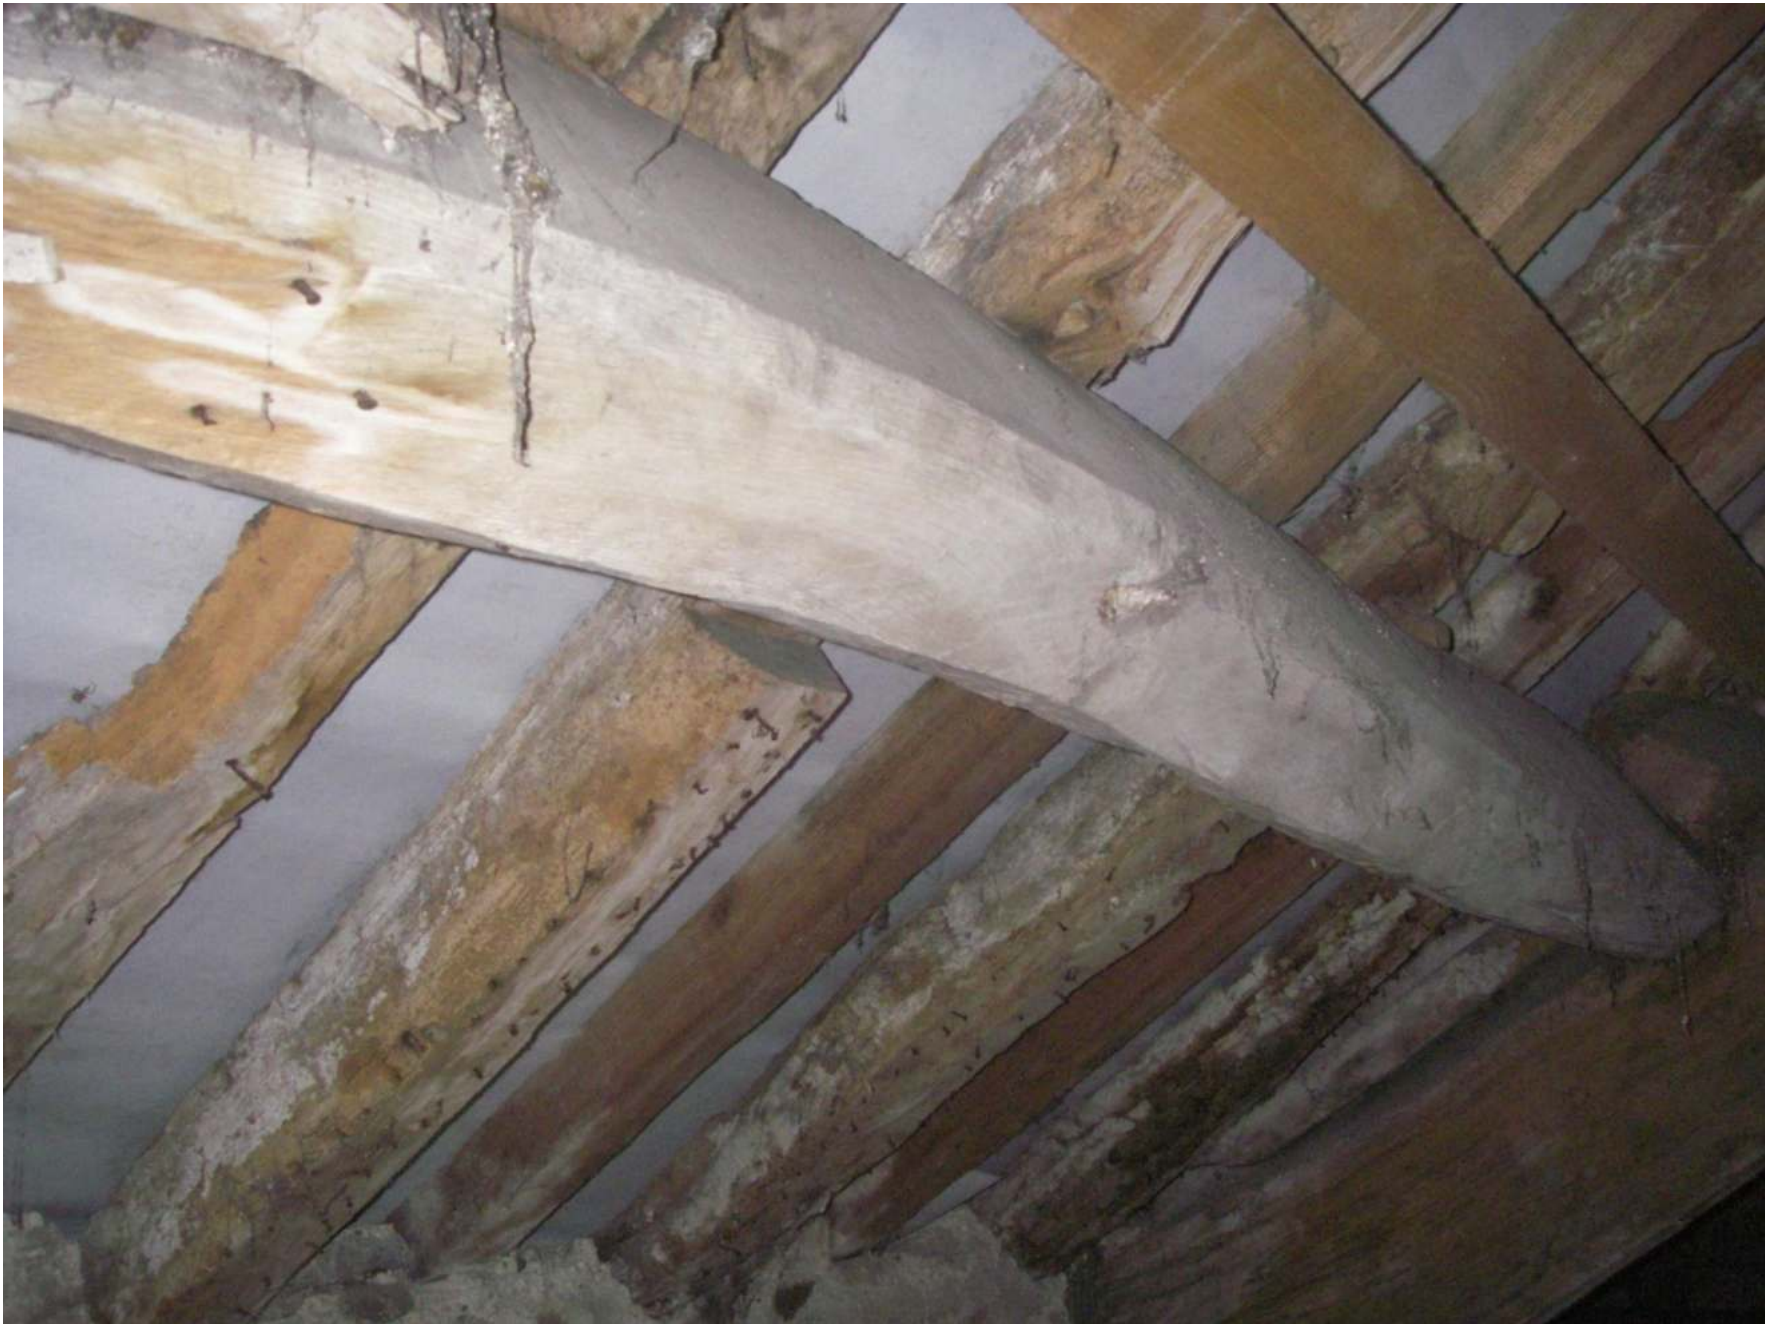
Principal rafter no.3
with roof strut
in a former cruck half-lap joint.

Note carpenter's red chalk
lines surviving.
