IDLP: Stories in Stone

“Boskins, Binks and Bressumers”
Recording vernacular buildings

Craven

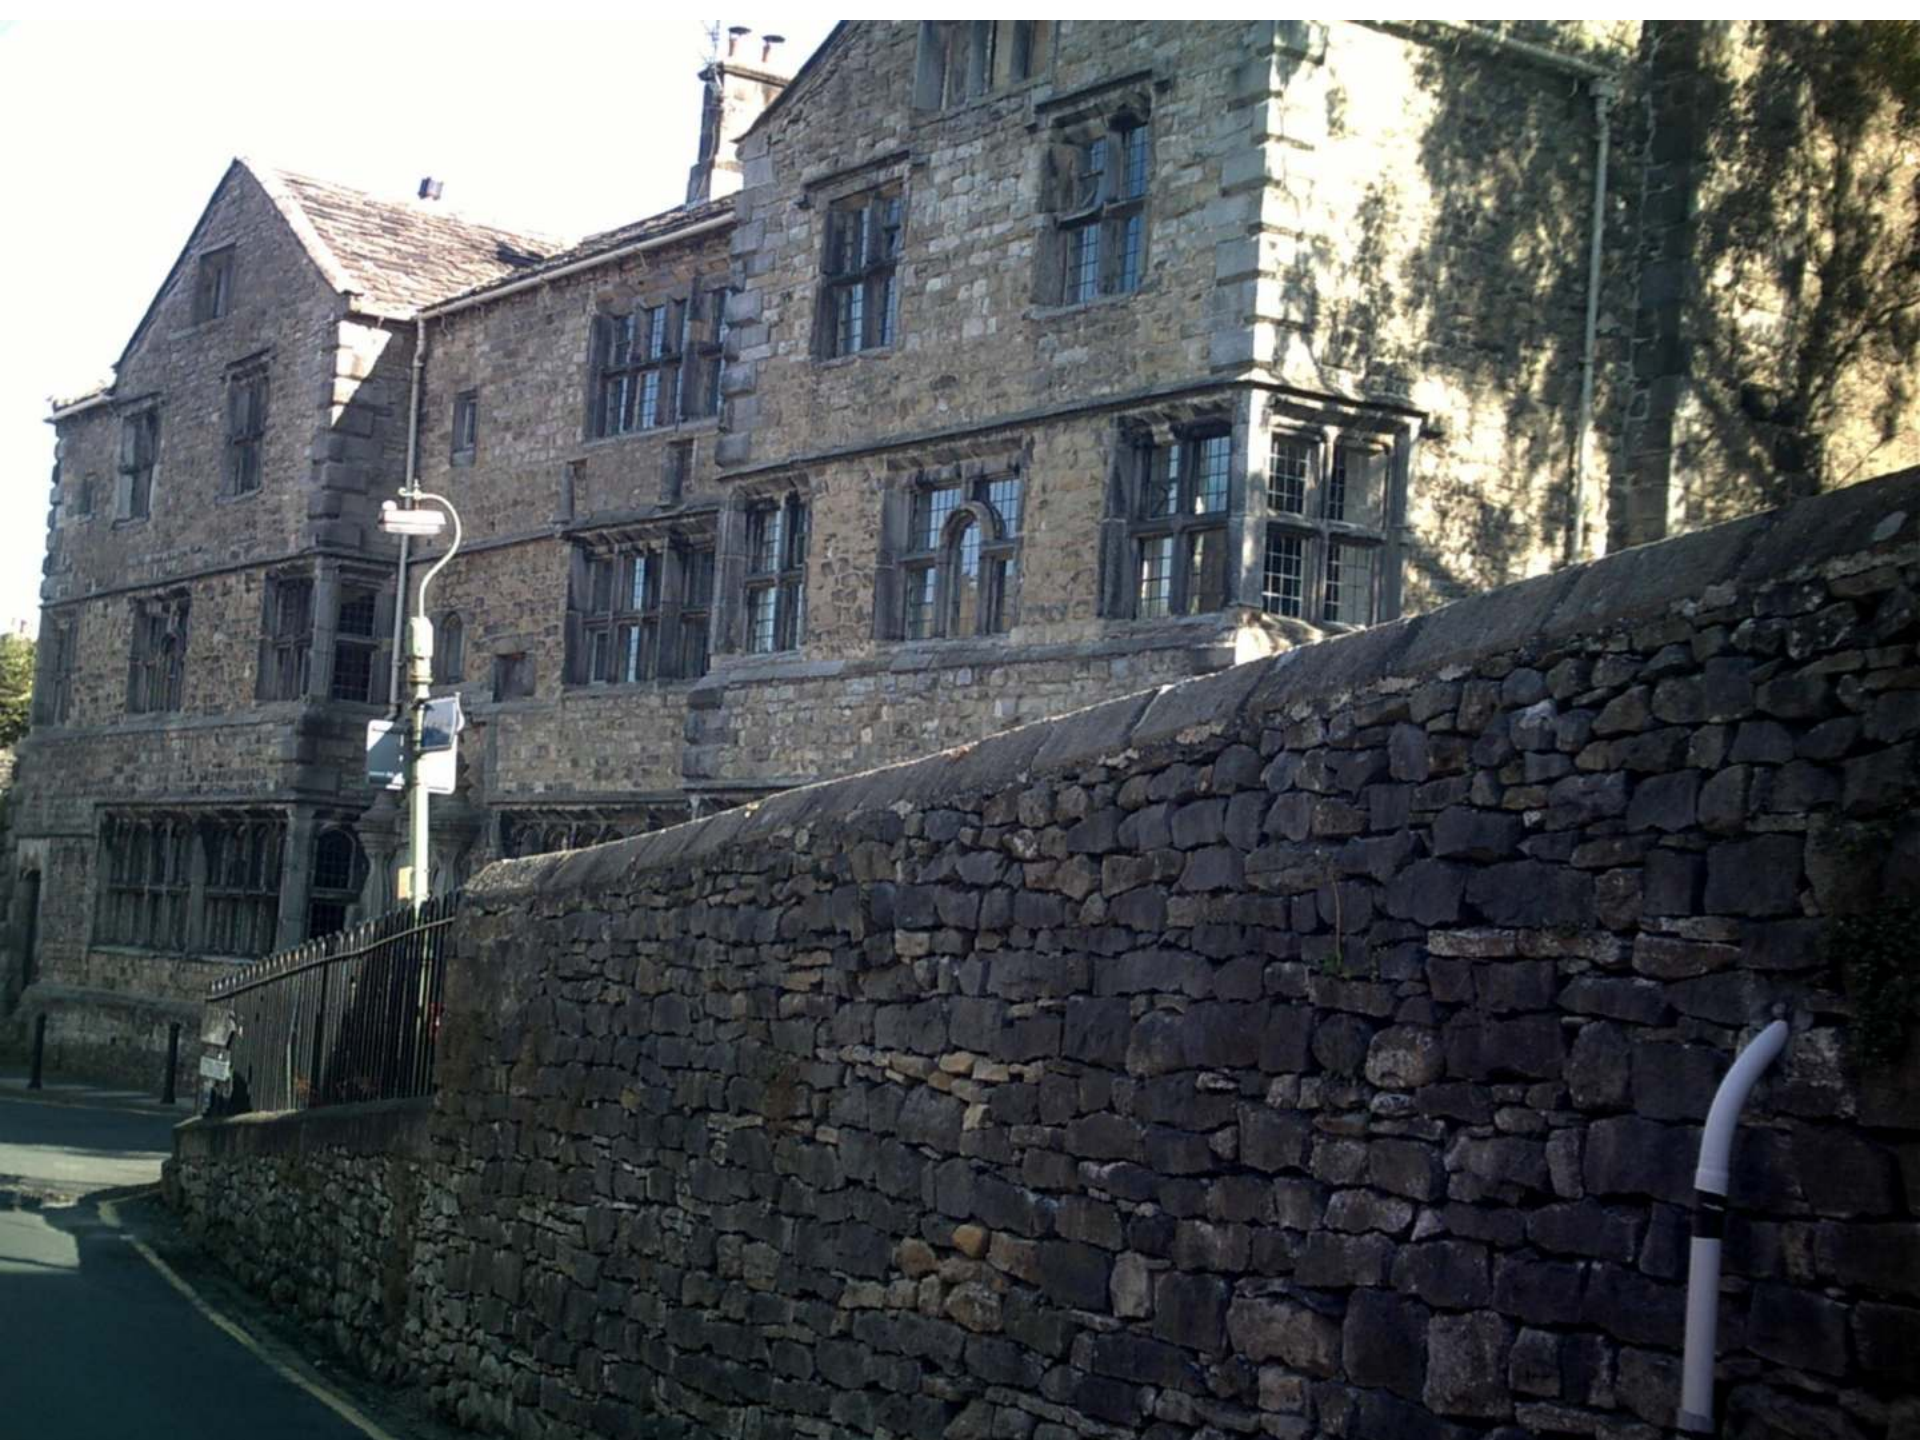
Figure 1

THE FOLLY

Principal (west) elevation and ground plan.
(not to scale)
