Littondale (2003)

SINK HILL BARN

## "HOWLEBECK LAITH"

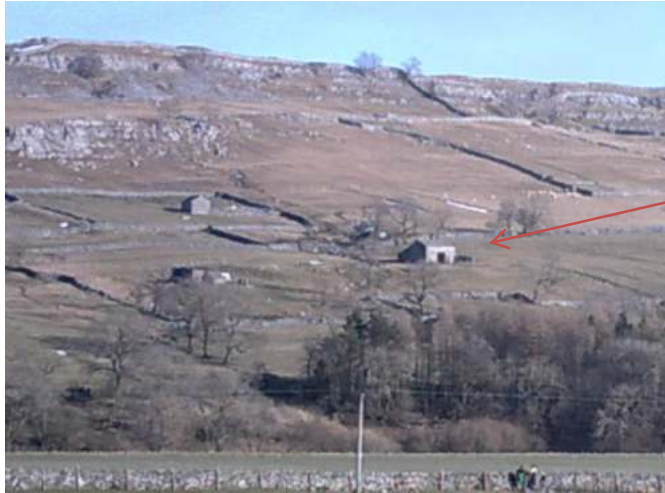
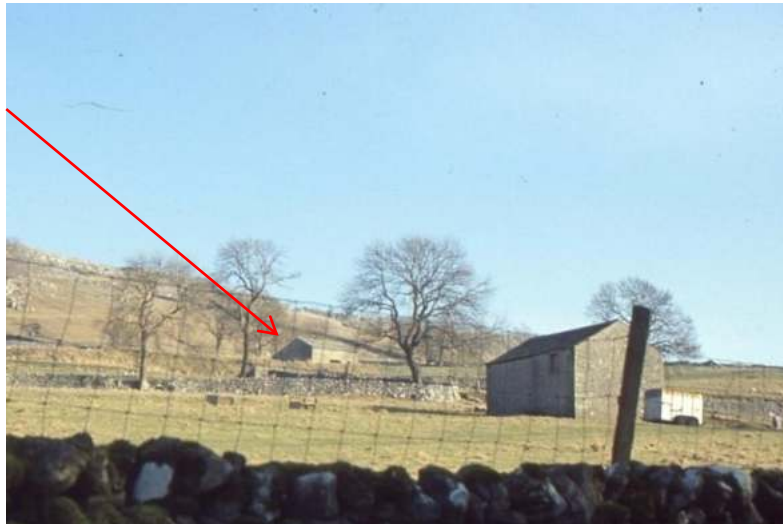
rebuilt by  
Thomas Kidd, mason,  
in 1689 at a cost of £3  
for the stonework

Dimensions marked  
in yards are those specified  
in 1689. Hatching shows  
where walls of that date  
survive.

The top illustration shows the  
likely original appearance,  
although there is no direct  
evidence for the thatched roof  
and the wide doorway.

The bottom illustration shows  
the existing appearance of  
the barn, as recorded by  
Alison Armstrong in 2006.  
There have been many  
alterations from the 18th to  
the early 20th centuries.

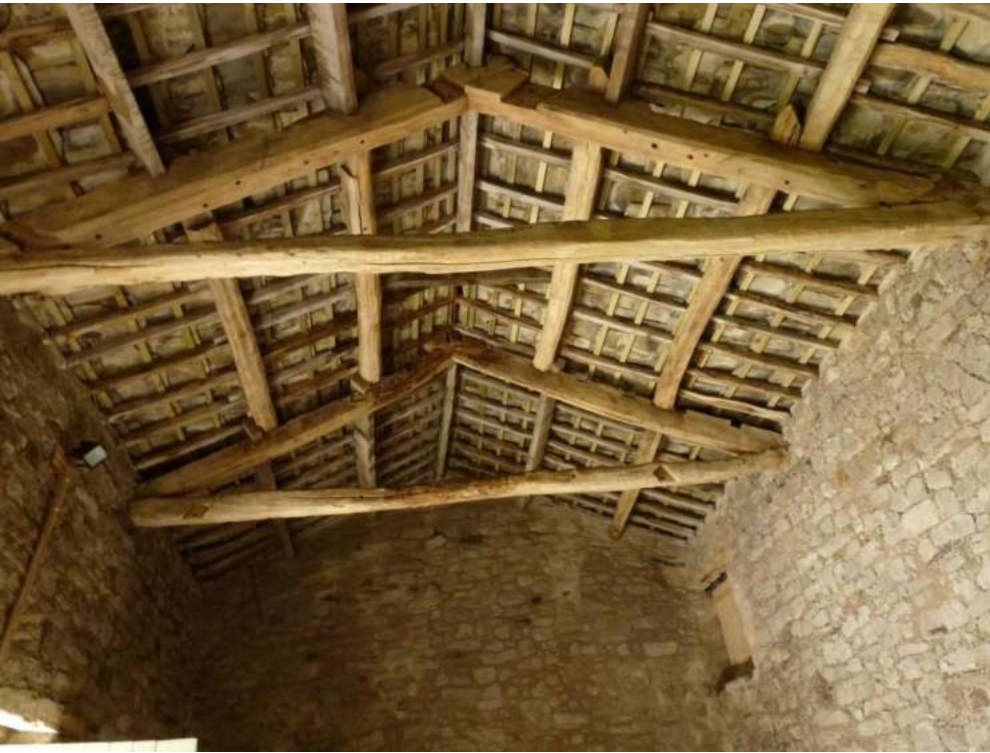
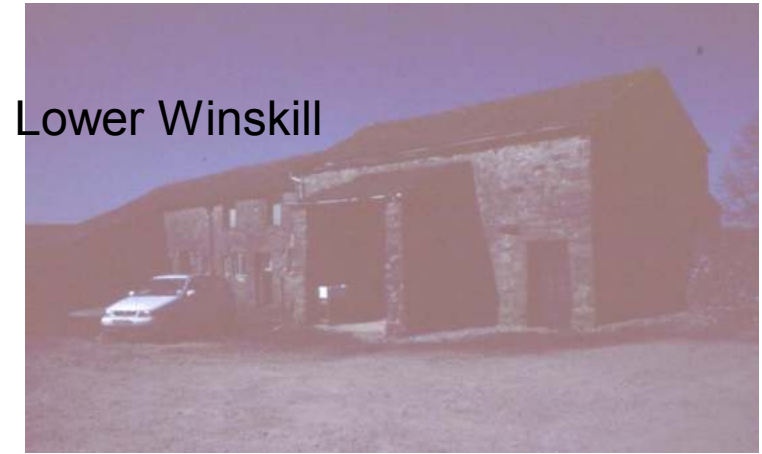
LOWER WINSKILL

Truss at section C<sub>1</sub>-C<sub>2</sub>, in the east barn, showing principals with halvings remaining from their former use as cruck blades. The backs of the principals show where wind-braces in the cruck structure were fixed. The soffits of the principals (not shown) are marked with red chalk lines used by the carpenter when adopting them for re-use in the present truss. All purlins but one (hatched) are plank-like members, the exception being another re-used piece from a cruck structure.

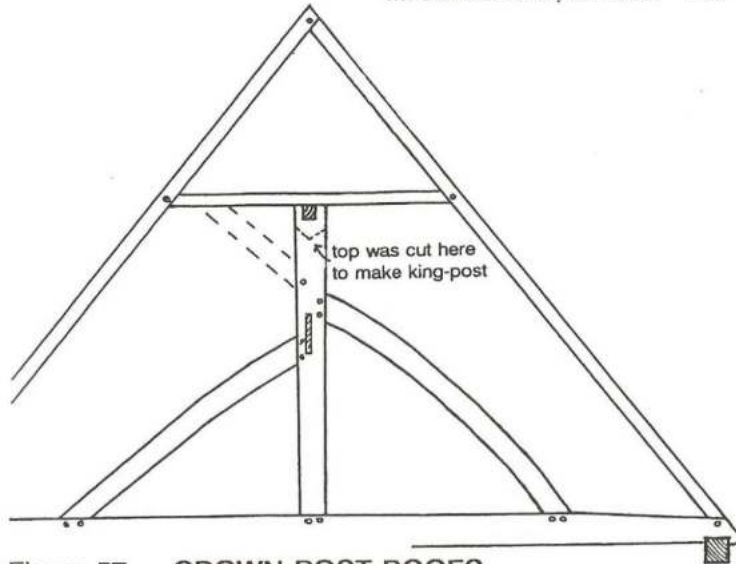
Figure 57. CROWN-POST ROOFS

Test of the hypothesis that king-posts from Aire View Barn (top) and High Bradley Old Hall (bottom) were adapted from former crown-posts. Braces are shown where existing king-posts have empty mortices, and reflect the angle of the mortices.

(Compare king-posts in Figures 25 and 53.)

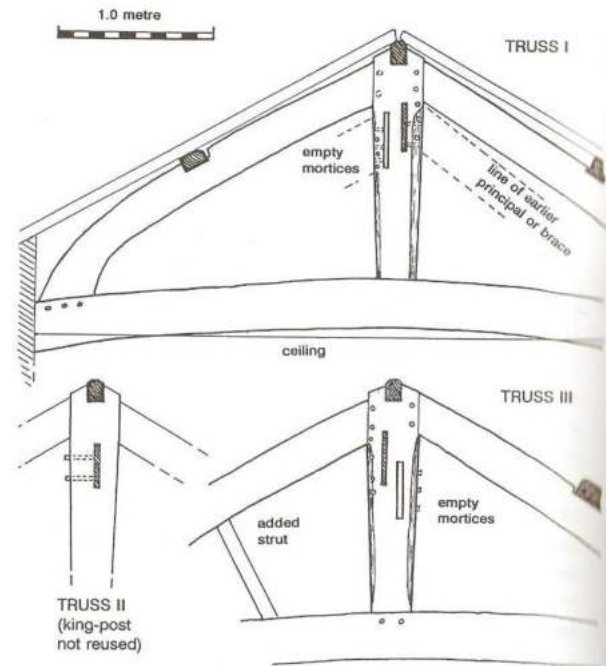
Figure 53.

## KING-POST TRUSSES at OLD HALL

(heavy hatching is where timbers are seen in section; shading is on chamfers)

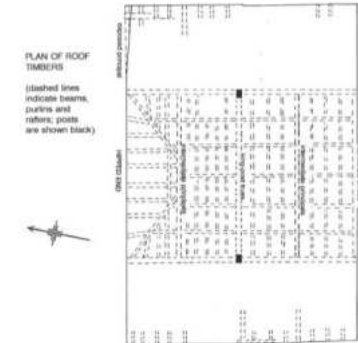
AISLE rafters are shown only where posts are required under them

AISLE rafters shown only where required

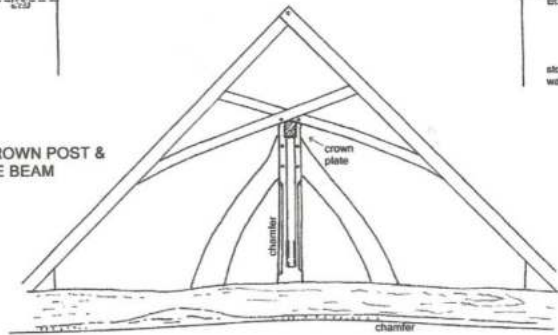
**CARLETON-IN-CRAVEN, RAFTER**

Drawing by Alison Armstrong,  
with details comparable to  
the Gisburn roof noted.  
(not to scale)

The reference to the roof being "open" means that there was no ceiling, and the rafters would all be visible. The impression left by an exposed roof of closely-spaced rafter couples could well be likened to a wicker-work cradle, upside-down. The report by Alison Armstrong quoted on p. 3 mentions rafters of two kinds, one as illustrated on p. 4, and the other from an arch-braced couple, illustrated below. If the latter type were predominant, the cradle effect could have been particularly pronounced.

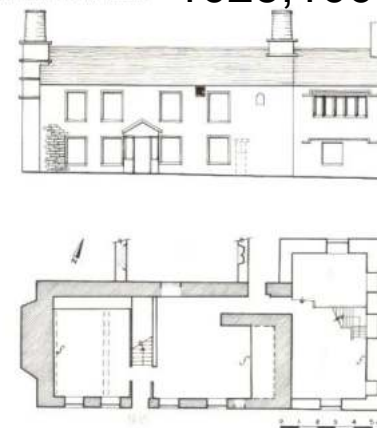
Figure 5.5 Dent, High Hall (543). Large 1625 farmhouse with rubble-walling; one huge external stack and one internal, both fireplaces enclosed inside. Extended by parlour and dairy added at one end, and by rear kitchen wing with another stone-attached fireplace 4m across occupying whole gable end, probably built 1665.

timber firehood in the housestead and a stone-framed fireplace in the parlour. Similar in style and date is a deserted house called Brandon Carr at Bewerley in Niddersdale (296), which had the same heating arrangements. High Hall, Dent (Figure 5.5), beyond the present county boundary to the North-West, is dated 1625 and, at that date had two end chimneys massively built in stone; it was enlarged to more than double the size in 1664. Another early example is Holgate (Figure 5.6), in the fells to the north of Swaledale, and is dated 1632, which may be considered remarkably early for so remote a region. These early examples are all fairly large farmhouses, not cottages, though their size varies from
