Surveying and drawing-up; the tricky stuff...

More training on the how and why
of recording vernacular buildings...

THE KILNSEY PROJECT

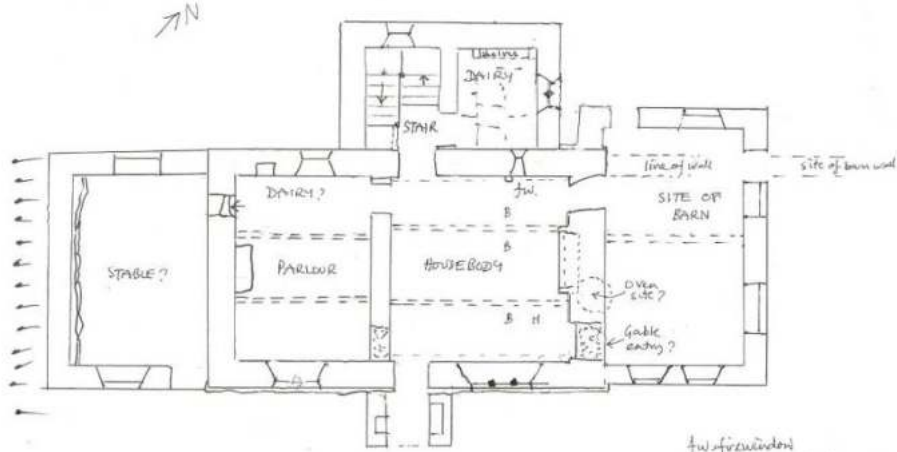
Fig 2 PLAN

GILL HEAD FARM

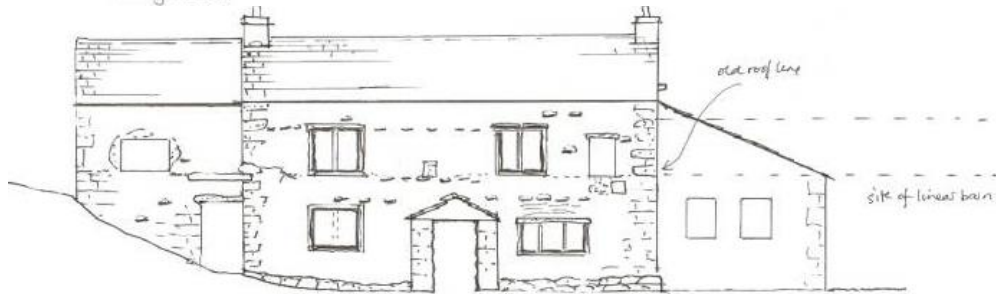
Fig 1 SOUTH ELEVATION

GILL HEAD FARM, SCALES MOOR

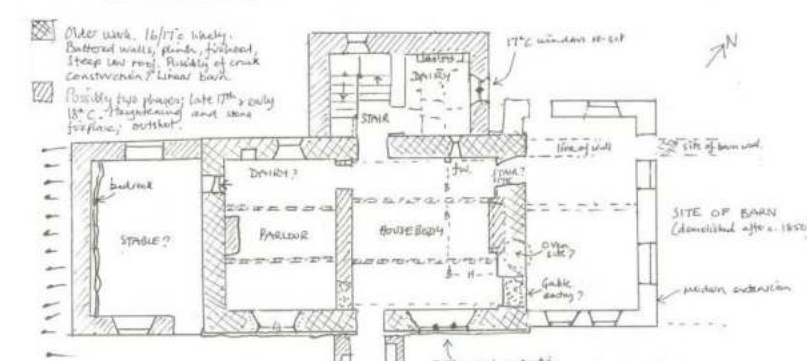
Fig 4 Possible dating

GILL HEAD FARM -

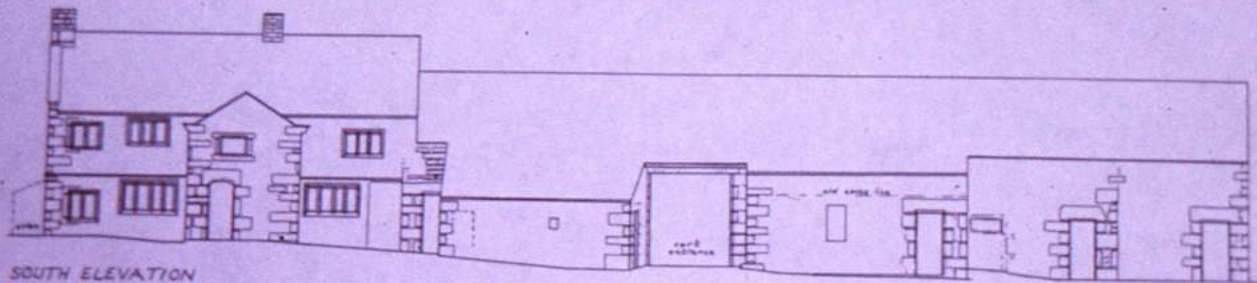
SOUTH ELEVATION

CROW TREES
SILSDEN MOOR SE 025495

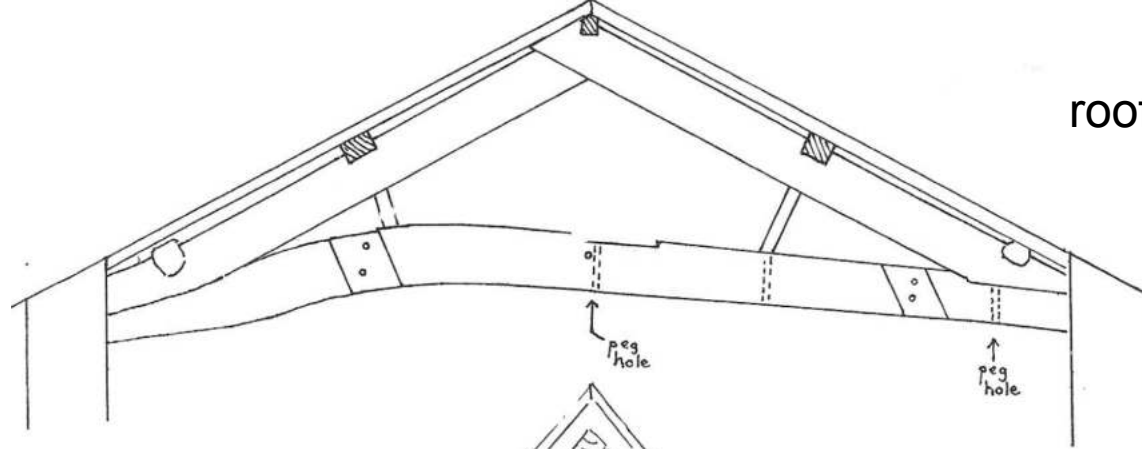
RECONSTRUCTION
cruck blades of the same
size as above fitted into
the width of the
western part of
the existing barn

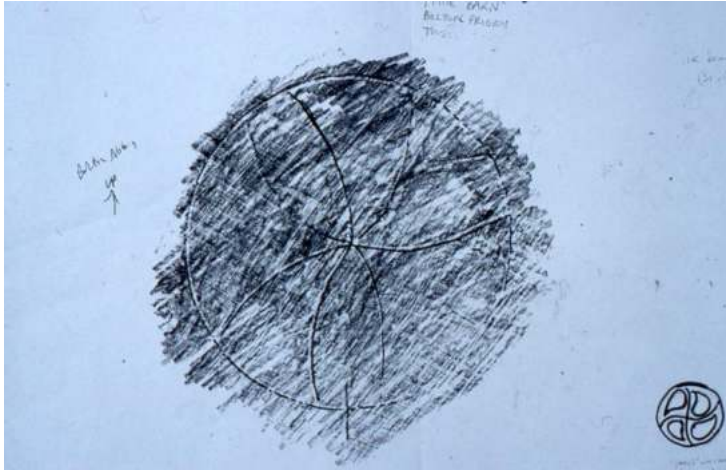
Figure 14
Stonework detail at The Folly

above:
Rubbing of the carving on the soffit of the main door lintel - a pattern of circles overlapping to form a hexafoil at the centre. An "apotropaic" or perhaps just a "good luck" symbol.
below:
Carving on one of two corbels supporting a sleeper beam above the window in the south parlour.

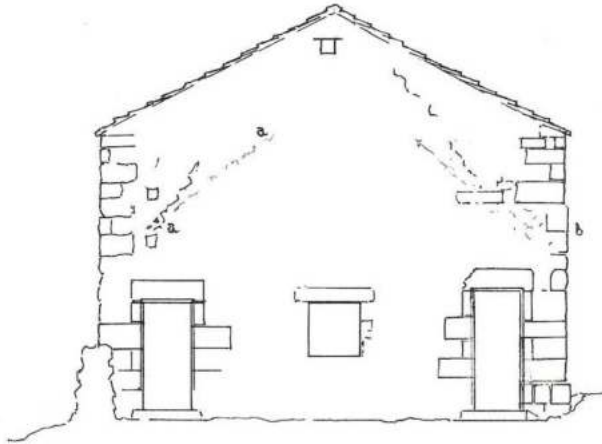
a --- a is a shadow roof-line visible both inside and outside the barr
b is the level of a former eaves line visible on the north side

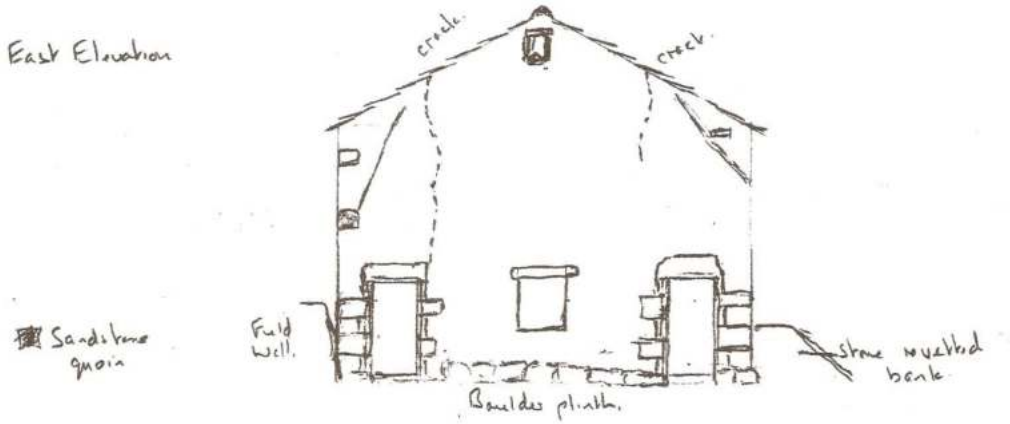
East Elevation

Door chamfers
jamb 10cm
lintels 9/10cm.

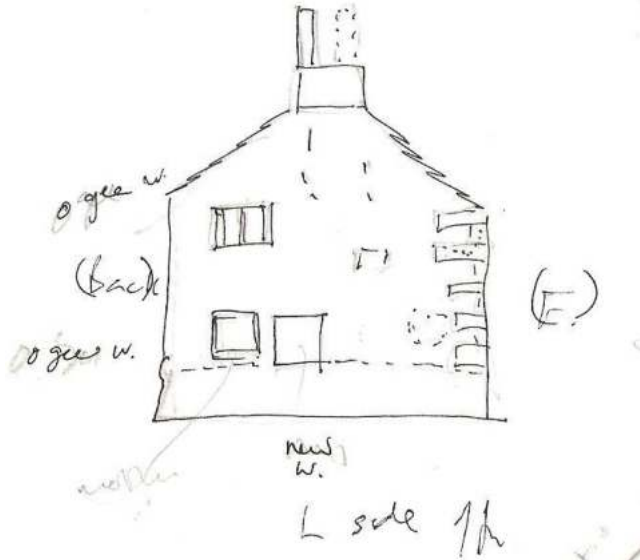
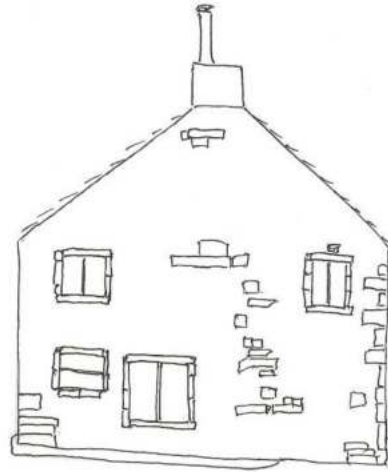
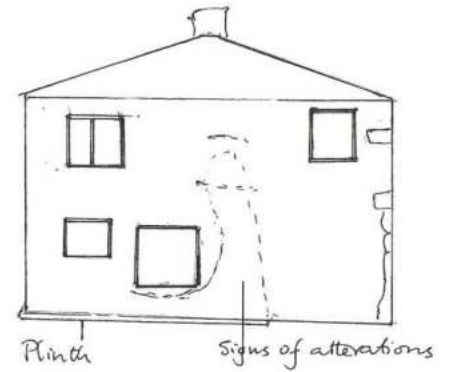
This gable end has a walling feature of stone blocks from the chimney stack and which appear to belong to the insertion of fireplaces when the building became two cottages. The windows include two more of the small ogee mullioned windows like those seen at the front. The lower one has its mullions removed and the sill replaced by a coarse cement in which round beads of glassy slag have been incorporated.

The other two windows are 19/20thC of sawn sandstone. The plinth continues with the ground cut away at the rear. Quoins here are of sharply cut sandstone. Two huge slab quoins lower down occur where the plinth is cemented over. The water wheel for powering medieval fulling stocks or for 17thC lead smelting bellows, may have been near this area and explain some of the massive plinth walling on the gable corner. The leat is shown on the TA map as entering through the gable wall.

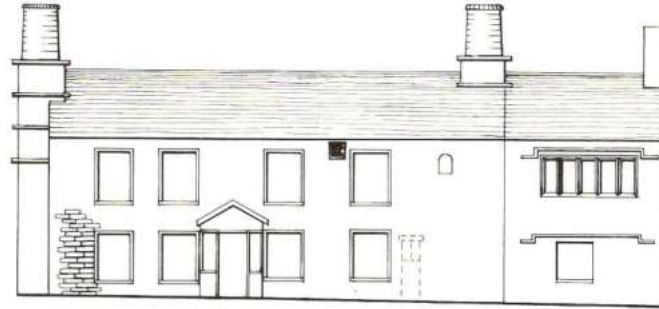
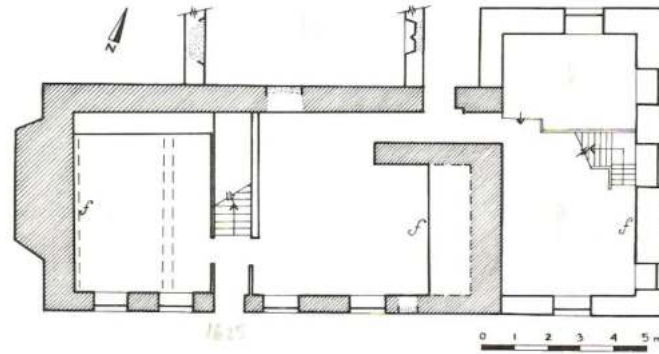
Figure 5.5. Dent, High Hall [543]. Large 1625 farmhouse with rubble walling; one huge external stack and one internal, both fireplaces concealed inside. Extended by parlour and dairy added at one end, and by rear kitchen wing with another stone-arched fireplace 4m across occupying whole gable end, probably built 1665.

timber firehood in the housestead and a stone-framed fireplace in the parlour. Similar in style and date is a derelict house called Brandstone Carr at Bewerley in Nidderdale [286], which had the same heating arrangements. High Hall, Dent (Figure 5.5), beyond the present county boundary to the North-West, is dated 1625 and at that date had two end chimneys massively built in stone; it was enlarged to more than double the size in 1664. Another early example is Holgate (Figure 5.6), in the hills to the north of Swaledale, and is dated 1632, which must be considered remarkably early for so remote a region. These early examples are all fairly large farmhouses, not cottages, though their size varies from
