ARCHAEOLOGICAL SURVEY of NORTON TOWER, RYLSTONE, CRAVEN (YORKSHIRE DALES NATIONAL PARK) and ASSOCIATED LANDSCAPE

A report to Mr J. Caygill

OASIS reference: thebriga1-119134

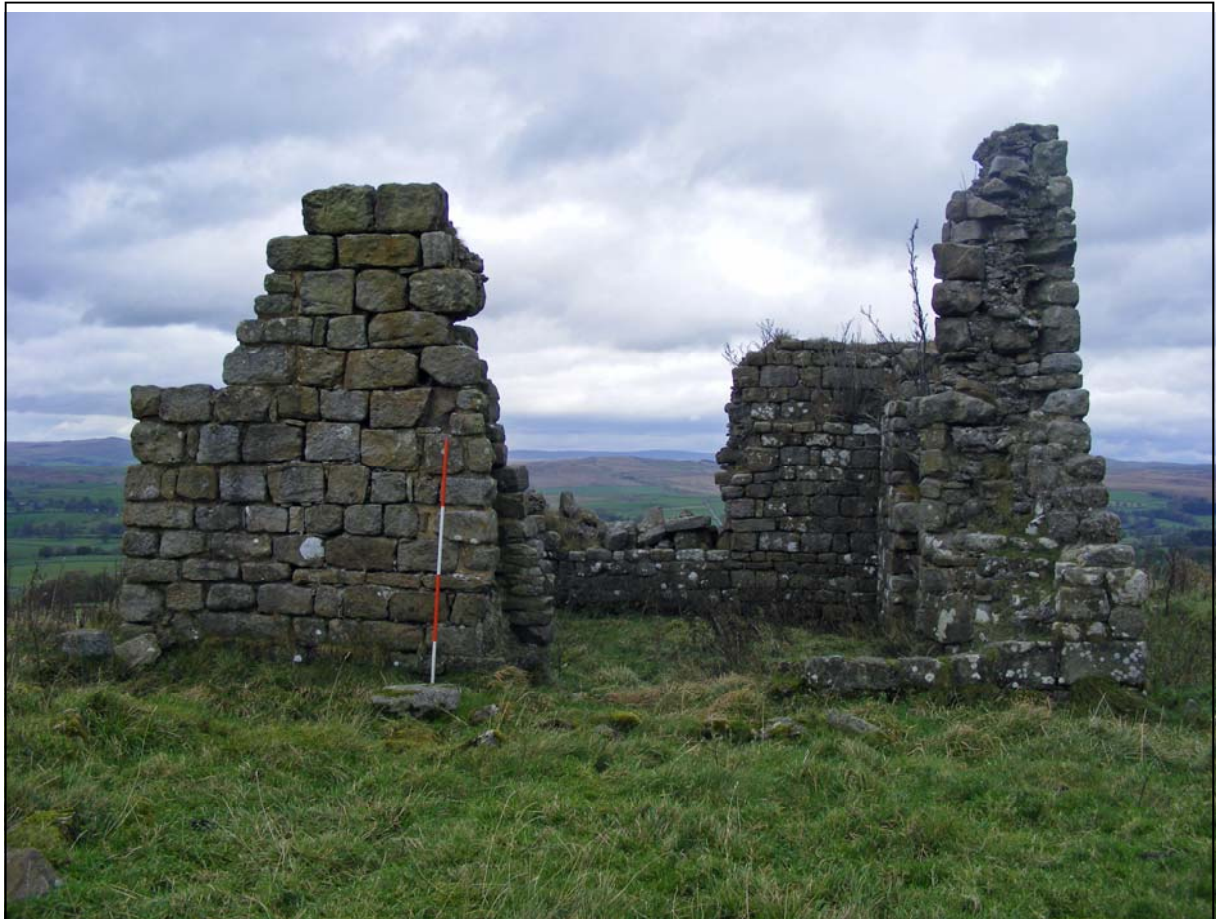
Fig. 6

South elevation: photograph

22. **South side.** The south side of the Tower (Figs. 5 & 6) contains the original, and apparently the only, entrance, though this survives as little more than a gap, with the remains of the left-hand jamb: to the right of the doorway the wall has been reduced to a couple of courses. There is a threshold of boulders, rather worn (Fig. 7). The right-hand jamb has a draw-bar socket (visible in Fig. 8). Outside the entrance, and parallel with the wall, lies a line of stones (Fig. 8) which at first glance appear to represent a porch or outbuilding to protect the Tower's entrance; they are in fact rounded boulders rather than the rectangular blocks used for the building and are part of a wall which runs to the east and is discussed below.

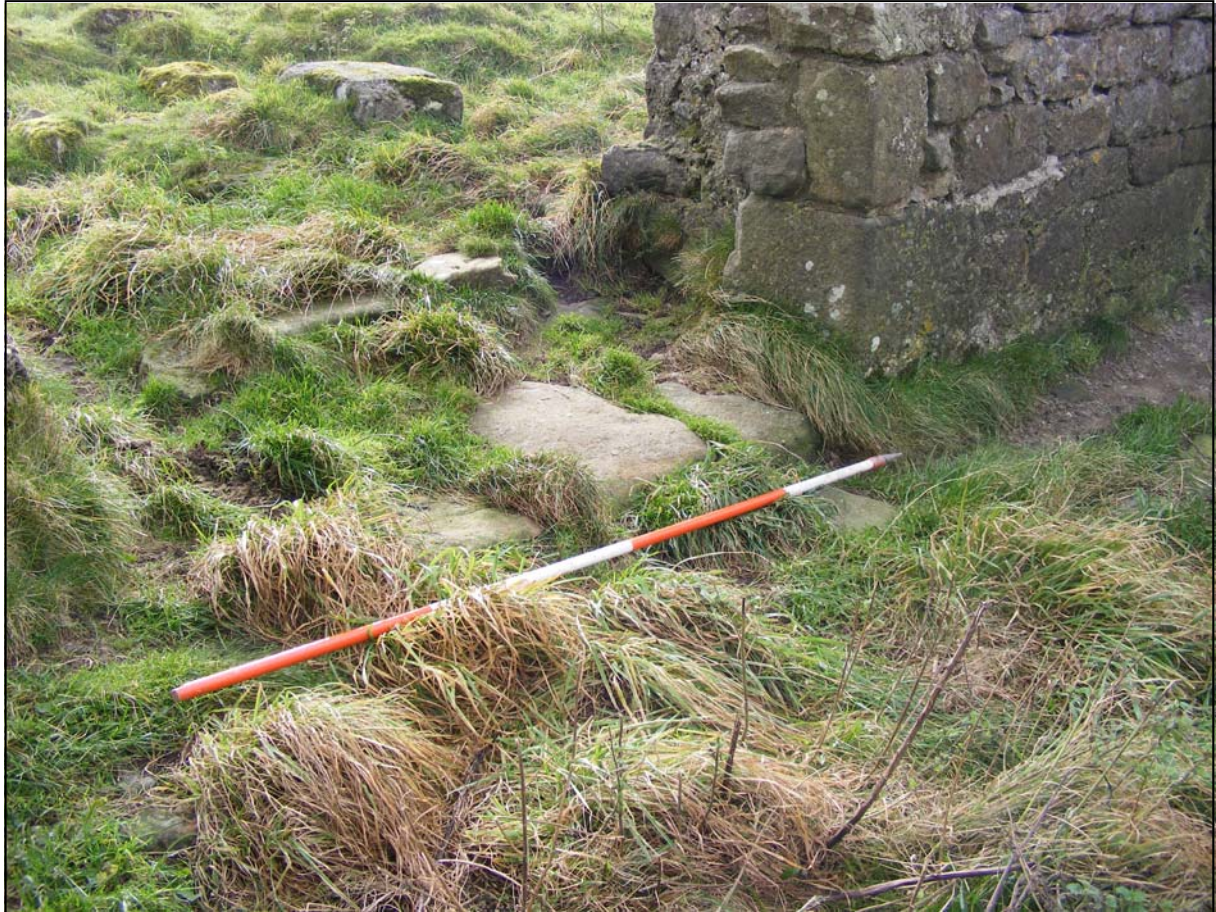
Fig. 7

Threshold seen from interior

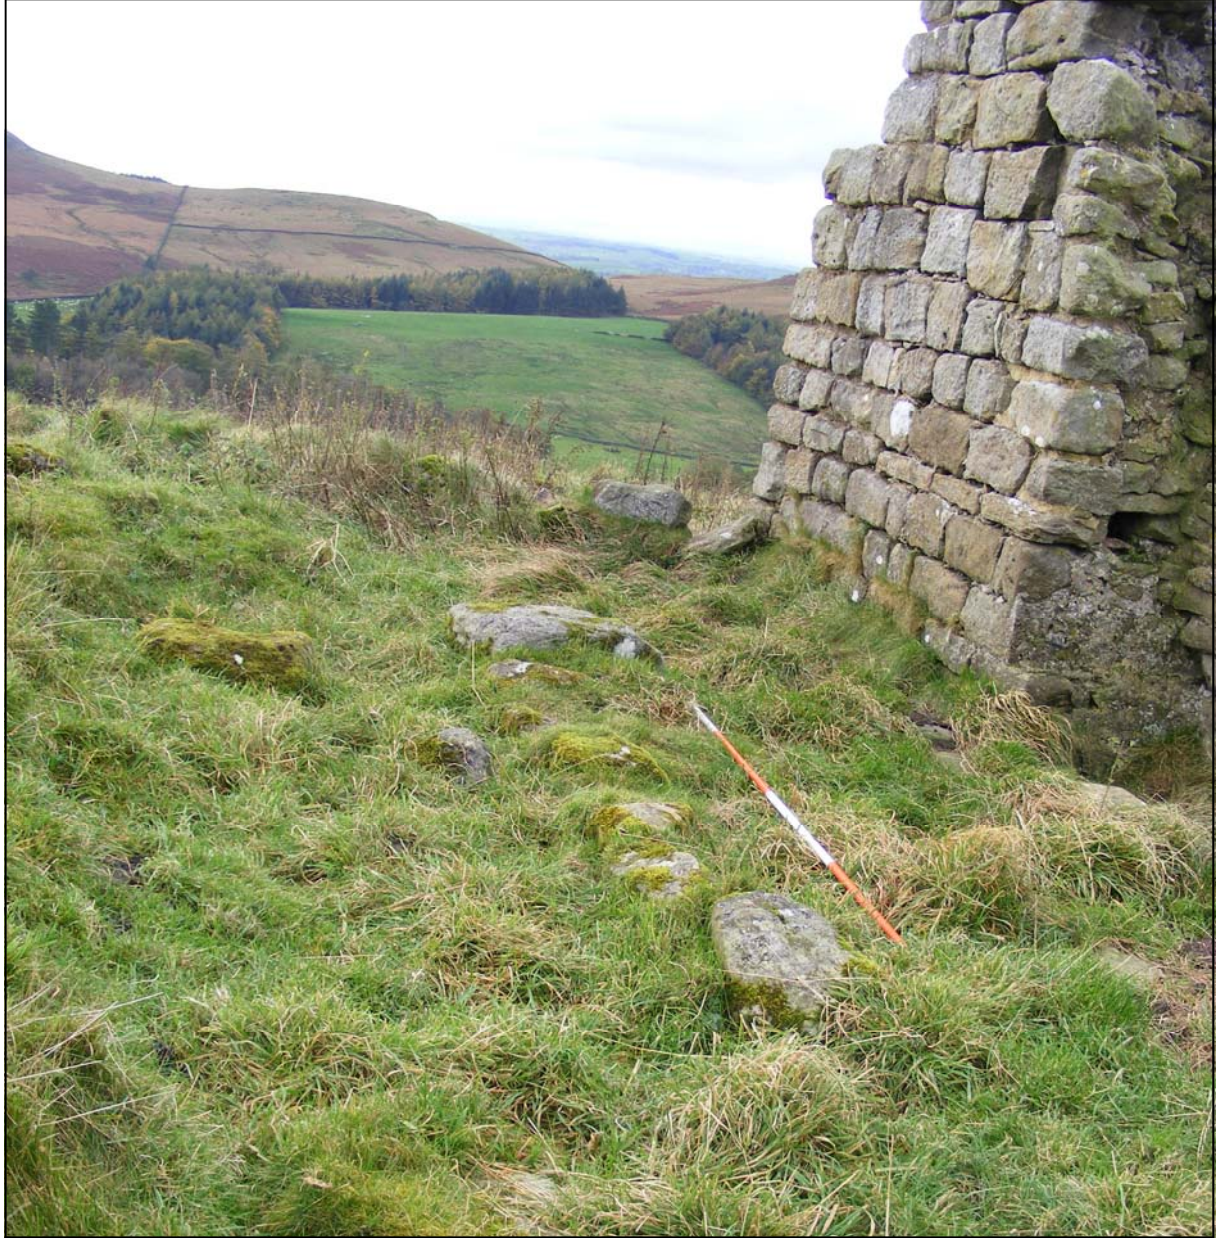
Fig. 8

Wall outside door, showing also draw-bar socket

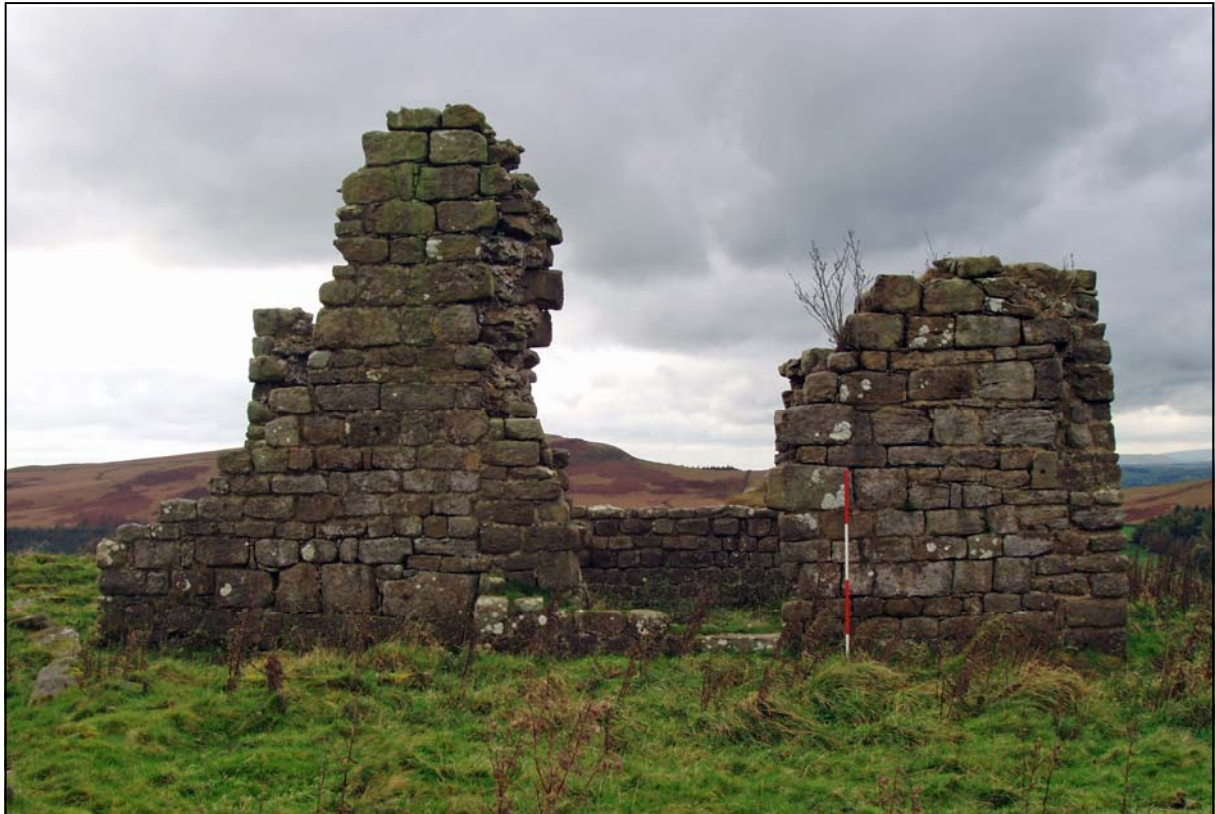
Fig. 10

Eastern elevation: photograph

23. **East side.** The left-hand part of the eastern side (Figs 9 & 10) stands to a height of four metres, and the right-hand side to three. The central part has been leveled to the height of the low, rectangular plinth which projects from the line of the wall (Fig 11), which can only represent the base of a chimney. There is a vertical discontinuity in the coursing of the masonry of the wall above the left-hand edge of this feature (visible adjacent to the vertical scale in Fig. 11), showing the repair of an old collapse of the chimney: this is more evident in the internal elevation and is discussed below.

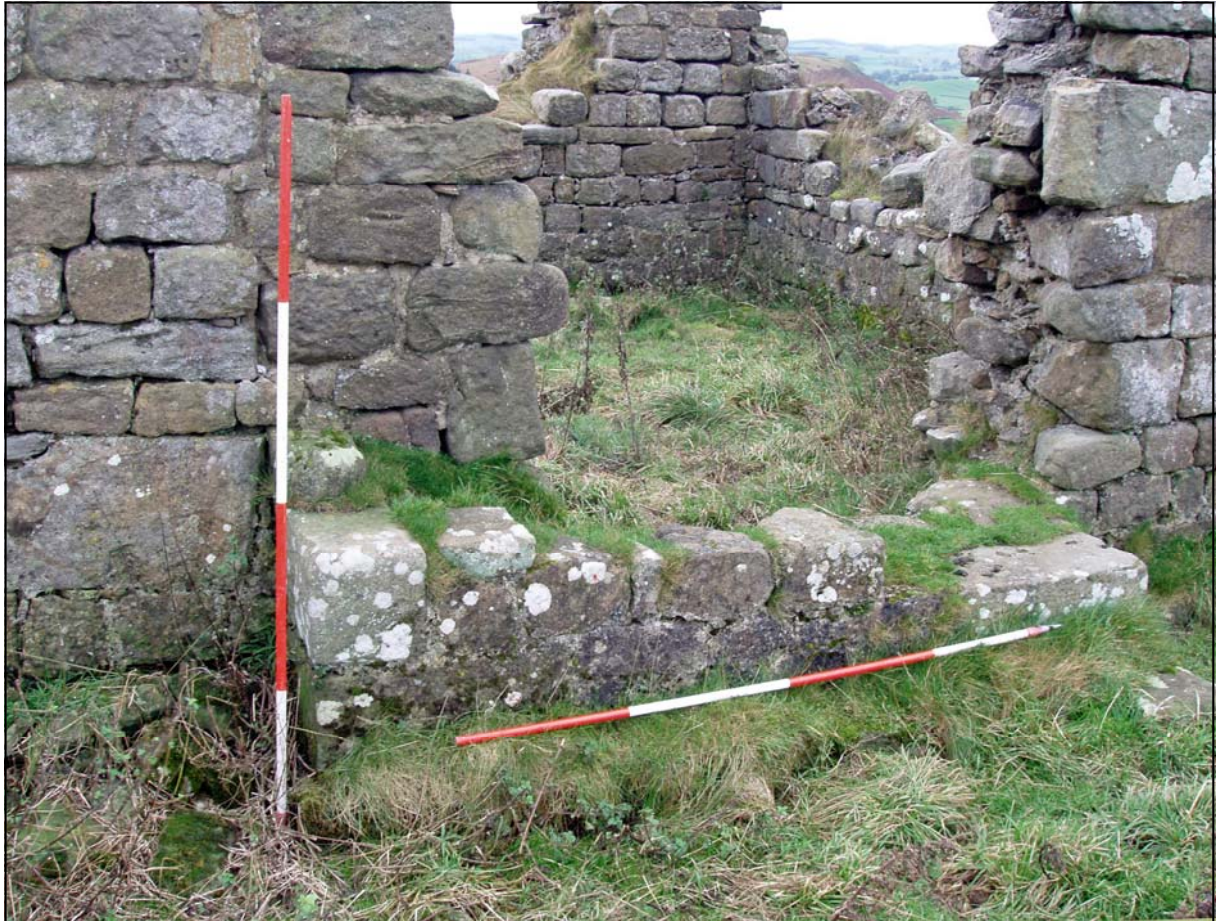
Fig. 11

Base of chimney

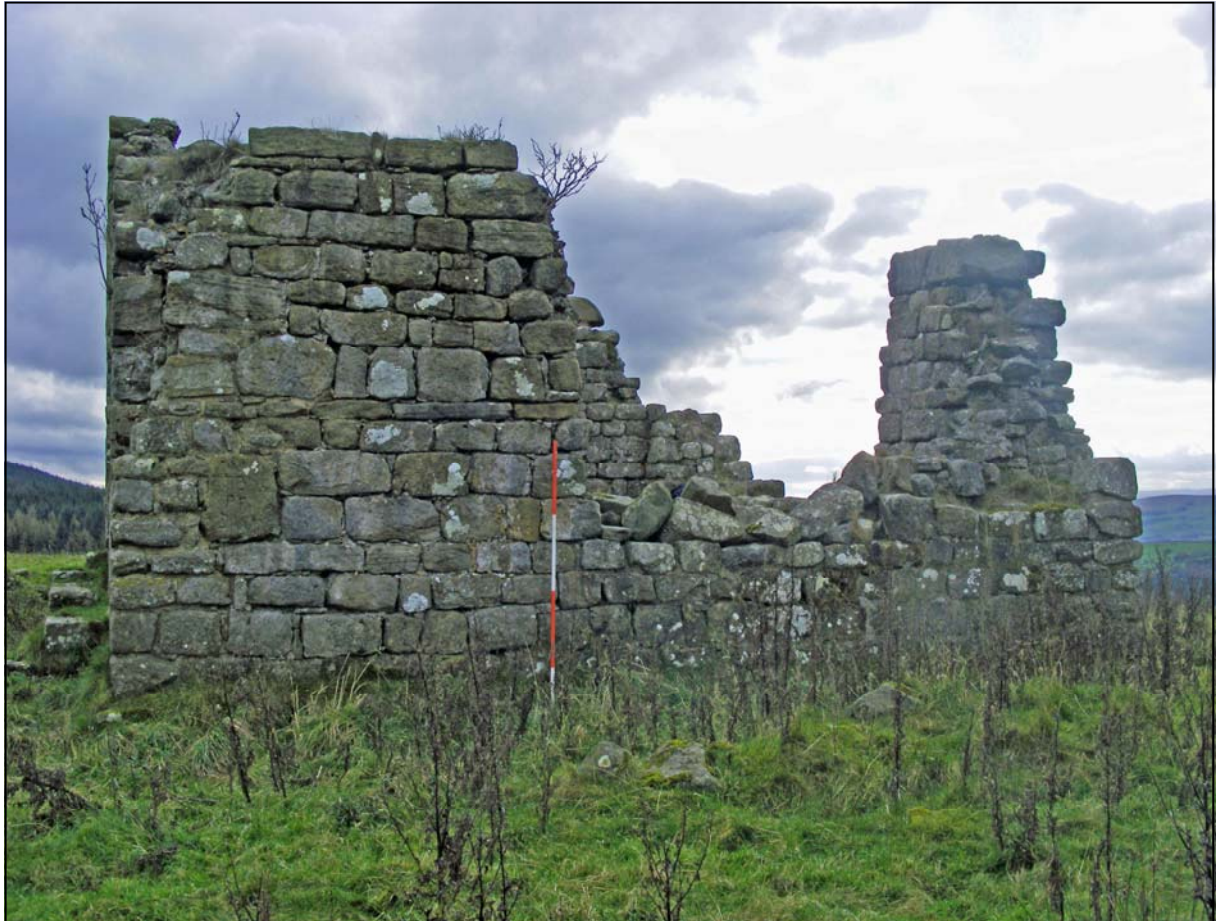
Fig. 13

Eastern elevation: photograph

24. **North side.** The left-hand side of the northern side (Figs 12 & 13) stands to a height of almost four metres, though the rest has been reduced to less than half of that. At just over two metres is a string course or leveling course of thinner stone slabs, quite distinct from the squareish blocks used elsewhere; this feature does not appear on the other sides of the Tower (where the walls survive to that height). It coincides with the internal ledge for support of the timber first floor, and probably represents a recognized stage in the building of the Tower.

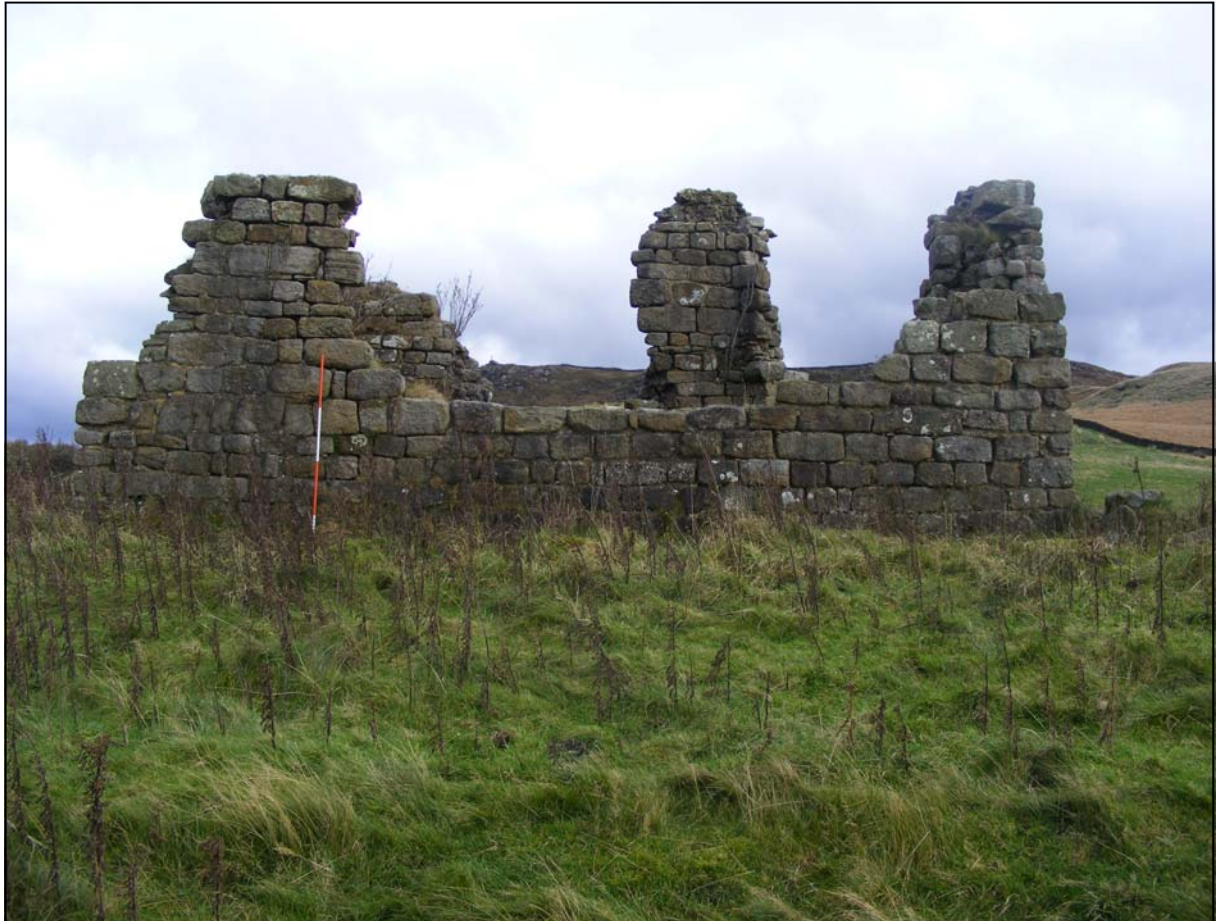
Fig. 15

Western elevation: photograph

25. **West side.** The western side (Figs 14 & 15) has also been reduced in its central part to a height of less than two metres, though it stands higher at the corners. It contains no particular feature of note.

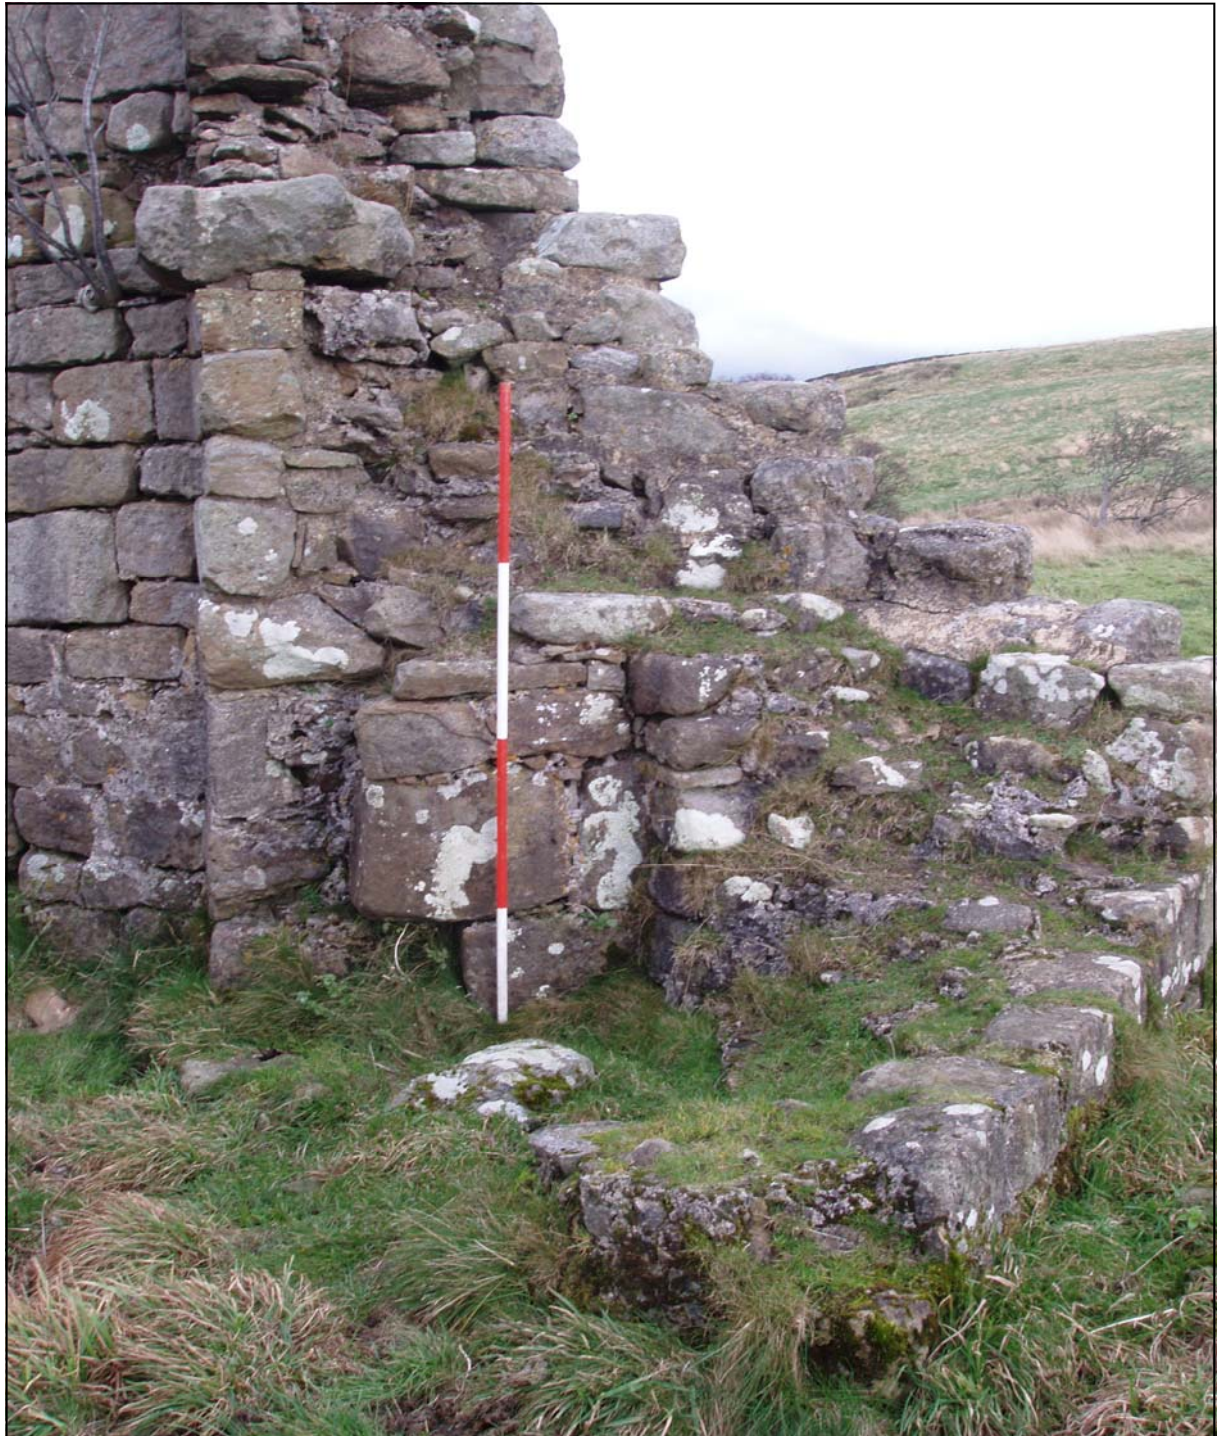
Fig. 18

Detail of stair remains

26. The most striking feature of the interior is the mutilated vestiges of a staircase in the south-east corner (Fig. 18). Little survives beyond the left-hand jamb of the stair entrance; elsewhere, facing stones have been lost and wall-core material exposed. A single block at the corner (Fig. 19) represents the only piece of worked stone to survive in the entire building; it still bears patches of what appears to be original render.

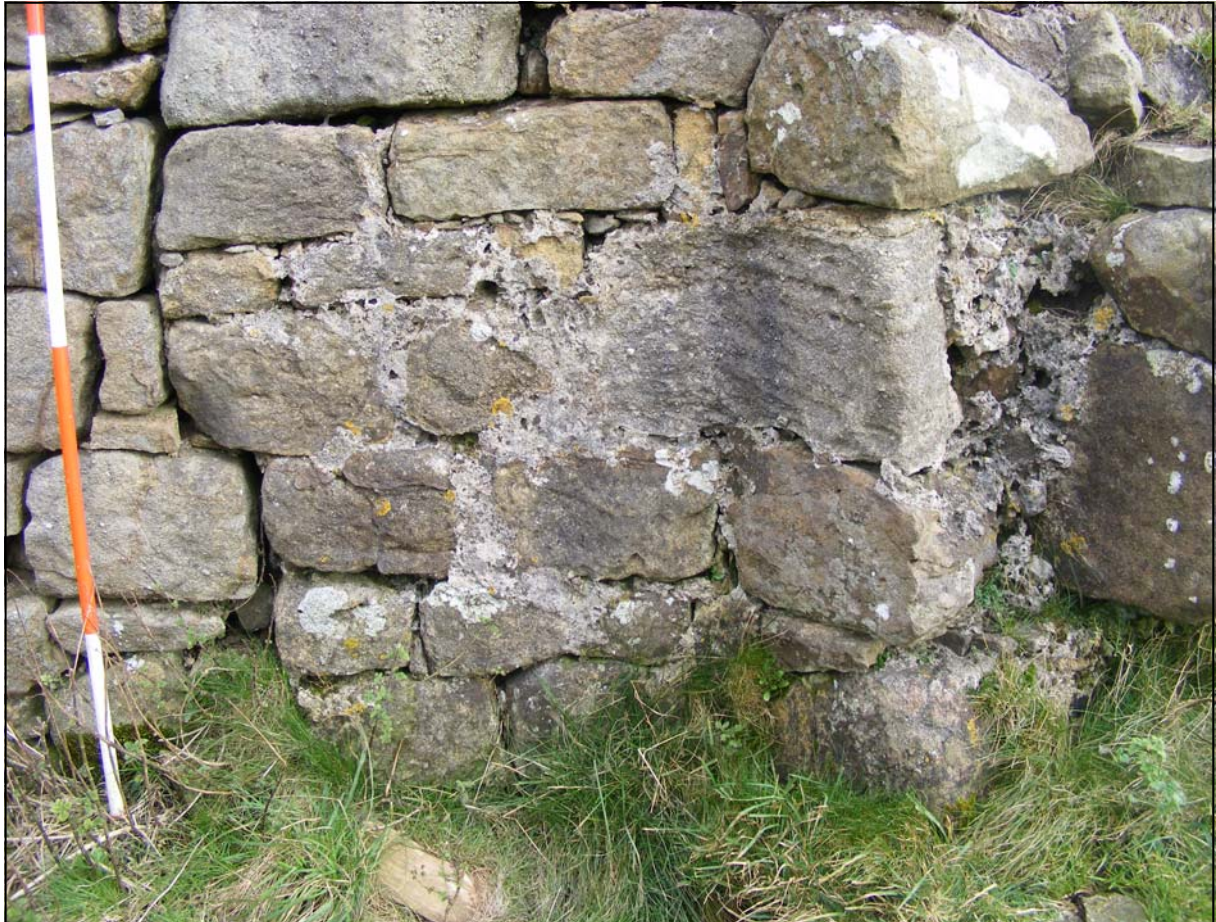
Fig. 19

Detail of stair corner

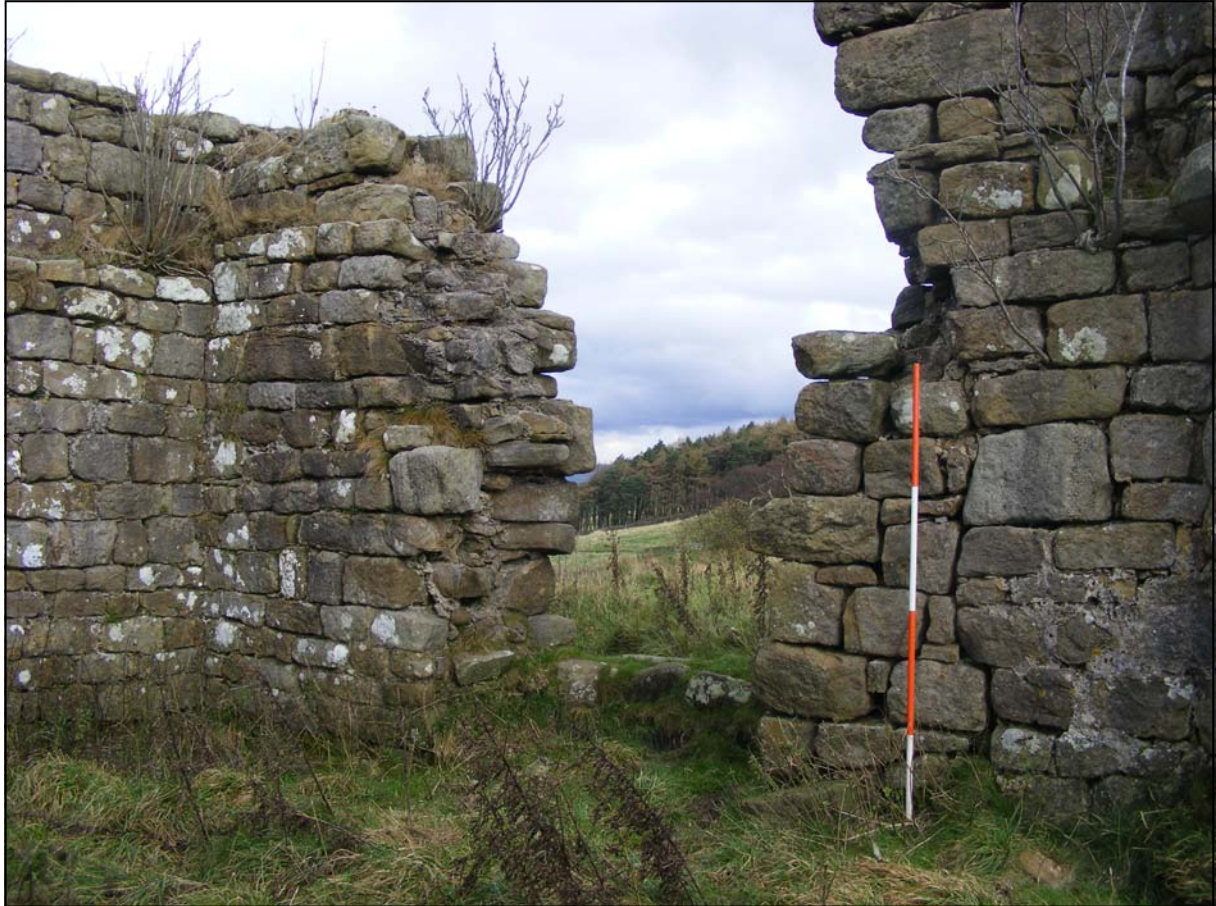
Fig. 19

Detail of stair fireplace (internal)

27. On the eastern side, the central area which formerly contained the fireplace has been reduced to ground level, leaving only the base projecting outwards from the wall. Fig. 20 shows the vertical discontinuity (just to the right of the scale) which may be interpreted as a rather clumsy repair after collapse of the fireplace wall; it does not represent a partial blocking or contraction of the fireplace, since it corresponds to the southern edge of the fireplace's external projection and apparently respects the full original width of the feature. At ground level, and almost entirely covered by vegetation, the area of the gap is paved by large sandstone slabs which must be the original hearth-stones.

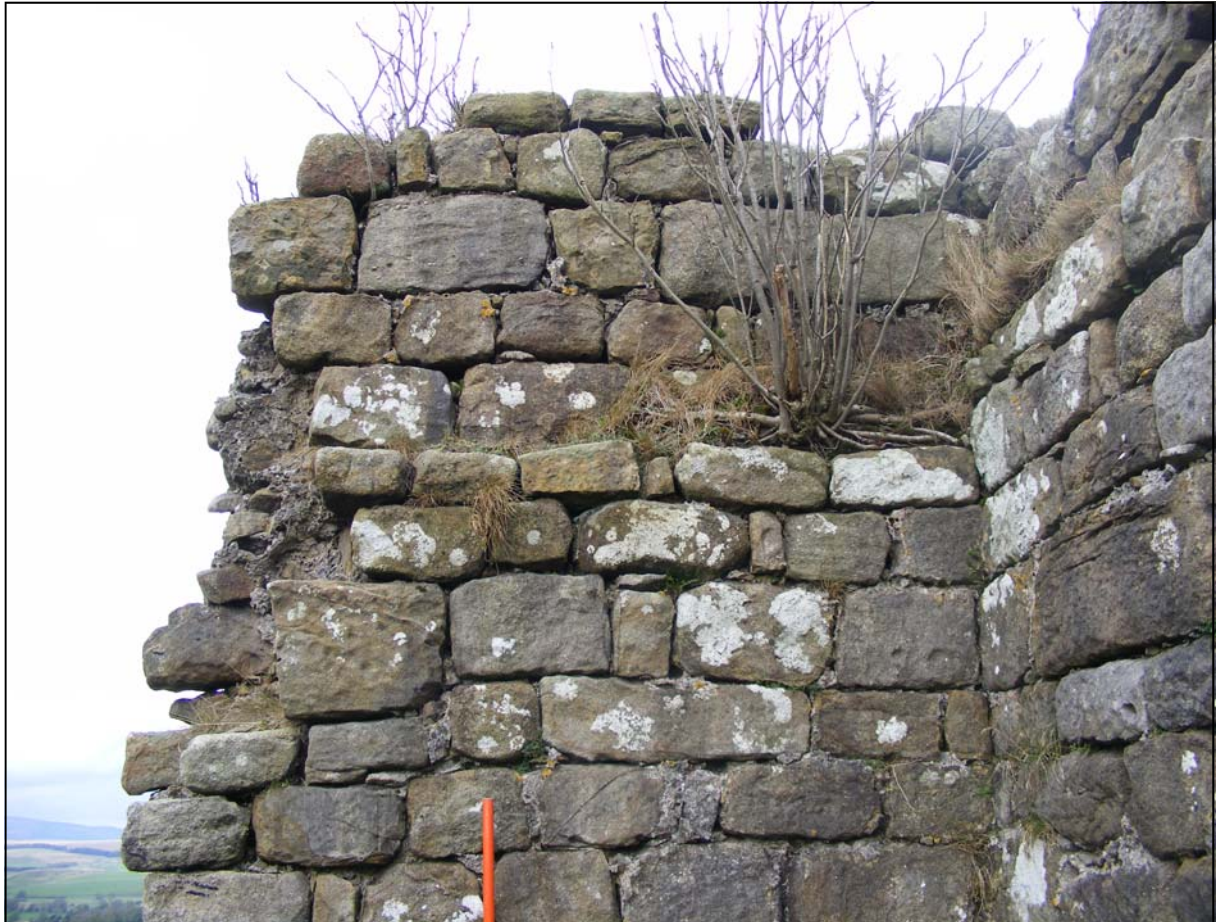
Ledge for floor timbers

28. Where the wall survives above a level of 2.25 metres, the ledge which formerly supported the timbers of the floor above may be seen. Fig. 21 shows it in the north wall, with a sycamore seedling sprouting from it; on the right return wall it can be seen on the eastern side, at a level some 15 cms higher than on the northern side. This may indicate the use of a lattice of crossed beams, those above supported by lower beams of a thickness of circa 15 cms.

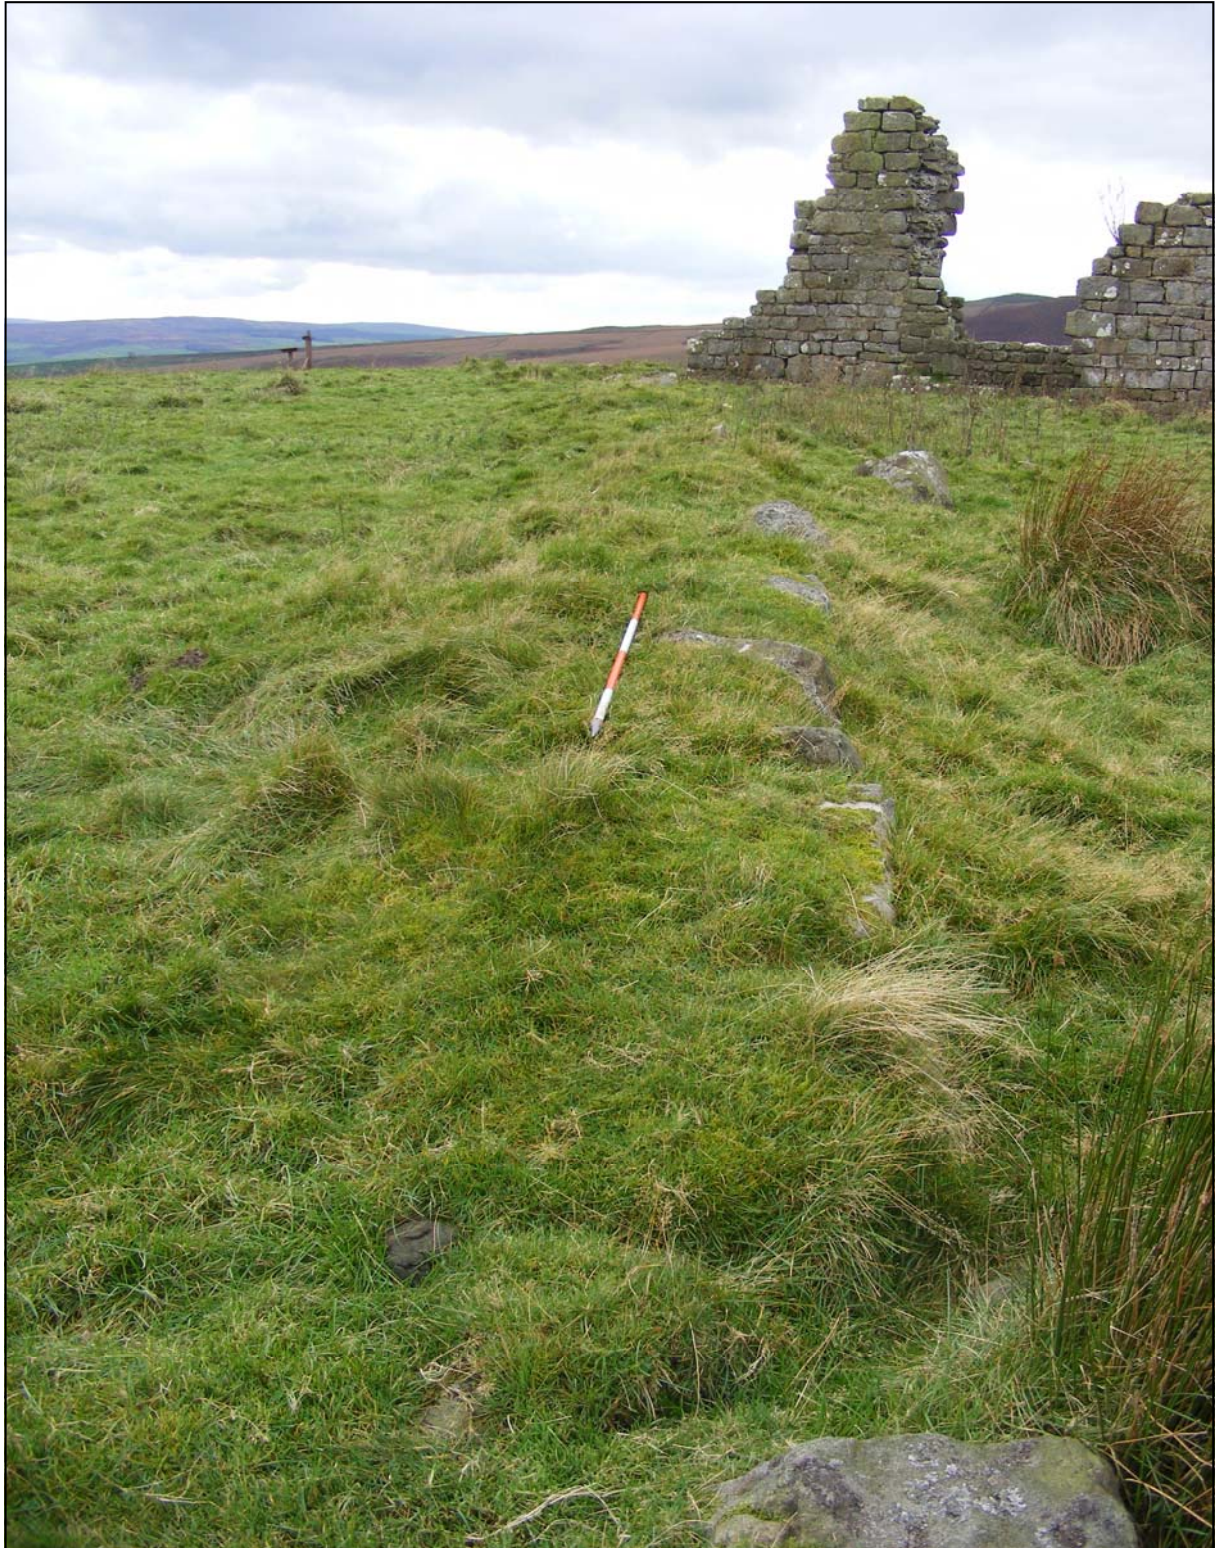
Fig. 23

Old wall, looking from north-east

30. The distribution of historic features is shown in Fig. 22. Immediately adjacent to the Tower is the base of a stone wall, built of large boulders and over a metre in thickness (Figs. 23 & 24). It is aligned close to the south-west corner of the Tower, but does not quite meet it; it includes the short, straight length of stones near the Tower's entrance (see 22, above). The alignment of the wall deviates at the Tower, clearly respecting a pre-existing feature. To the south-west, it peters out on the rough slope down to Scale Hill Farm. To the north-east it runs rather sinuously for 50 metres, then appears to turn to the south, following the line of the existing field wall, which is built upon a very heavy foundation and lies within a distinct cut which is an average of a metre deep.

31. It seems likely that the old wall represents the boundary of the deer park which was established in the 17th century after the estate had been acquired by the Cliffords. This is suggested by the massive scale of the wall, and by the hollow which runs along its western edge and which can be seen as the remains of a ha-ha. If this is the case, the creation of the park may be seen as the formal enclosure of an existing hunting ground, in which the Tower played an important part. It is likely that it served as a guard-house for the hunting grounds- which were, of course, the subject of considerable dispute- but it was perhaps equally important as a banqueting house, important in the complex and competitive protocols of hospitality involved in Tudor hunting.

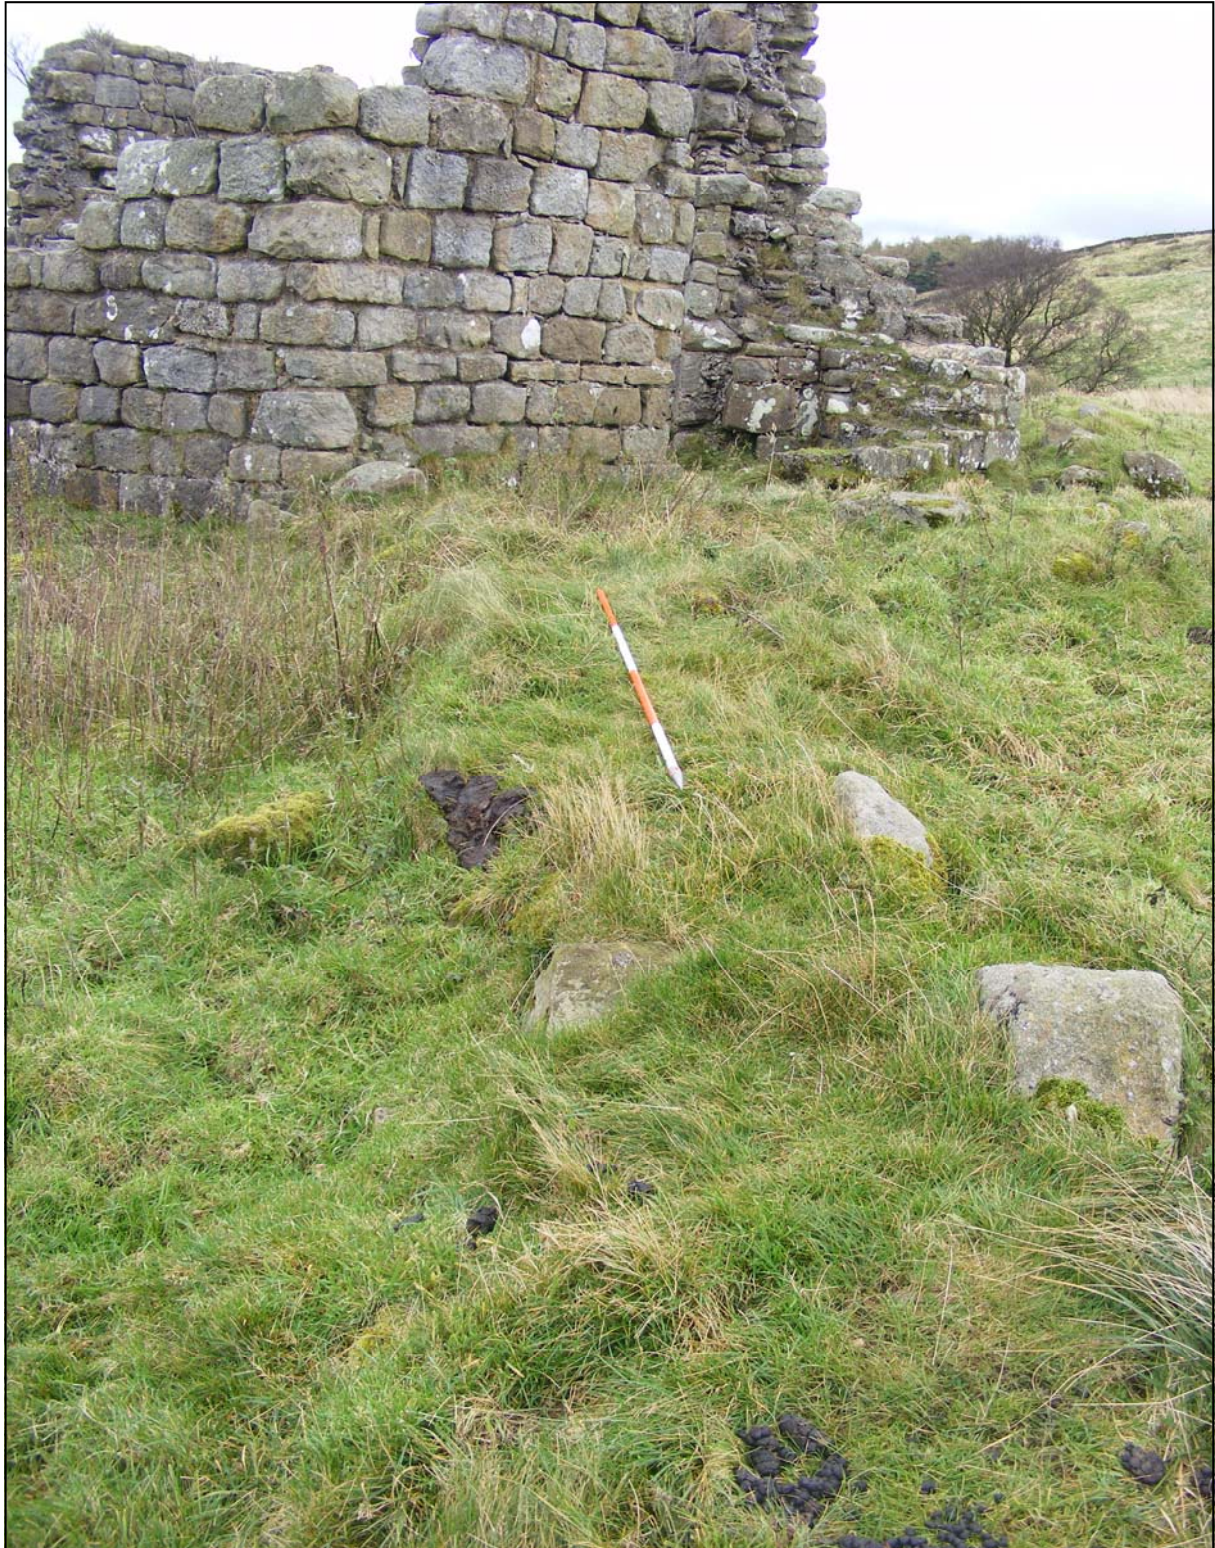
Fig. 24

Old wall, looking from south-west

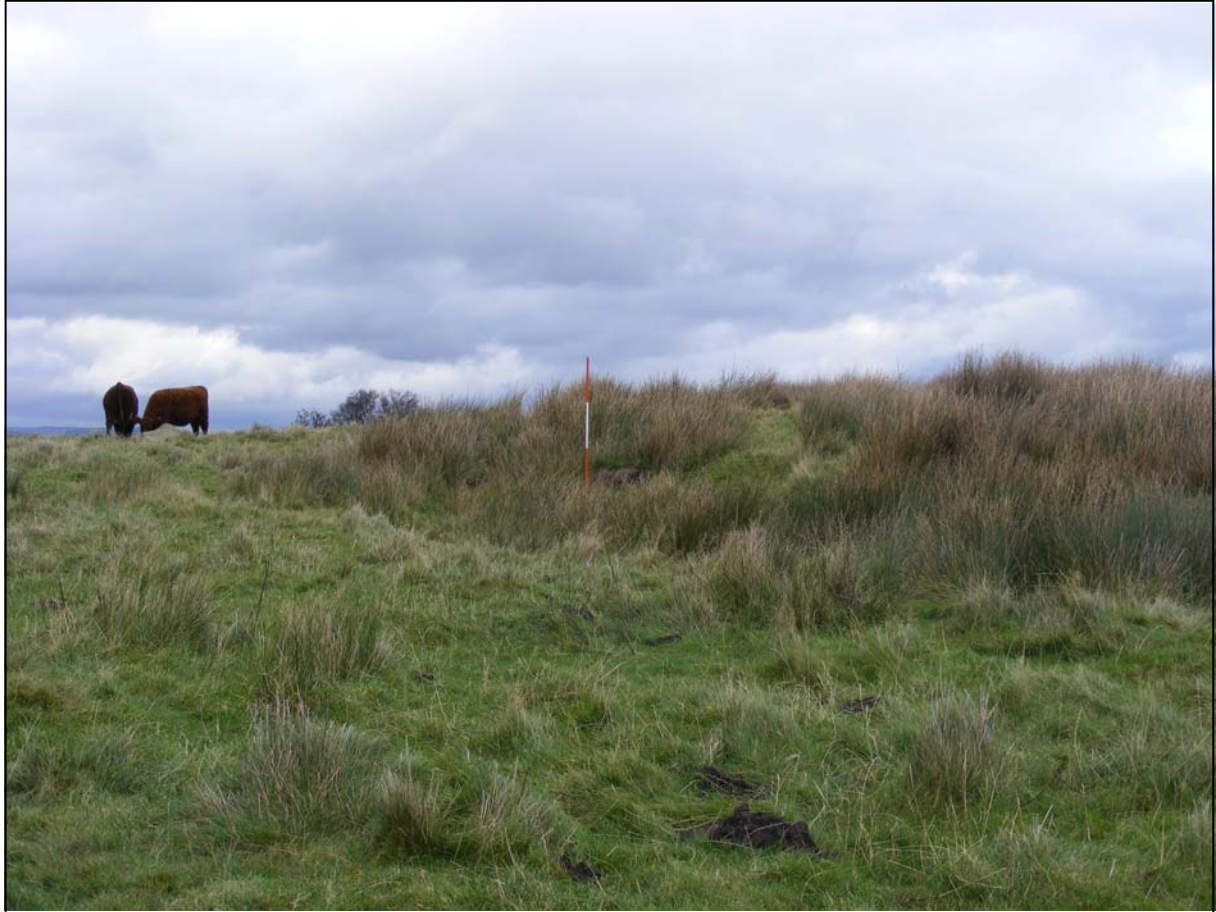
Fig. 25

Central pillow mound

32. Interpretation of the landscape south of the Tower as a deer park is supported by the presence of three pillow mounds. These are rectilinear features, in the form of a low, level mound, ditched on all sides. Their identification with artificial coney warrens is well-established and, in this case, is supported by an attested history of rabbit-breeding at Rylstone. The best-preserved of the three (Fig. 25) is hard against the suggested ha-ha: it is symmetrical and measures 32 metres by 21 metres across the top of the mound; this one, at least, resembles a classic pillow mound. South of it, and also hard against the supposed park boundary; less symmetrical in shape and possibly mutilated on its western side, is another which measures 28 metres by 11 metres. A third (Fig. 26) lies to the west: this is badly mutilated, the west side removed by a large crater which looks almost like a small quarry. All are considerably overgrown, but stand an average of 2.5 metres above the bottoms of their ditches. It is not clear to what extent the disturbances may be attributed to an archaeological investigation of two of them by F. Villey, in 1921; certainly, the large, quarry-like disturbance to the westernmost mound is shown on his plan. The investigation produced nothing but some charcoal.

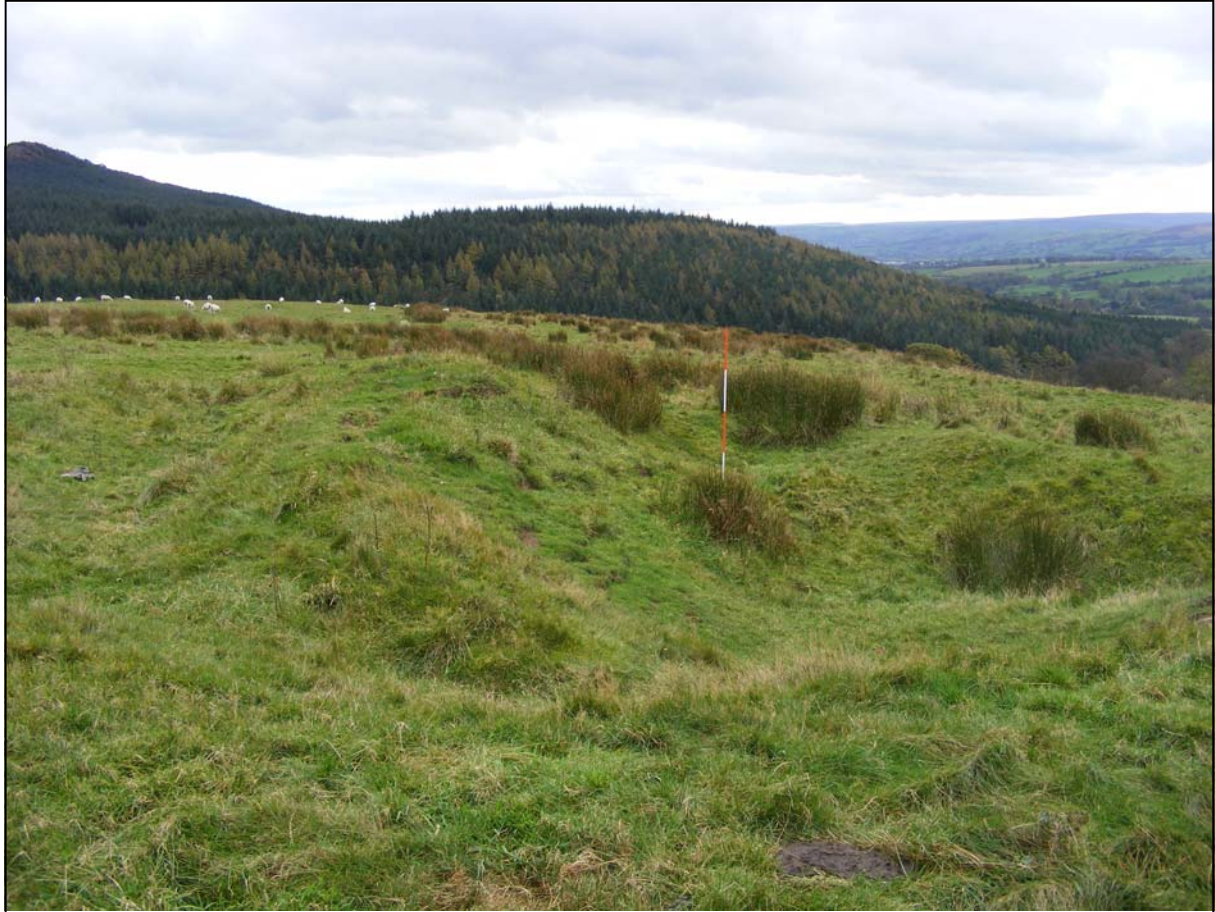
Fig. 26

Mutilated pillow mound

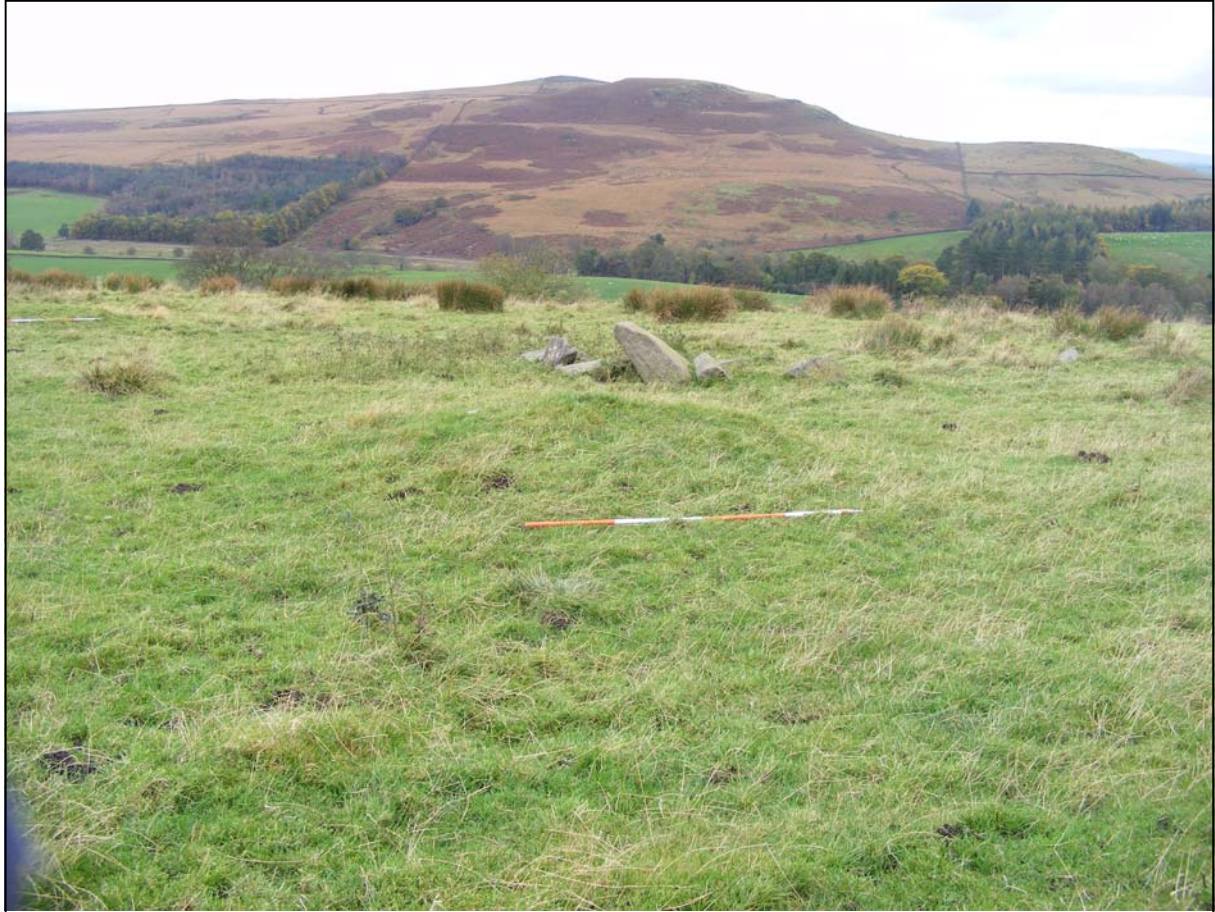
Fig. 27

Typical cairn

33. Scattered across the area to the south of the Tower is a cluster of ten distinct cairns, as well as two more possible cairns, one of which is badly disturbed. All are completely vegetated, and appear as small grassy mounds; all are in the range of 2.5 to 3.5 metres in diameter and 40 to 50 cms high (Fig. 27), though the edges of most are indistinct and they may extend further under the soil. To ascribe a date or a function to these cairns is not straightforward. They are recorded in the Historic Environment Record as clearance cairns, and may well be no more than heaps of stones picked from the surface of a naturally stoney field; indeed, occasional fresh-looking, unvegetated piles of stones in the general area suggest that this practice continues today. It was not possible to identify all 30 of the *small cairns of stones, which appear to have supported posts....(which) may have been for jousting games or horsemanship* (Raistrick, 1963), and the idea is not supported by the surviving evidence. Should these indeed have originated as clearance heaps, a prehistoric date is possible, but the possibility that they relate to the preparation of land for the deer-park cannot be discounted. Finally, it is possible that at least some represent prehistoric burial cairns: the site, on a false

crest and intervisible with known burial mounds, is in some ways typical of an Early Bronze Age cremation cemetery. Recent work has suggested that the distinction between 'clearance' cairnfields and burial cairns is by no means distinct, as at Crawley Edge in Weardale where one cairn containing a cremation with a Collared Urn occurred among others with no sign of burial activity.
