Bradford Potholers House SD 817722

HORTON IN RIBBLESDALE

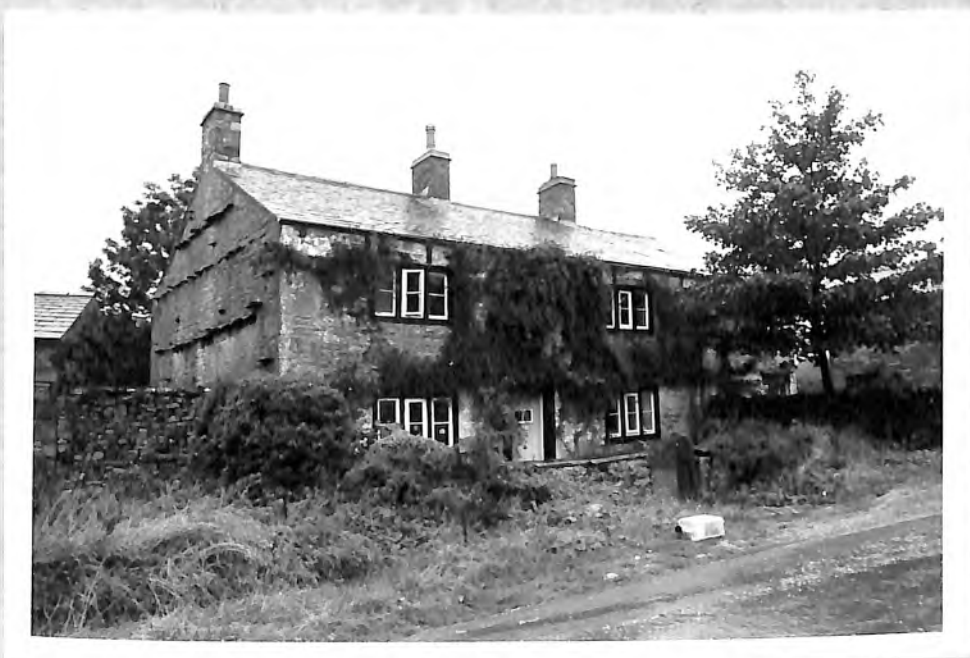
A two-storey 18th century house facing east, with four three-light flat mullioned windows and a central doorway framed with large quoins and a heavy lintel; there is a slate string course, and the upper storey is taller than the lower storey. A single bay outbuilding with external stone stairs has been built onto the north end. At the back there is a central staircase window framed in flat stone blocks with one transom; three small splayed windows with the mullions removed, and one three-light window also splayed in which the mullions remain; a plain back door. The house is two rooms deep and there is a thick central spine wall so that the two ranges were at one time separately roofed - as evidence of this, a tiebeam and principals can be seen in the front south bedroom. The beef kist has been removed. The front north bedroom has a good moulded stone fireplace, blocked. The staircase is modern. Downstairs in the houseplace (south west room) is a very large modernised fireplace with stone jawbs corbelled out at the top dating from c. 1800.

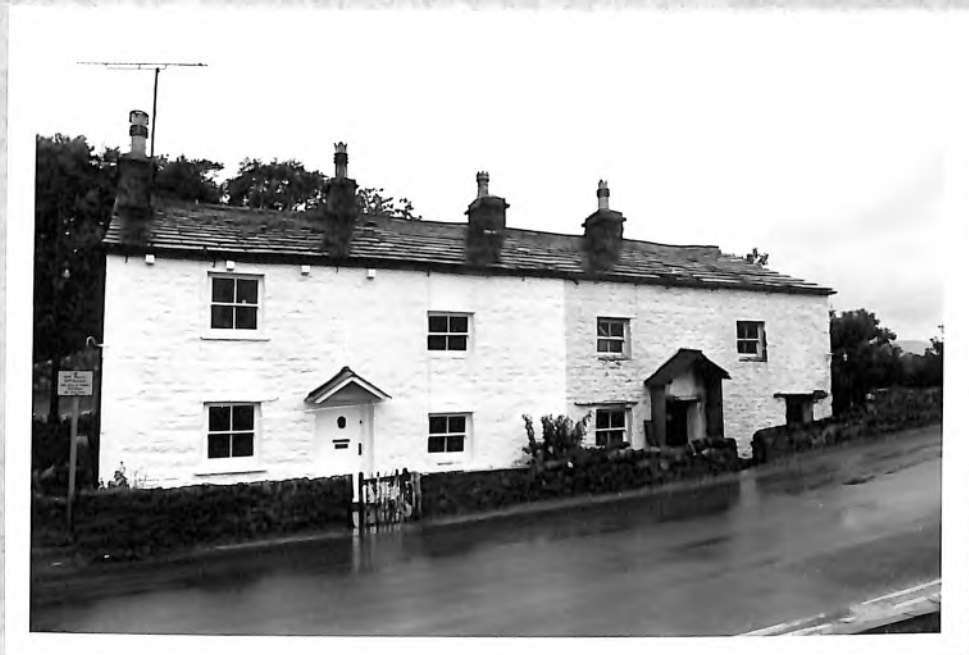
Bridge End Cottage SD 808727 and Hannam Cottage

Two double fronted cottages converted from a three-cell house, perhaps built in the early 19th century and the eaves later raised, and a late 19th century single-cell cottage added at the southern end. They are built of rubble with plain sunken sash windows and plain doors with simple gabled porches. Slate roofs. Group value with the bridge.

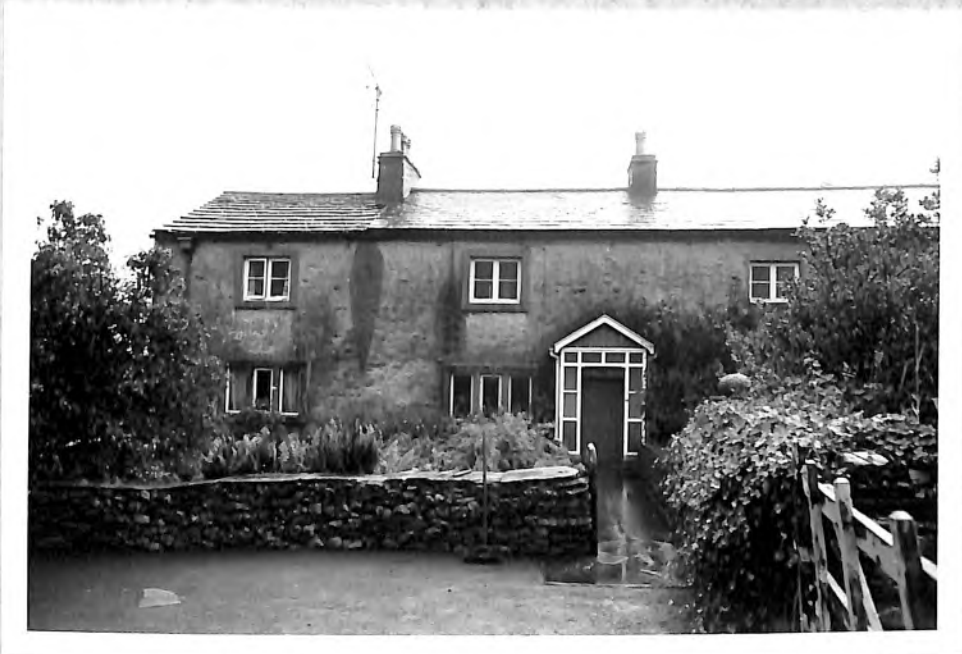
Higher Studfold

A plain farmhouse with rendered walls, later than Capsticks, group value only, as are the other houses in this location.

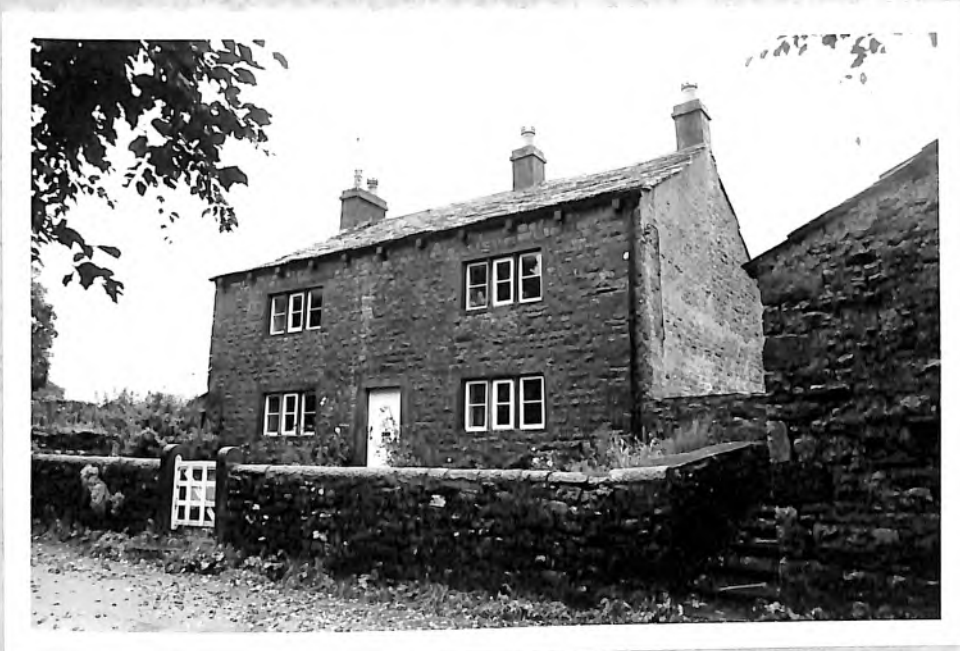
Crooks Farm SD 810721

Two storeys and two rooms deep of coursed rubble with flush quoins, a stone roof and three chimneys. The four three-light windows has very narrow splayed frames and narrow mullions, and the door is framed in flat stone blocks. Heavy square stone gutter brackets. The date may be mid 18th century or mid 19th century but in any case it is deliberately archaic in style.

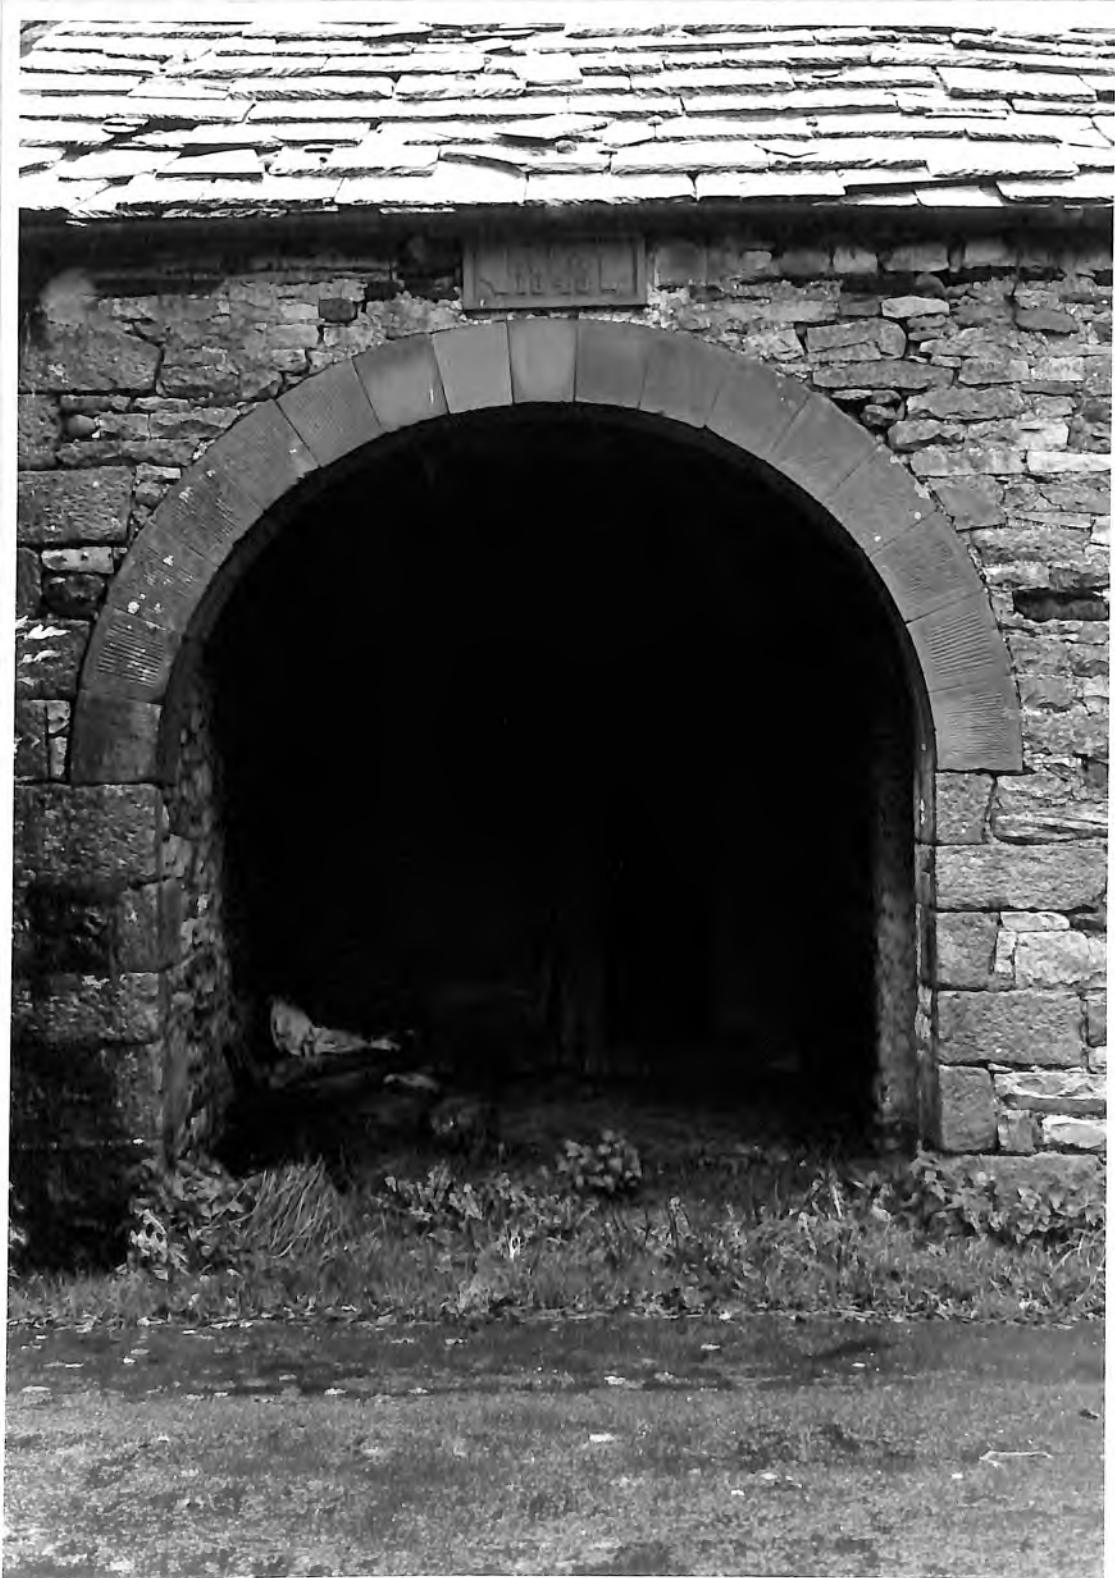
Crooks Farm Barn.

Barn with date 1843

This is a bauk barn with rear entrance at upper level, in front a cart entrance with cow byre to the north of it retaining wooden skell booses; the barn is probably early 18th century but was given a round dressed stone arch and a date plaque in the 19th century. Considerable group value. Buildings attached in a poor way and roofless but ought not to be lost as they maintain the row of building. Yet another bauk barn immediately next to Crooks Farm.

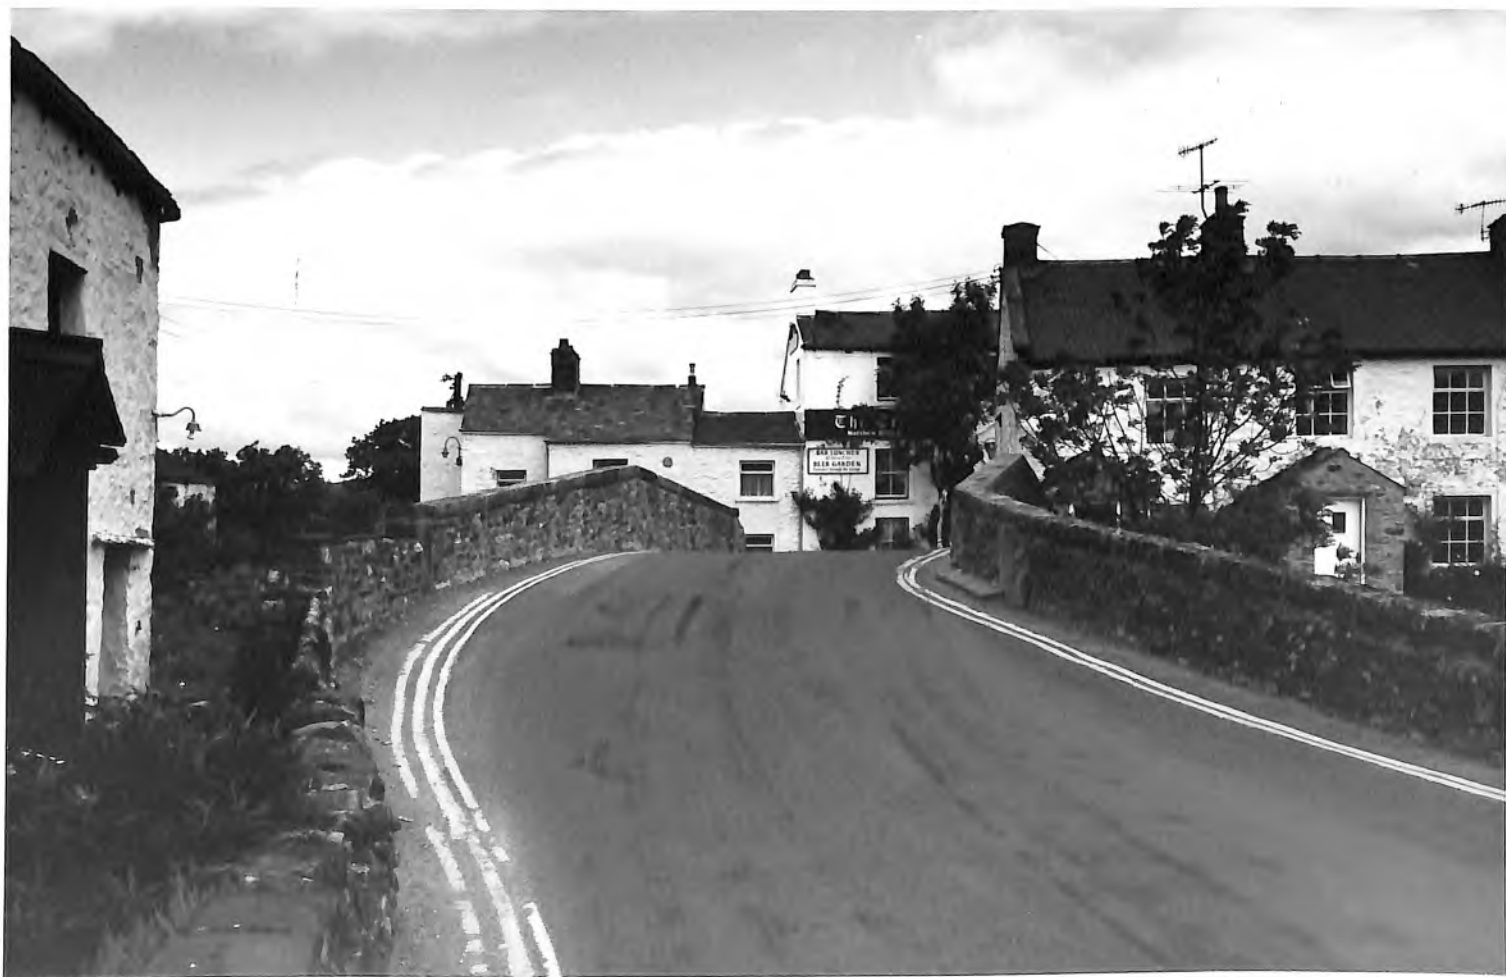
Crown Hotel SD 808727

An imposing 19th century Inn, presumably of the same date as the bridge leading to Rowe End. It has stuccoed walls and stone-framed windows to three storeys symmetrically arranged round a doorway in a porch. To the east the house has been extended by a further bay not quite so regularly designed, and low outbuildings. To the west, a two storey rubble-built cottage with a central chimney completes the group.

Part of the visual impact of this building is lost because it can only be seen close-to; it is unusually tall and imposing for a village inn. Architecturally unremarkable, it has some historic interest (like the Golden Lion near the church) as a reminder of the days when the Settle-Ribblehead road was an important through route.

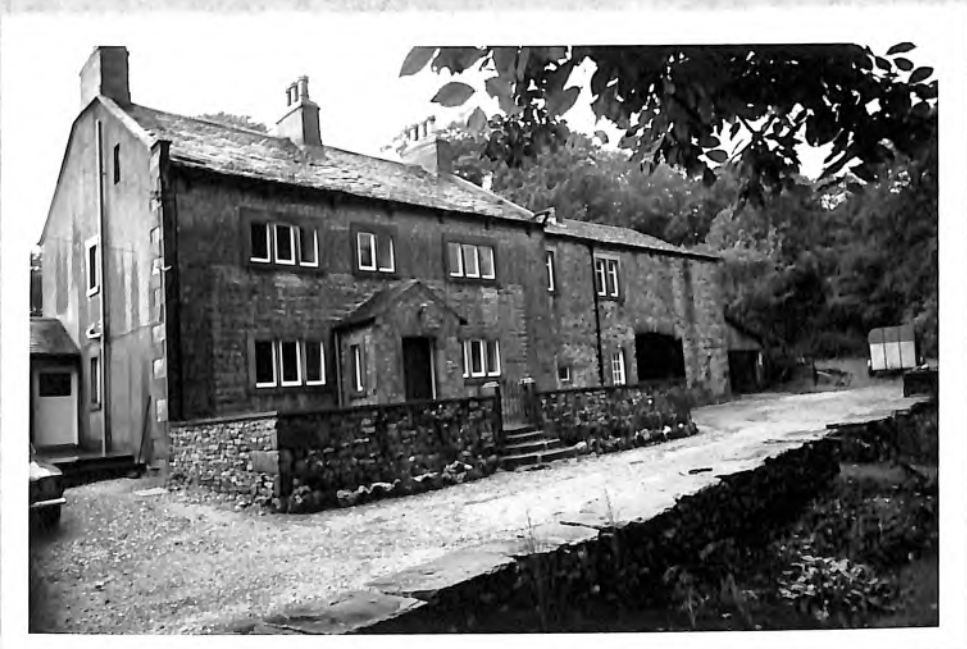
Douk Ghyll SD 813724

all framed in flat sandstone blocks just proud of the surface. Flush quions, three chimneys all in excellent condition. One of the outbuildings has a three-light and a two-light splayed mullion window flanking a plain door on its river side; above is a slate course marking earlier low eaves, but broken into by a later window; this is the shell of a former farmhouse, probably early 17th century, and deserves protection. It could with advantage be made into a dwelling again if the opportunity should arise.

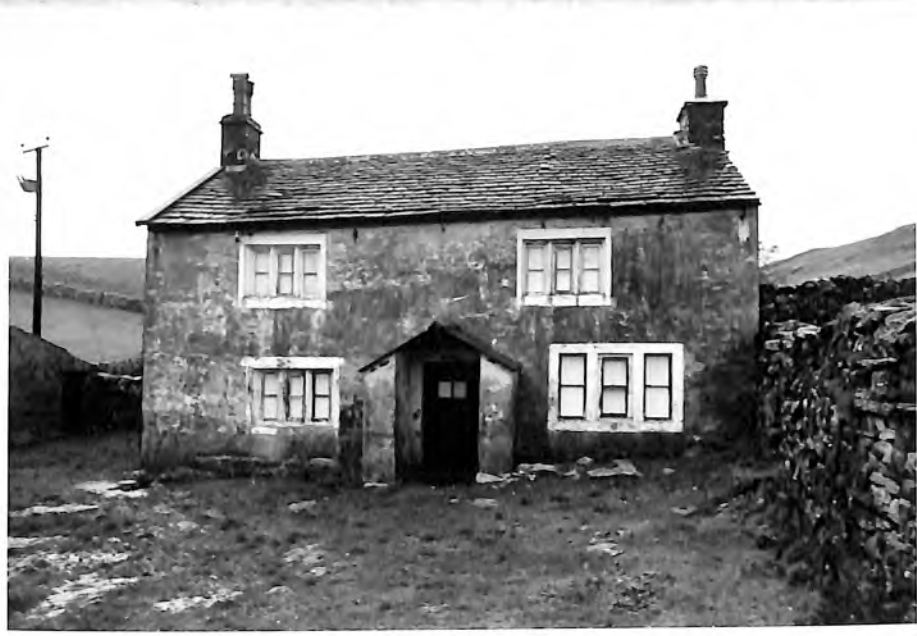
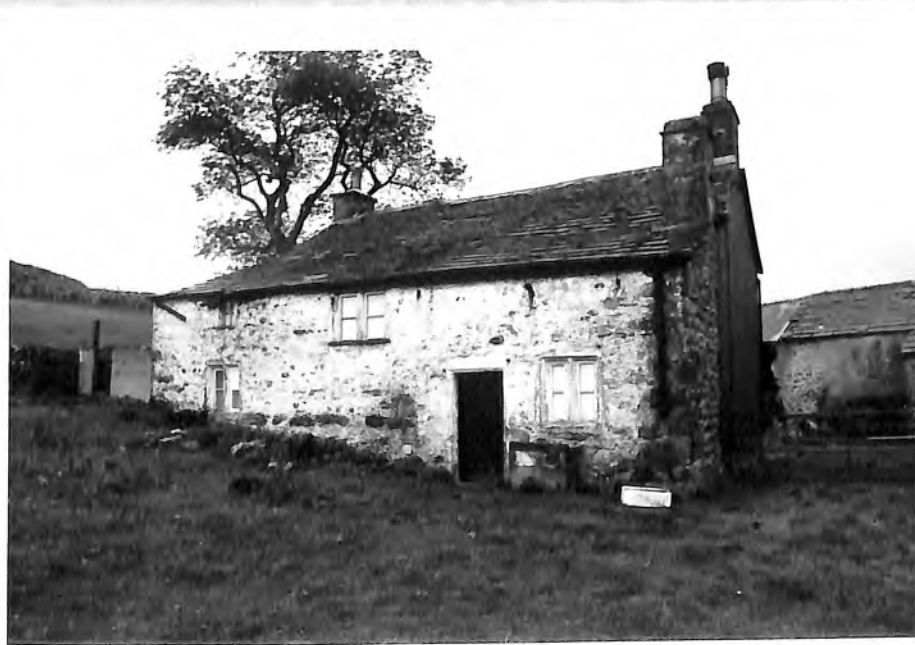
Fawber SD 808744

This house which lies high on the hillside facing southeast, was built soon after 1700 as a successor to an earlier house that has now been turned into a barn. It is two storeys, two rooms wide and two rooms deep. The front has three 3-light splayed mullion windows and the fourth rather larger 3-light window has flat mullions and a square block frame. The front door is hidden by a plain porch. The rear of the house has lower eaves and contains two smaller rooms with the staircase between them. The east end chimney has an external stack. The house is in reasonable condition though only used intermittently (as a study centre?). It is a good example of its kind.

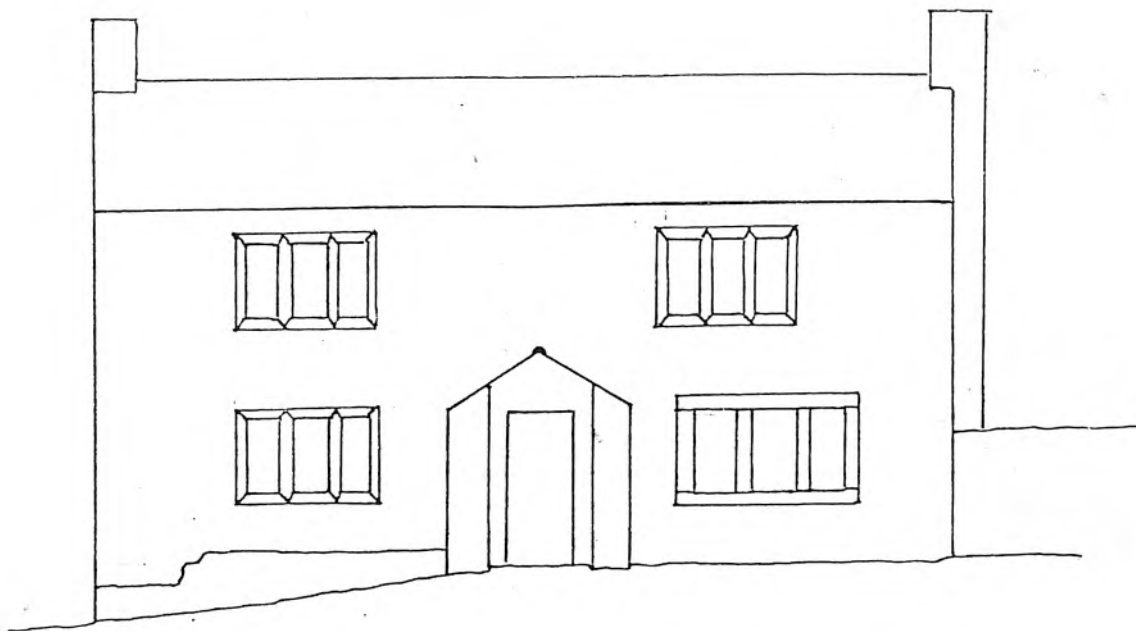
HORTON IN RIBBLESDALE, FAWBER 'B'. SD 807745. visited 8-7-79.

The present farmhouse at Fawber appears to be in use as some sort of study centre. It stands on a remote site, above 1,000 feet, to the east of the farm buildings facing south. Still farther west is the laithe which was formed out of the earlier house (Fawber 'A'). The track by which it is reached from the Newhouses-Birkwith road is now no more than a footpath.

It is built of rubble rendered over most of its surface, on an irregular plinth with a slate roof. All the windows except one are recessed, splayed mullion windows, the exception being the 3-light window with flat-fronted, rear-splayed mullions in the main living-room. The house is in good repair but the interior could not be measured; the inside of the plan, therefore, is sketched only.

The back part of the house is a two-storey outshot with the stairs in the middle. There was originally a transomed 4-light stair-window, the two lower lights now blocked. West of the stairs is a back kitchen with a fairly large round fireplace-arch in the west wall filled in and heavily painted over, with stone shelving built in front of it. The room to the east of the stairs is a dairy with more stone shelves.

The house has the typical plan of the district, a stone wall dividing the front of the house from the back but the other walls only light partitions. It is later than house 'A', but not long after the end of the 17th century, perhaps about 1720-30. The housestead window is later than this - after 1750.

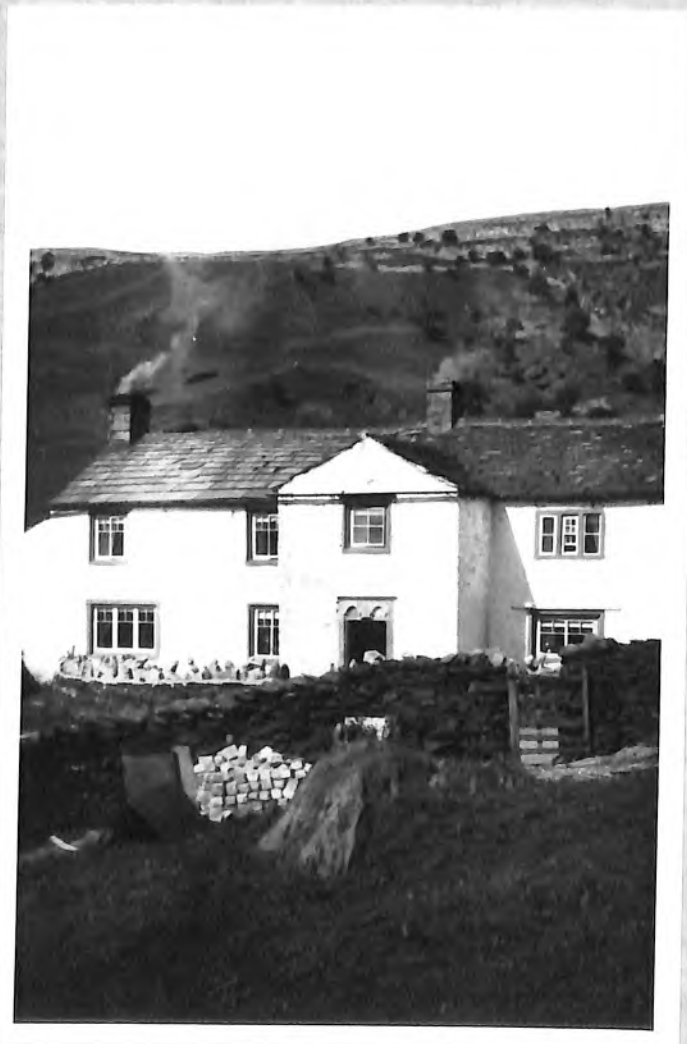
Foredale SD 804700

Left of the porch are a formerly three-light window with a flat stone frame and a modern glazed door; in the upper storey two tall formerly two-light windows with rebated splayed frames, mullions removed. To the right of the porch is an upper three-light window with flat stoned frame and mullions and a three-light rebated splayed window below, the mullions removed, and a dripstone over it.

There is also a fine chimney with a stepped stack at the north end, and two other chimneys. At the back are several small windows with splayed frames.

The barn, opposite the north end of the house, is built of (local stone, (Horton slabs?)) and has a reused cruck as a lintel; inside, the roof timbers include strongly curved members that may also be reused crucks. List says 'in the barn is a panel bearing the date 1657'.

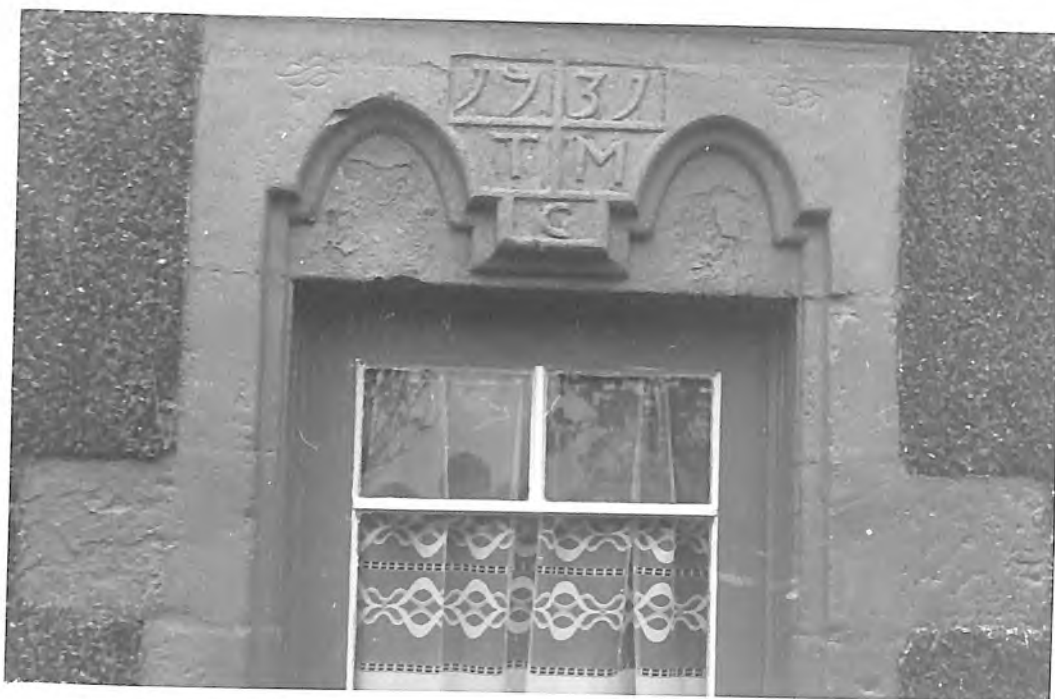
Date-stone at front of house.

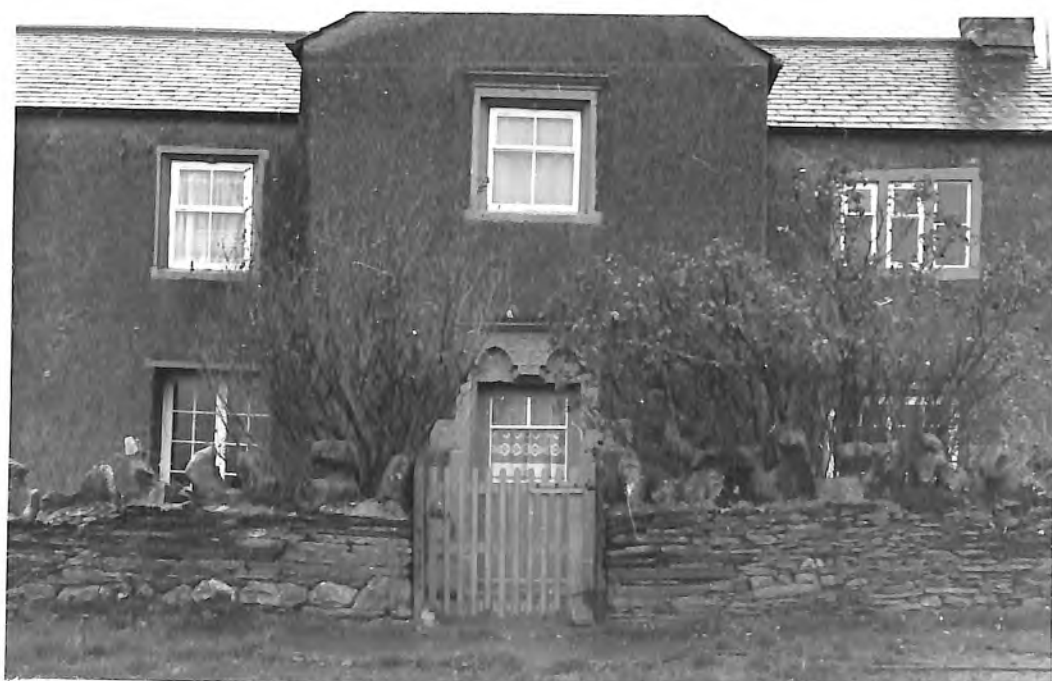
Front of House.

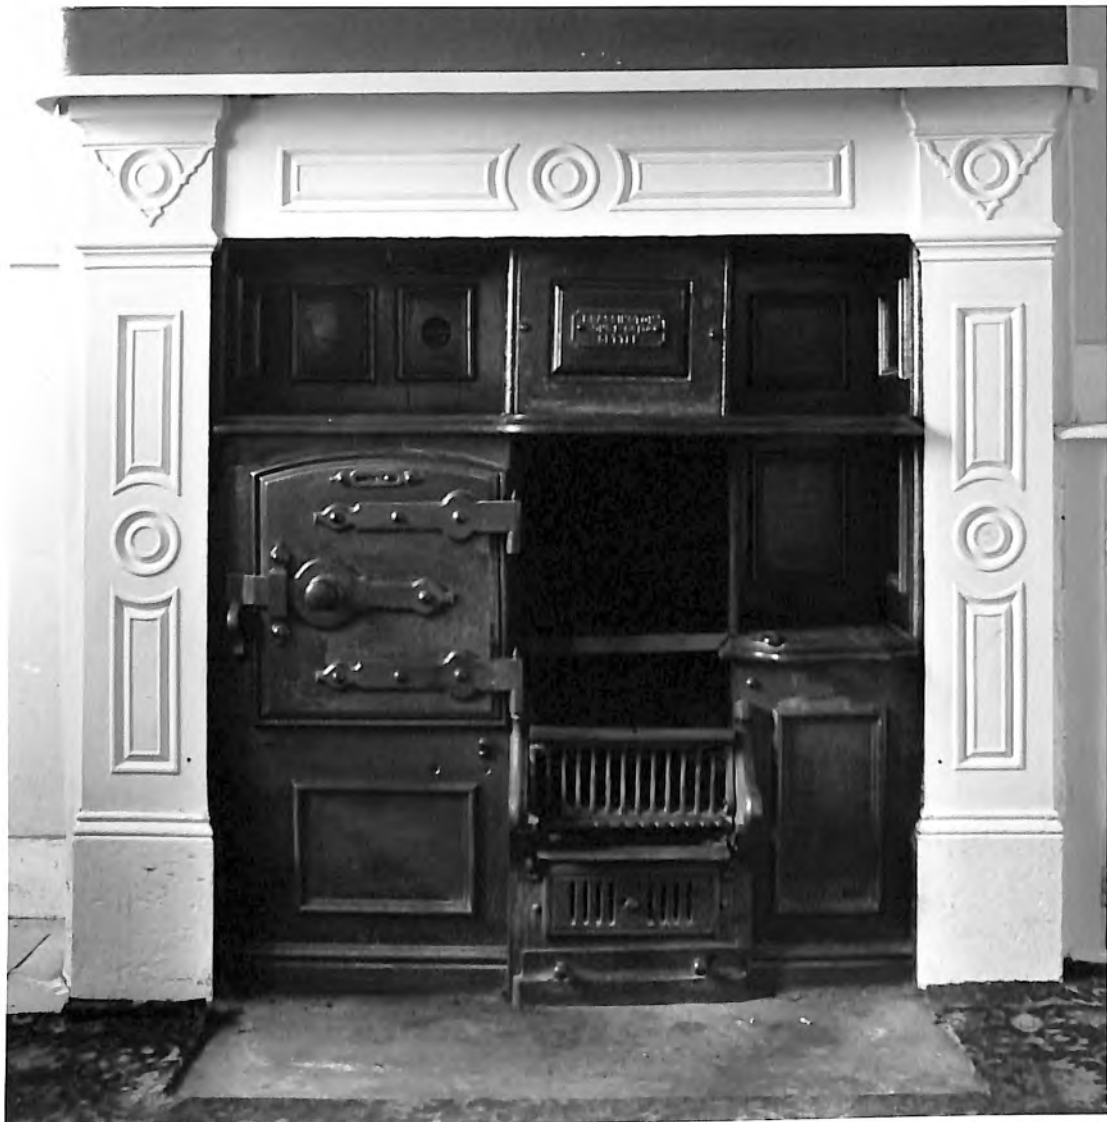
A range in one of the cottages.

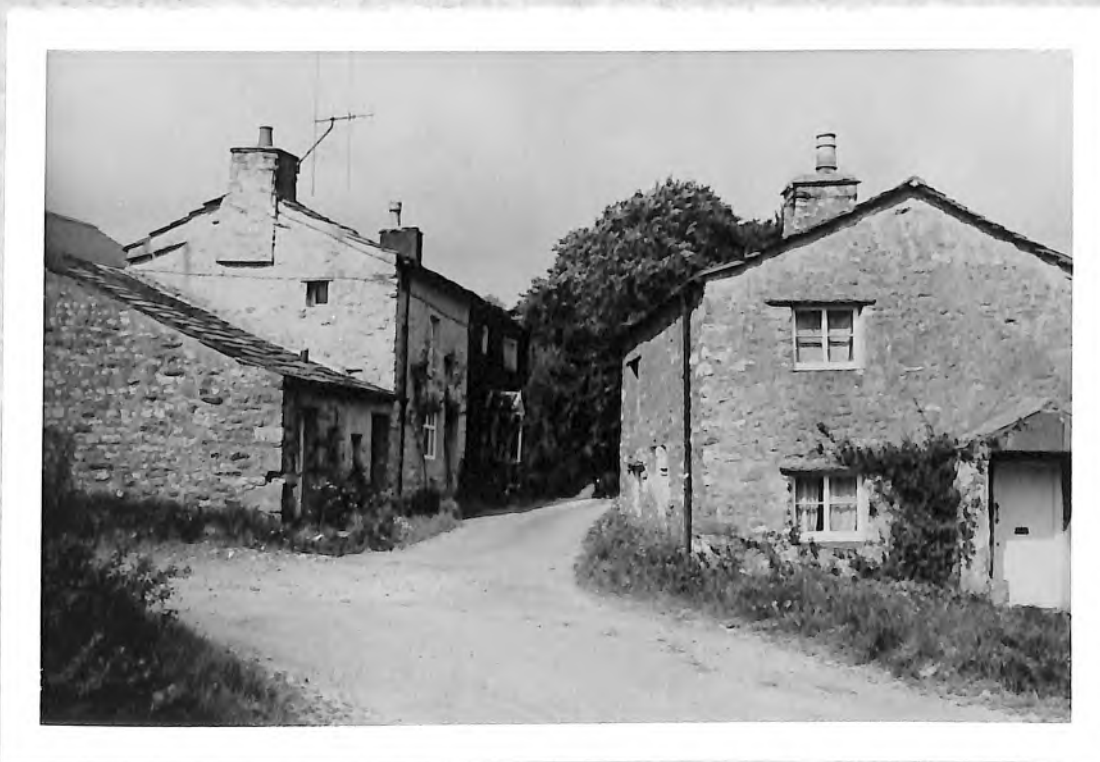
Ghyll Head cottages SD 811722

Two cottages formerly a 17th century farmhouse, facing east towards the river. The north cottage is covered in dark grey pebble-dash but has a blocked two light splayed mullion window in the gable end; a single arched light and a three-light upper window, also splayed, in front but below them a plain doorway and a large square steel-framed single pane window. The south cottage had a splayed two-light upper window, now with the mullion removed and the sill dropped, and a large single pane lower window under a concrete lintel where there was formerly a stone-framed sash window, this replaced a four-light window described in the List: plain door. Corbelled-out plain chimneys at each end.

In front, Ghyll Cottage, no architectural value but of group value.

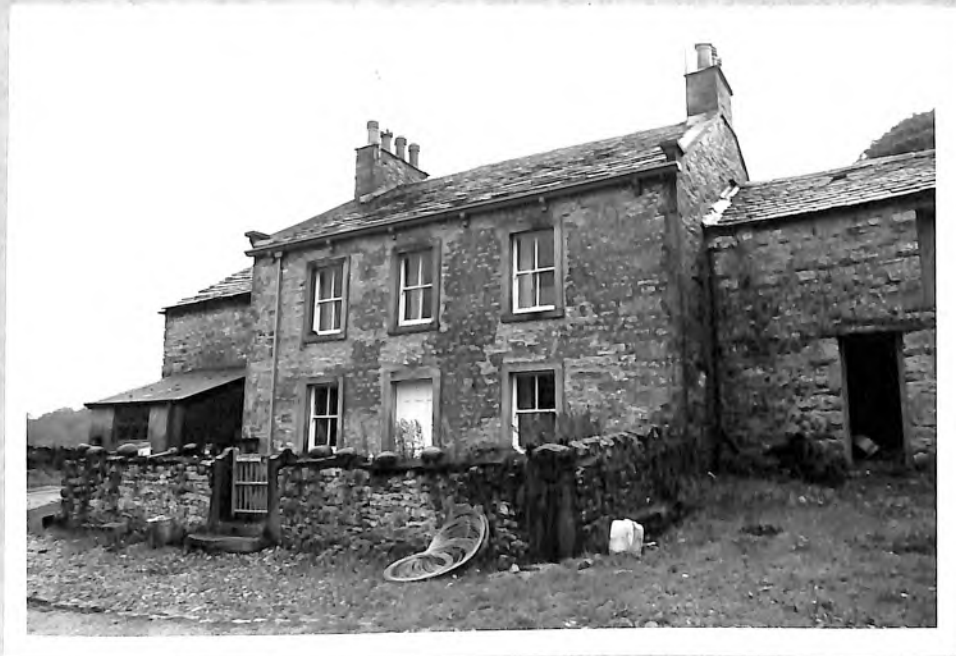
Greengates SD 817722

The symmetrically designed front facing southeast or south has four tall sash windows and a door framed in flat milled sandstone blocks, the lintel inscribed F E F 1781 in characters of a 19th century type. Nine panelled door. Moulded stone gutter brackets, and plain gable-copings with kneelers. At the back there are splayed frames to what seem to have been cross windows, and a fine doorway with a deep, cyma-moulded lintel and jawbs, with the inscription 17^F_{TA} 12. Against the west end is an outbuilding with a west facing window re-using a large stone-lintel with a Tudor arch under a squared head.

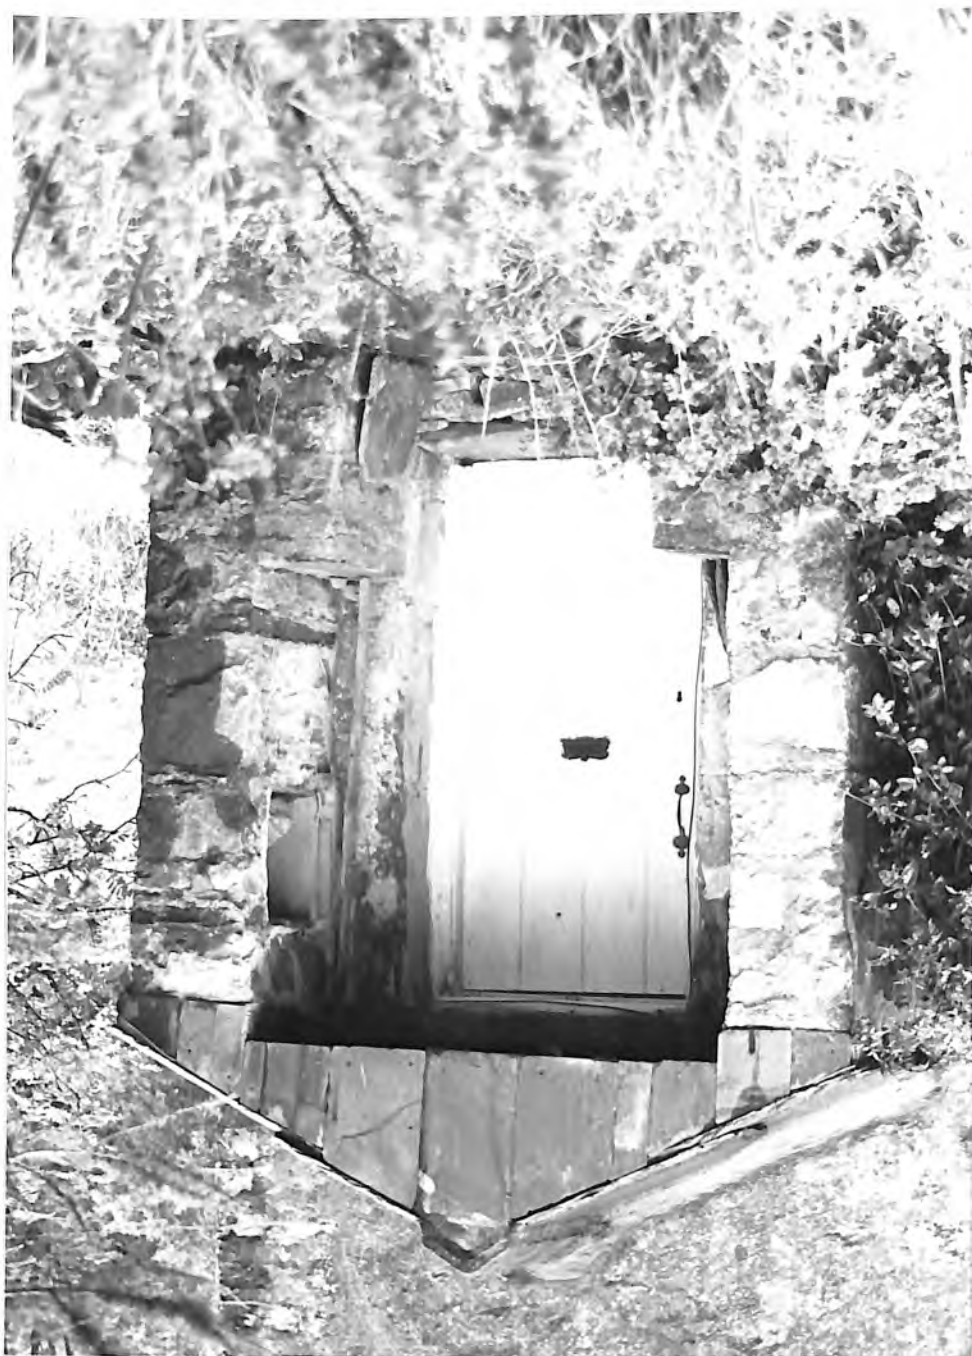
Ghyll Cottare (2).

Doorway of cottare.

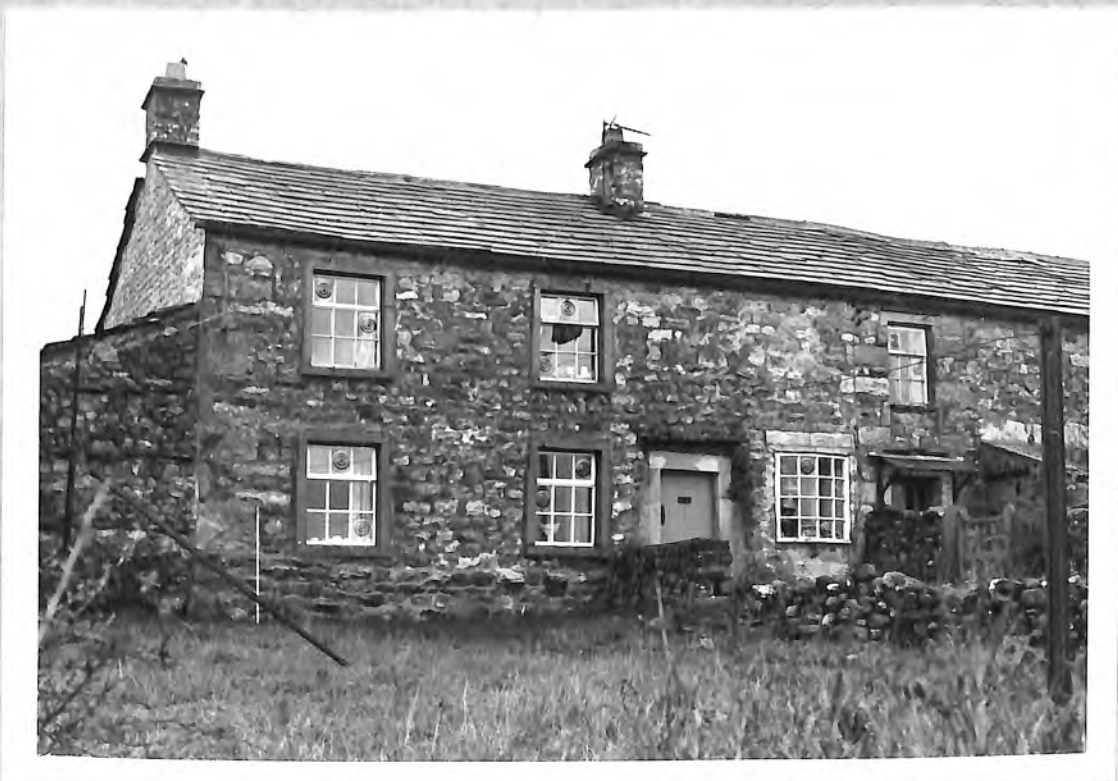
Harber SD 807729

This small farmhouse stands alone to the east of the Newhouses road with a laithe attached at the eastern end. It faces south. It is rubble built with stone-framed windows and a quoined door, but formerly had lower splayed-mullion windows of which some traces remain and a deep door lintel replaced by a shallower one. It was built soon after 1700 as a two-cell house with the door opening into a lobby in front of the chimney stack, a 17th century plan of which this is the only example in this parish. A non-domestic end east of the front door has been made into a kitchen with a recent shallow-bay window glazed with bulls-eye glass. There is a rear dairy wing with no upper floor though it is two storeys high. A cupboard inside a blocked fire-window is dated 1747. This house is of considerable historical interest as an example of a building design now uncommon; recent alterations to the windows etc. do not seriously detract from this

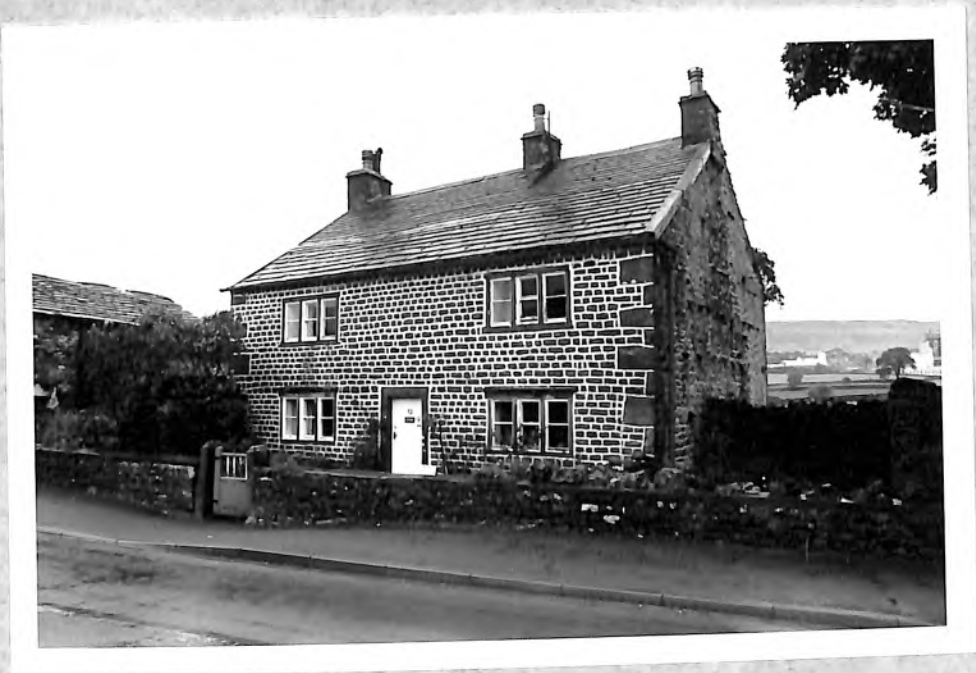
Holme Farm SD 809722

Two storey house with four three-light windows framed in squared blocks set in regularly coursed well-squared masonry with flush quoins. The similarly framed door is covered by a modern porch. There are three chimneys. Good 18th century work. Adjoining buildings end-on to road in derelict condition, probably older than the house.

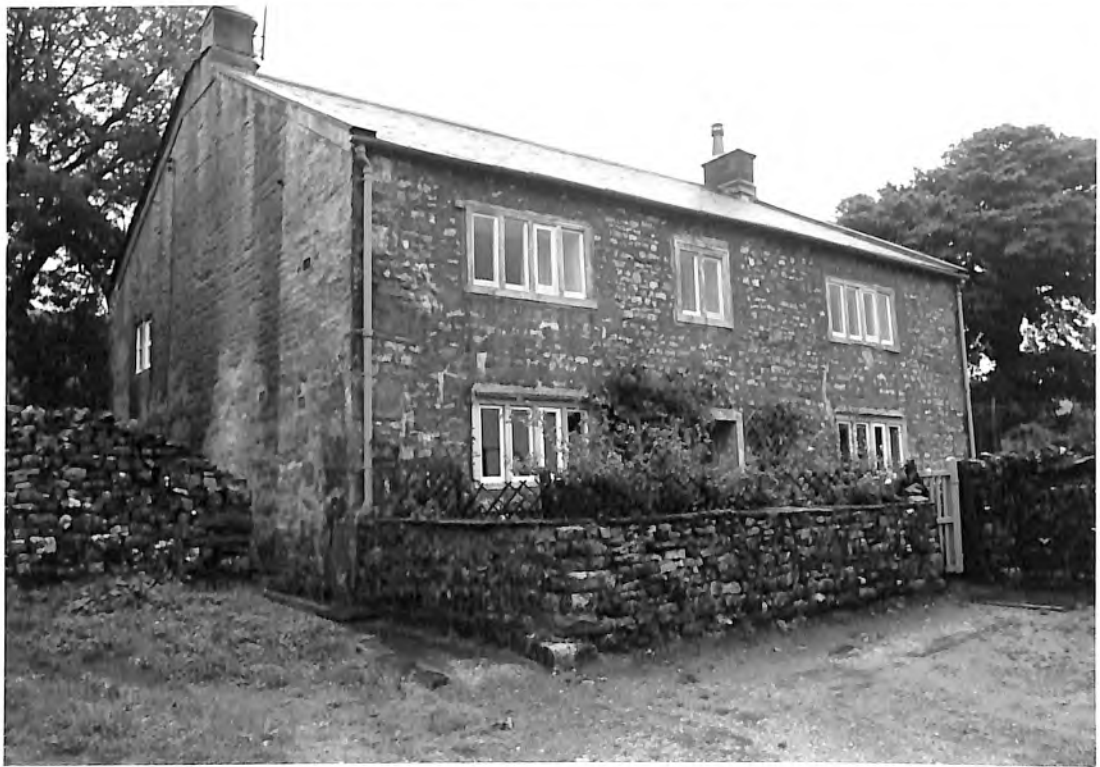
0-12
Keepers Cottage,
Brackenbottom SD 817722

A two storey two room deep house facing south at the north end of the hamlet with four four-light windows on the front framed in narrow flat-moulded architraves, and a two light window to match over the door. The lower windows have dripstones. The front doorway is built of 19th century milled blocks. The barn opposite has been demolished, but there is another large barn near the west end of the house with big gritstone quoins, a tall cart door facing west and a three-door cowhouse at the south end towards the road.
