# Strolling around Selside

On Sunday 2 July, as part of the 1995 Annual Conference, we were given a guided tour of Selside, a small hamlet two miles north of Horton-in-Ribblesdale. Our guide was Hilary Fenten, who lives in Selside.

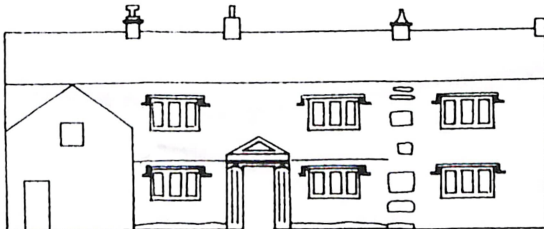
The Shaws

Our final call was at **Shaws Farm**, or The Shaws, the home of Hilary and Wilf Fenten. This house reputedly dated from 1680 (the central part) with a 19th century extension at one end, and a further extension to the other end, believed to have been used as a milking parlour.

The front door was graced by an added 18th century porch, lettered JJ 1738, and clearly reused from elsewhere. The stone pedimented and pilastered porch sat uneasily on this vernacular Dales farmhouse, as did the carved two-panel 17th century door also brought from elsewhere. The staircase too, with its fat turned balusters of apparent 17th century date, was believed to come from another building.

The biggest surprise lay in the roof, where reversed and cut down cruck posts had been refashioned and reused. Clearly, this was a house worthy of more detailed inspection in the future, and our thanks must go to Hilary and Wilf for their enthusiastic help in the exploration of their home and hamlet.

*Not correct in many details!*
